**HISTORICAL SITE ASSESSMENT
OF THE CURTIS BAY DEPOT
CURTIS BAY, MARYLAND**

Prepared for the
Defense National Stockpile Center
Defense Logistics Agency

FINAL REPORT

MAY 2005

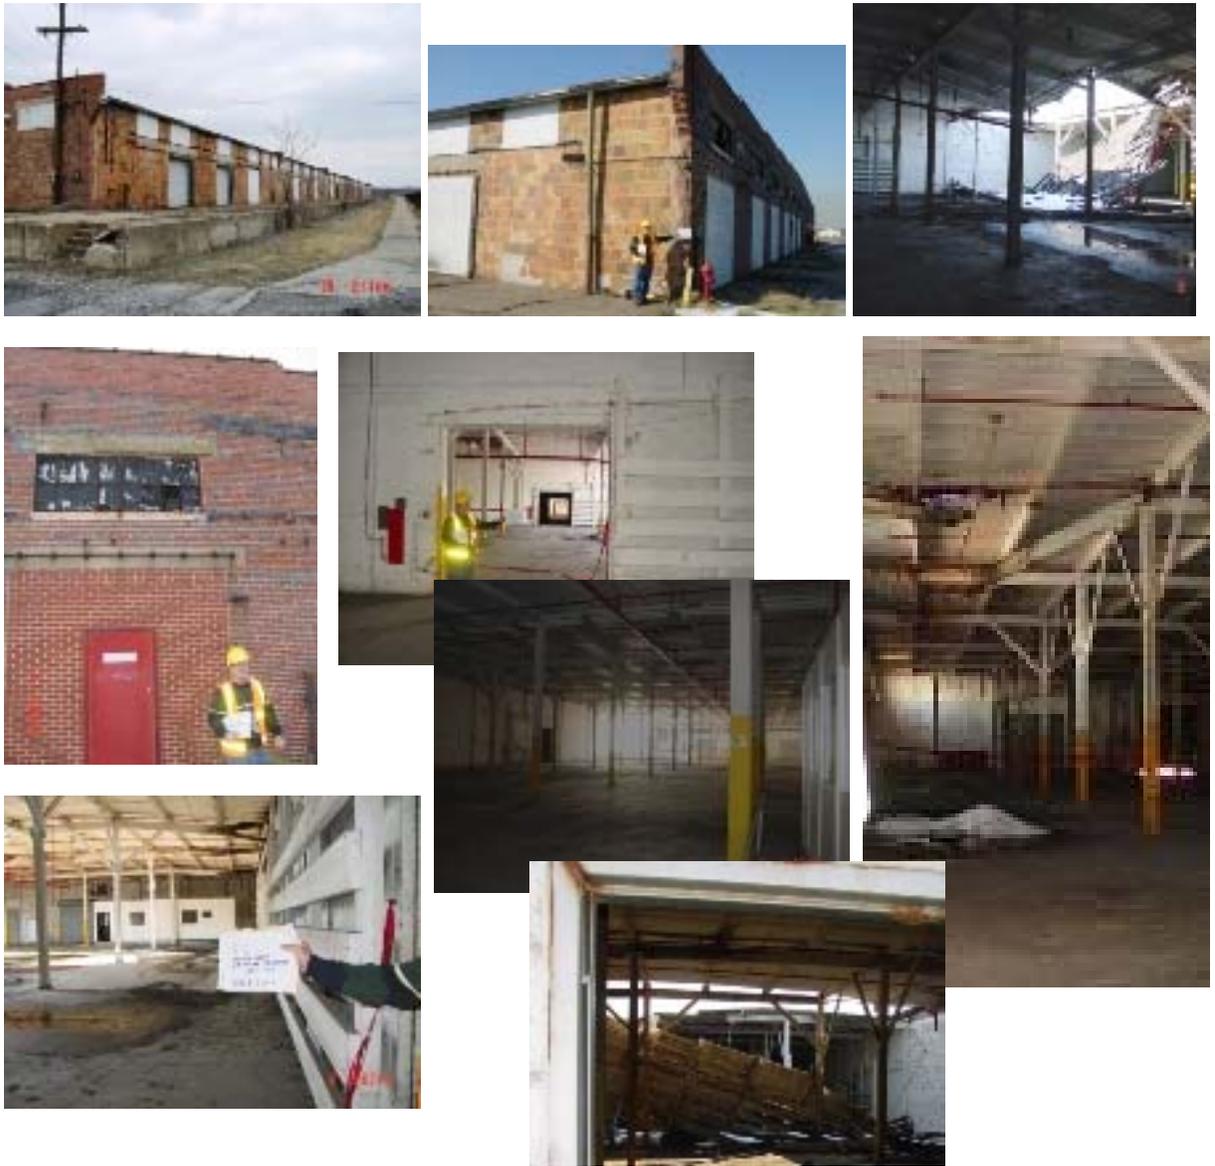
Dimensions: 240' x 600'. Several collapsed roof areas, and roof structural problems, but these could be roped off (and accessed by pole mounted equipment, or robotic equipment). Not certain that power is off (but probably should be). Supplemental lighting would likely be needed for surveying. Some areas where roll-up doors previously existed are now filled with concrete block. Bird droppings in some areas.

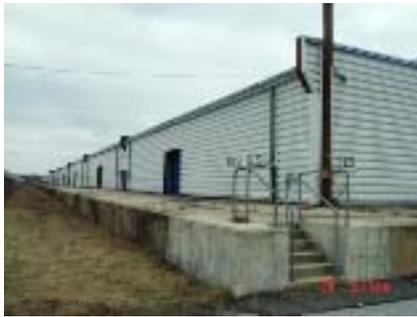
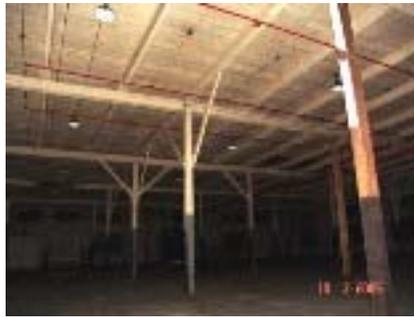
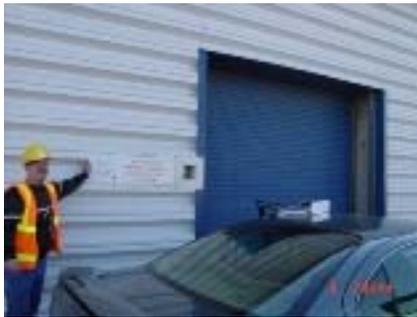
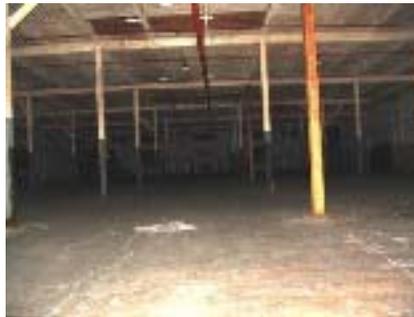
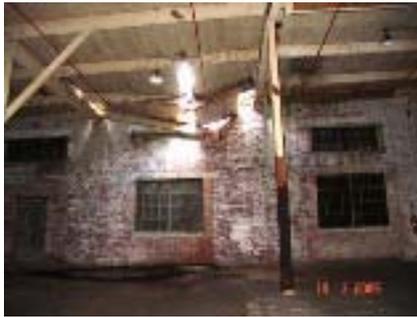
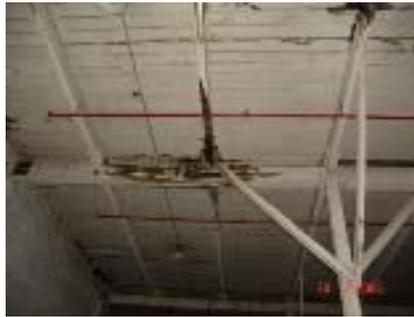
BUILDING 1022
CONDITION IV

Dimensions: 240' x 600'. (less problems than in Building 1021) Some localized roof structural problems, but these could be roped off (and accessed by pole mounted or robotic equipment). A few small pre-fab. office areas might preclude access to some of the original floor surfaces. Sheet metal covering over exterior walls. Lighting – some working; some not. Would likely need supplemental lighting to conduct surveys.

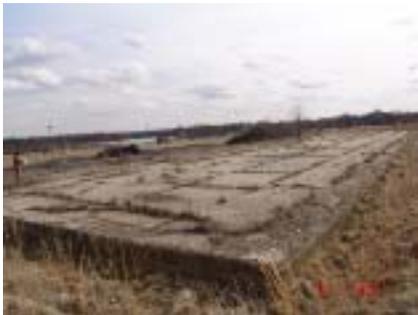
BUILDING C-1133
CONDITION I

Dimensions: 50' x 220'. A cleared slab with a few small collapsed concrete areas. Dock elevation approx. 5' (fall hazard). No road access (need to bush hog an access pathway).

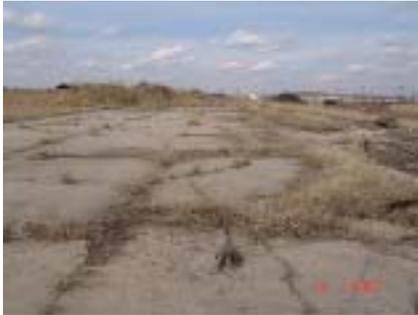
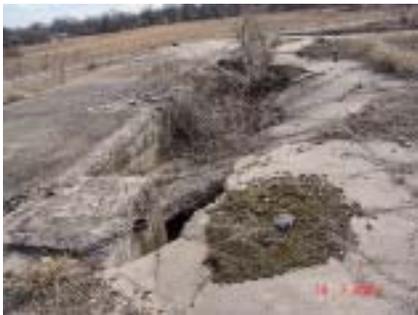
BUILDING C-1134

Dimensions: 50' x 220'. A slab with a grass covered dirt pile that covers 15-20% of slab area at the NW corner. Slab is collapsed at SE corner (approx. 20 to 25' long by 3' wide).

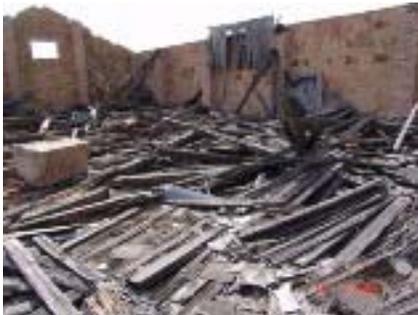
BUILDING D-1121

All roofing has collapsed, with debris covering slab. Several portions of wall are down, and stability of remaining walls is questionable. No road access (may need to bush hog an access pathway).

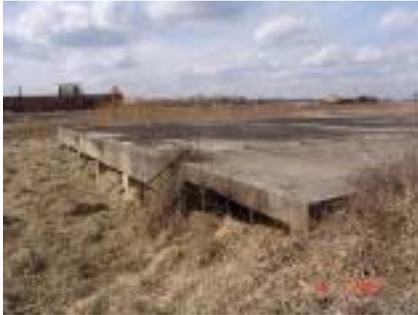
BUILDING D-1122

A cleared slab. South and west sides have elevation (fall) hazard ~ 6'. No road access (may need to bush hog an access pathway).

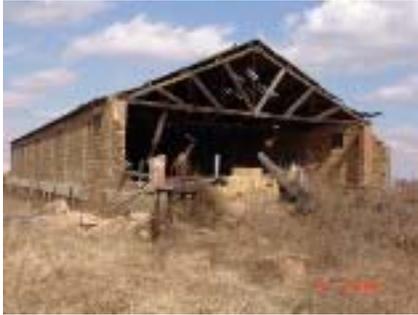
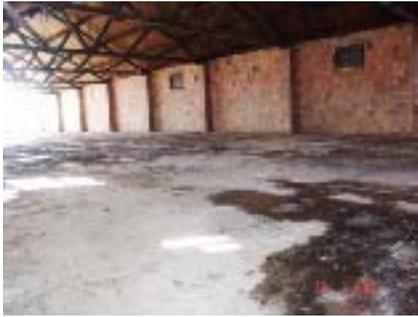
BUILDING D-1123

Nearly no debris on floor. Use pole-mounted or robotic equipment. Door 5 and surrounding area collapsed. South wall fallen outward. Early form of “concertina” razor wire on ground along west and north walls. Loose roof shingles – some blown 20-30 ft from building. No road access (may need to bush hog an access pathway).

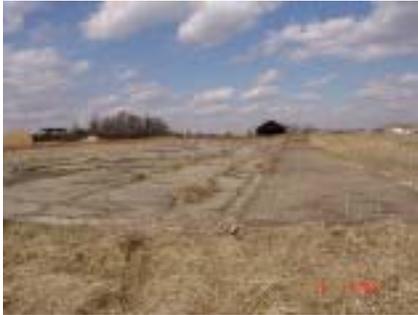
BUILDING D-1124

A cleared slab with a collapsed concrete area at NE corner (approx. 8' x 2'). No road access (may need to bush hog an access pathway).

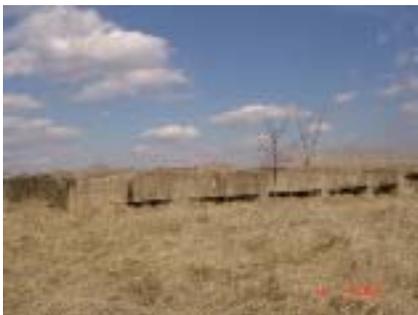
BUILDING D-1125

A cleared slab with a collapsed concrete area at NE corner (approx. 8' x 2'). No road access (may need to bush hog an access pathway).

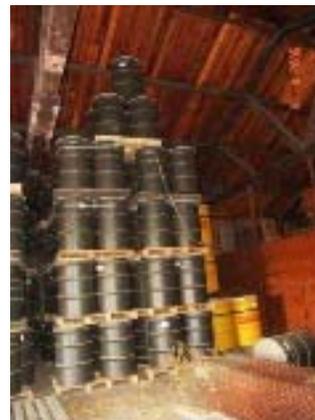
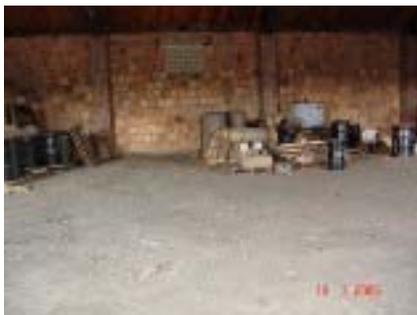
BUILDING E-1111
CONDITION II OR IV

Condition depends on amount of area required to survey to release this building. Wall buckling at north end of door 5 and roof truss is broken (supported by pyramid stack of railroad ties inside building). Remain out of this area. 60-70% of floor is accessible. Entry is okay for door 4 and points north (and can use poles or robotic equipment for areas south of this point). Stay back from stacked drums (at least a distance equal to height of drums). Power and lights available.

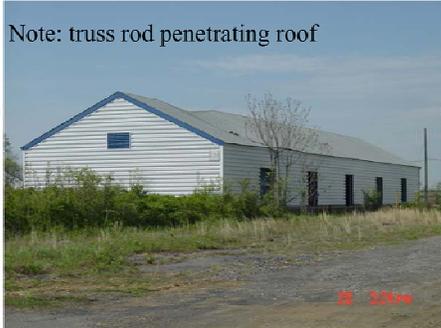
BUILDING E-1111 UPDATE

ORNL provided an update on the condition of Building E-1111 on April 27, 2005. Refer to the photograph annotations below.

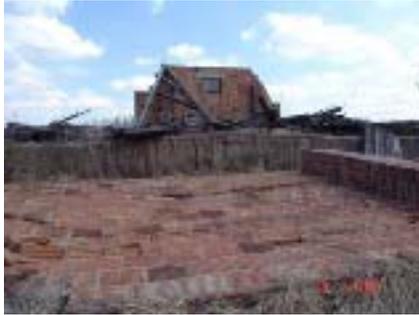
Small section of east wall is only wall still standing. North wall fallen outward. Most of east wall fallen outward onto dock. No clear floor areas (roofing material and two stacks of pallets cover floor). No road access. Need to bush hog an access pathway, or pull up railroad ties and use area as a road).

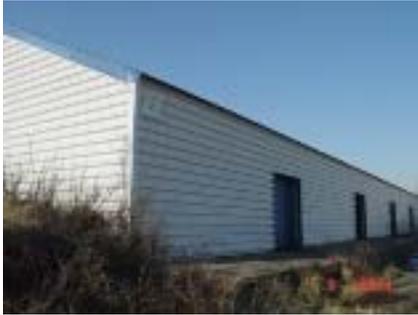
BUILDING F-731

Dimensions: 50' x 220'. Need to move pallets of drums to access floor for surveys. Okay for entry. Drums (empty) are stacked on south end (4 pallets deep by 9 pallets long, by up to 4 pallets high). Floor has several areas where the concrete was previously scabbled for decon purposes. Roof hole above drum storage area.

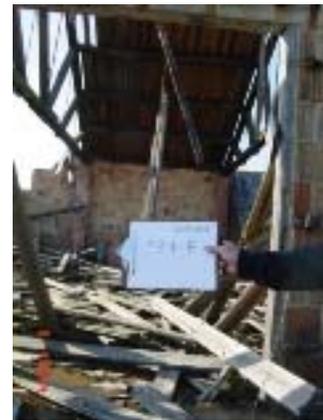
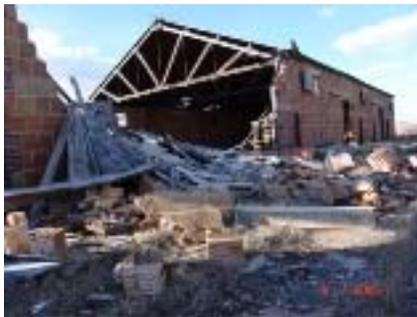
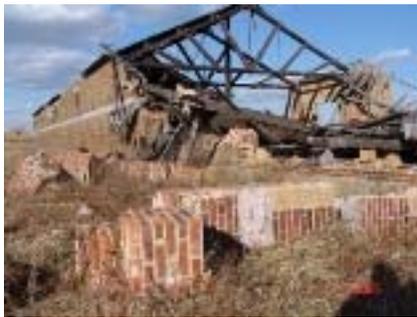
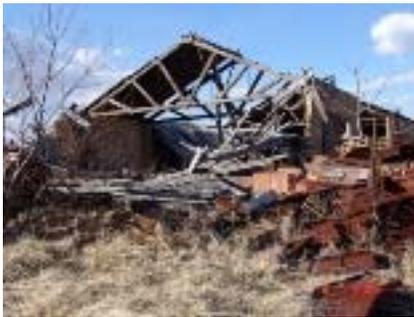
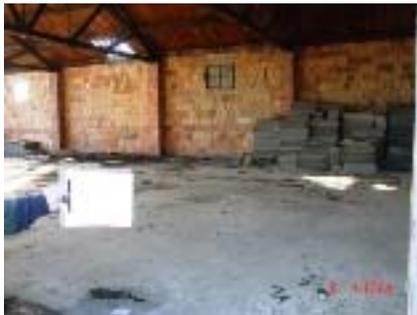
Dimensions: 50' x 220'. 2/5 of roof has collapsed; the rest has holes. Only portions of walls are standing. Remaining portion of roof and remaining portions of walls should be taken down. While some areas of the floor are clear, metal shelving and roofing debris block access to other portions of floor.

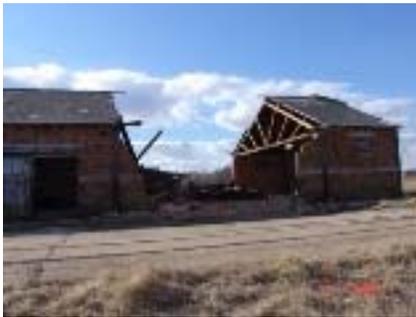
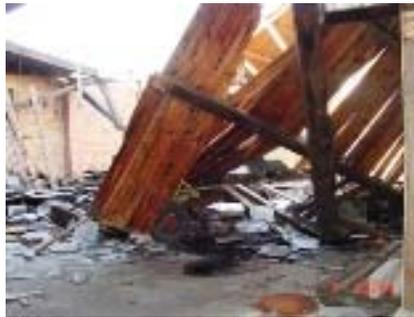
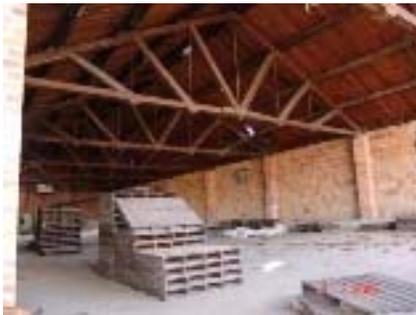
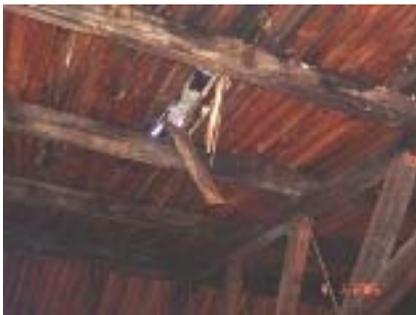
BUILDING F-735
CONDITION V

Dimensions: 50' x 220'. 20 to 25' section of building totally collapsed (near north end). A portion was intentionally knocked down in early 2005 (after a roof collapse) to allow access to retrieve some transformers. Remaining portions of roof should be taken down. This building has poured concrete dikes. Pallets and other items cover portions of the floor.

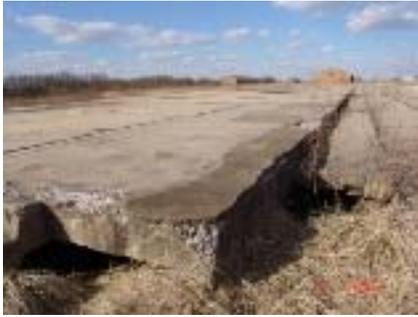
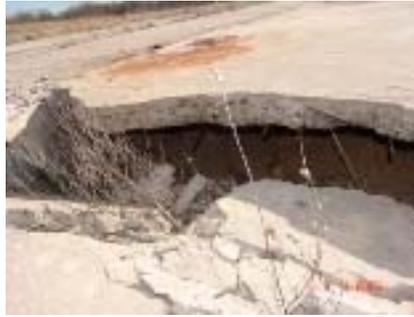
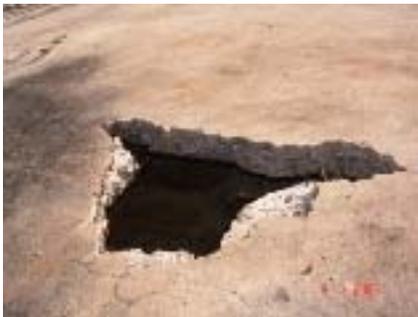
Dimensions: 50' x 220'. A cleared slab with several collapsed areas (4' to 8' by 4' to 6' deep).

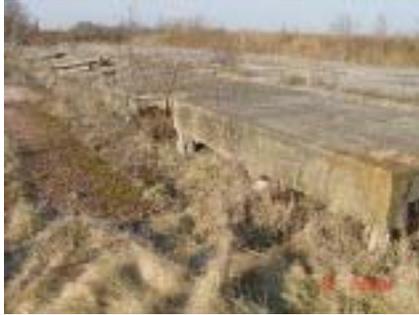
BUILDING G-721

A cleared slab (dock has collapsed in several places).

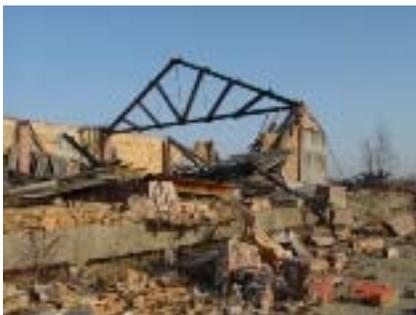
BUILDING G-722

All of north wall is down. North end of east wall is down. North half of roof is down. Large section of brick pillar “perched” half off loading dock. Lots of roof debris on concrete floor. Some metal shelving, tables, on south end. One bay has some clear areas for possible survey by pole or robotic equipment.

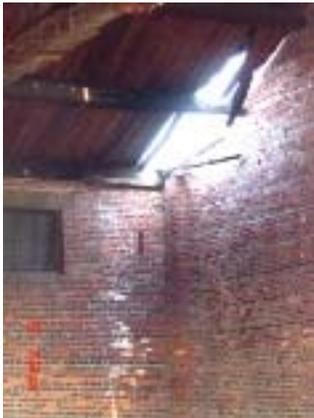
South end of roof is down. Roof hole in NW corner; and other roof deterioration areas. Door 5 (south end) is a sliding door and is shut (stuck?). Door 4 is slightly open. Floor is clear except at south end. Possibly access cleared areas by pole or robotic equipment. Heavy shingles could come off towards dock.

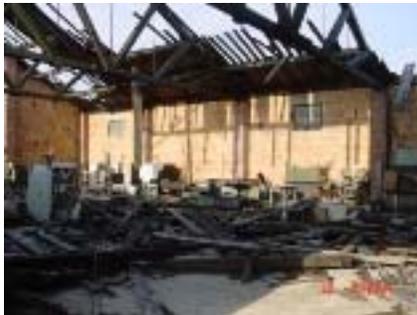
South end of roof is down (with roofing debris on floor). Roof overall is poor. Several areas of cleared floor. Possibly access these areas for survey by pole or robotic equipment. Some concern for potential of heavy shingles that could come off towards dock.

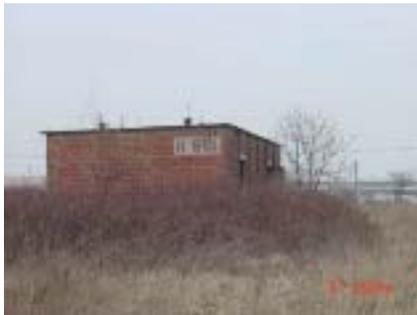
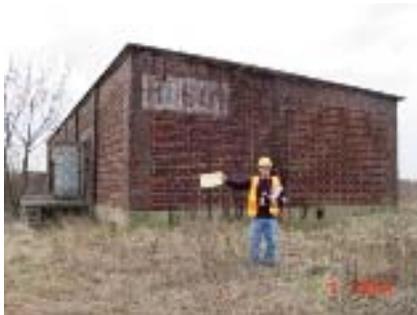
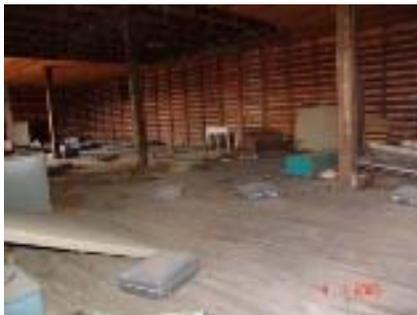
BUILDING H-711

Dimensions: 32' x 95'. Condition could possibly be changed to V after phase A. Roof hole at NW corner. Roof condition uncertain. Furniture and some other items on an otherwise clear wooden floor. Doors completely off south end of dock. Use pole-mounted survey equipment or robotic equipment. There is a crawl space under this building.

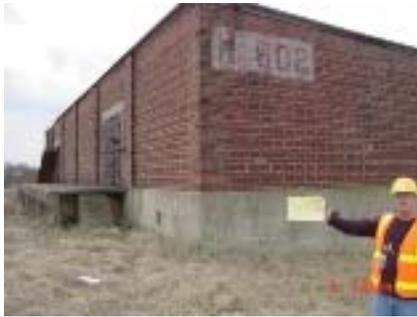
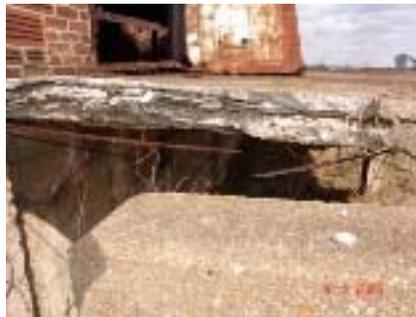
BUILDING H-712
CONDITION III

Dimensions: 32' x 95'. Condition could possibly be changed to V after phase A. 70-80% of wooden floor intact. Roof and ceiling collapsed at north and south ends. Doors at south end of dock – no access. Doors at north end of dock – left hand door is down, right hand door is hanging. Dock is in rough condition on extreme south end. There is a crawl space under this building.

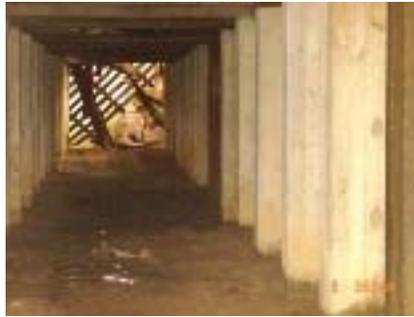
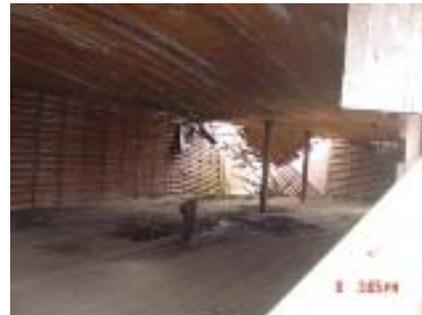
BUILDING H-713

Dimensions: 32' x 95'. Condition could possibly be changed to V after phase A. Roof and ceiling collapsed at NW and SE corners. 70-80% of wooden floor intact. Floor holes in some areas, including at least one where the roof support column has collapsed through floor. Doors at south end of dock – right hand door is hanging and could fall (secure in place or remove). Dock – elevation hazard (greater than 4'). There is a crawl space under this building.

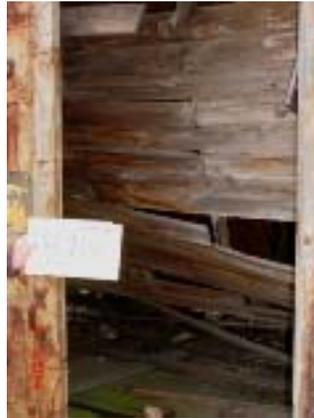
BUILDING H-714
CONDITION V

Dimensions: 32' x 95'. Ceiling and roof collapsed and debris covers wooden floor. There is a crawl space under this building (and roof, ceiling, and floor debris has fallen into some areas of the crawl space). Radiation signs on doors.

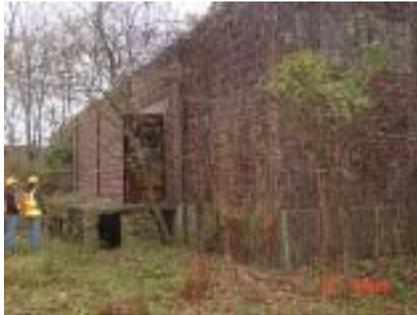
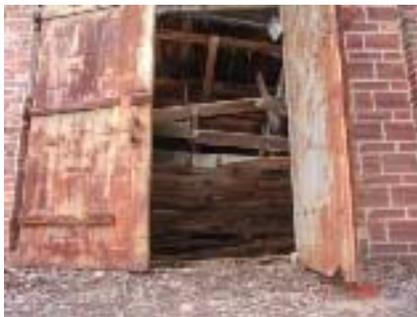
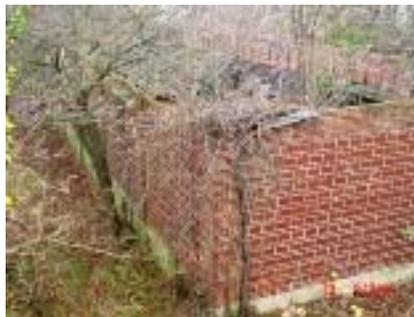
BUILDING H-715

Dimensions: approximately 32' x 95'. Deconstruction may be complicated by the high berm on three sides which restricts equipment access to area. Roof and ceiling collapsed, and debris covers floor.

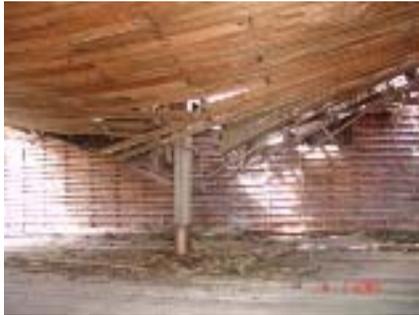
BUILDING I-531

Dimensions are similar to an “H” building. Condition could possibly be changed to V after phase A. Roof collapsed at SW corner. Approximately 70% of floor still intact. Ceiling low. Could use pole-mounted survey equipment or robotic equipment (from doorways). Brick and terra cotta block.

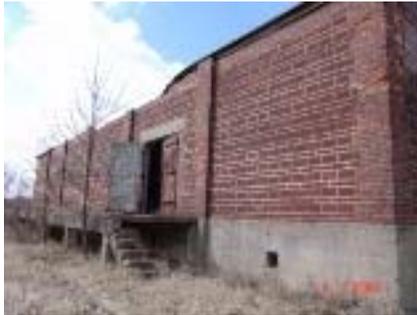
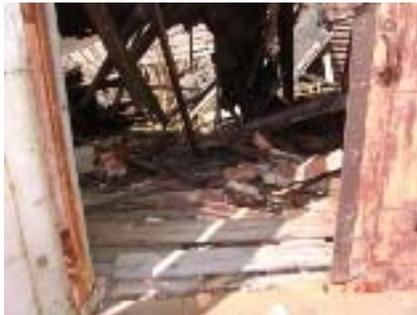
BUILDING I-631

Dimensions are similar to an “H” building. Majority of roof collapsed and debris covers wooden floor. Very minimal access at the south end of the dock (door stuck with only ~6” opening). No worthwhile access from north end of dock. Gutters loose at north and NE areas.

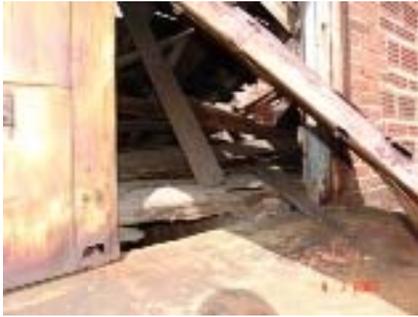
BUILDING I-632

Dimensions are similar to an “H” building. No access through doors at north end of dock (roofing debris covers floor area and door way). Some floor accessible from south end of dock (for pole-mounted or robotic survey equipment). Noted several large chips of brick have fallen, and continuing chips would be a head hazard.

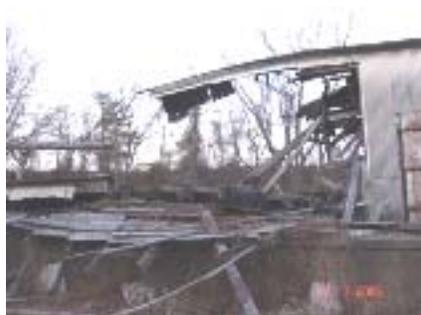
Dimensions are similar to an “H” building. North end partially standing. South wall standing. East and west walls essentially gone (except at north end). Debris covering wooden floor. Corrugated asbestos siding. There is a crawl space under this building.

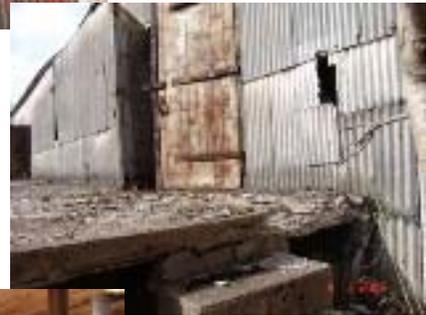
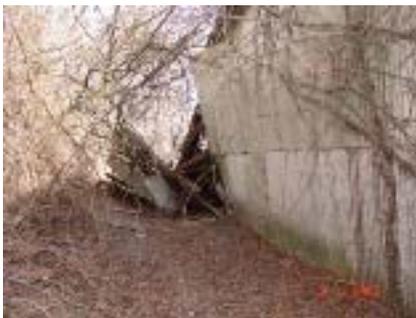
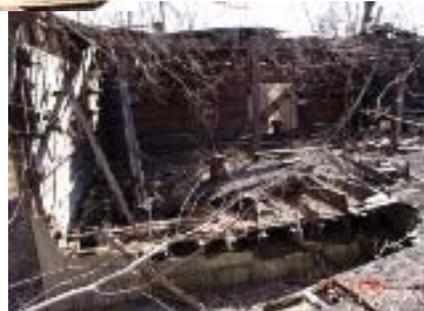
BUILDING I-636

Dimensions are similar to an “H” building. East and south walls standing. South end roof still up. West wall gone (except at south end). Debris covering most of the wooden floor. Possibly could use pole-mounted survey equipment to survey a little floor area at SE corner. Corrugated asbestos siding. Dock has holes on north end, and is crumbling badly.

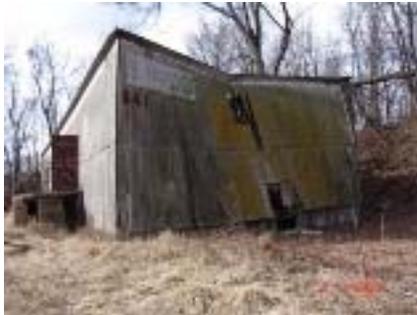
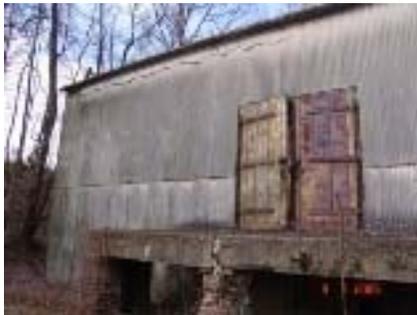
BUILDING I-641
CONDITION V

Dimensions are similar to an “H” building. North wall partially leaning inward. Partial roof on north end. Stay away from west wall (could fall outward). West wall (south end) collapsed. East and south walls still standing. Doors on south end of dock are stuck (barely open). There is a crawl space under this building. Corrugated asbestos siding.

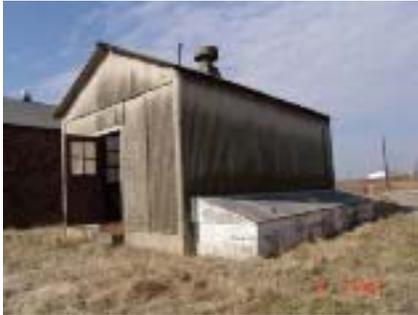
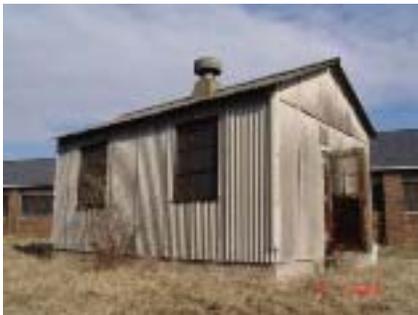
FUEL OIL BUILDING

Dimensions 15' x 25'. Located south of Building 825. Unguarded perimeter walkway around pit w/tank.
