Point Beach Nuclear Plant Unit 1
Docket No. 50-266
License No. DPR-24

Fall 2005 Unit 1 (U1R29) Steam Generator Tube Inspection Report

FALL 2005 UNIT 1 (U1R29) STEAM GENERATOR TUBE INSPECTION REPORT

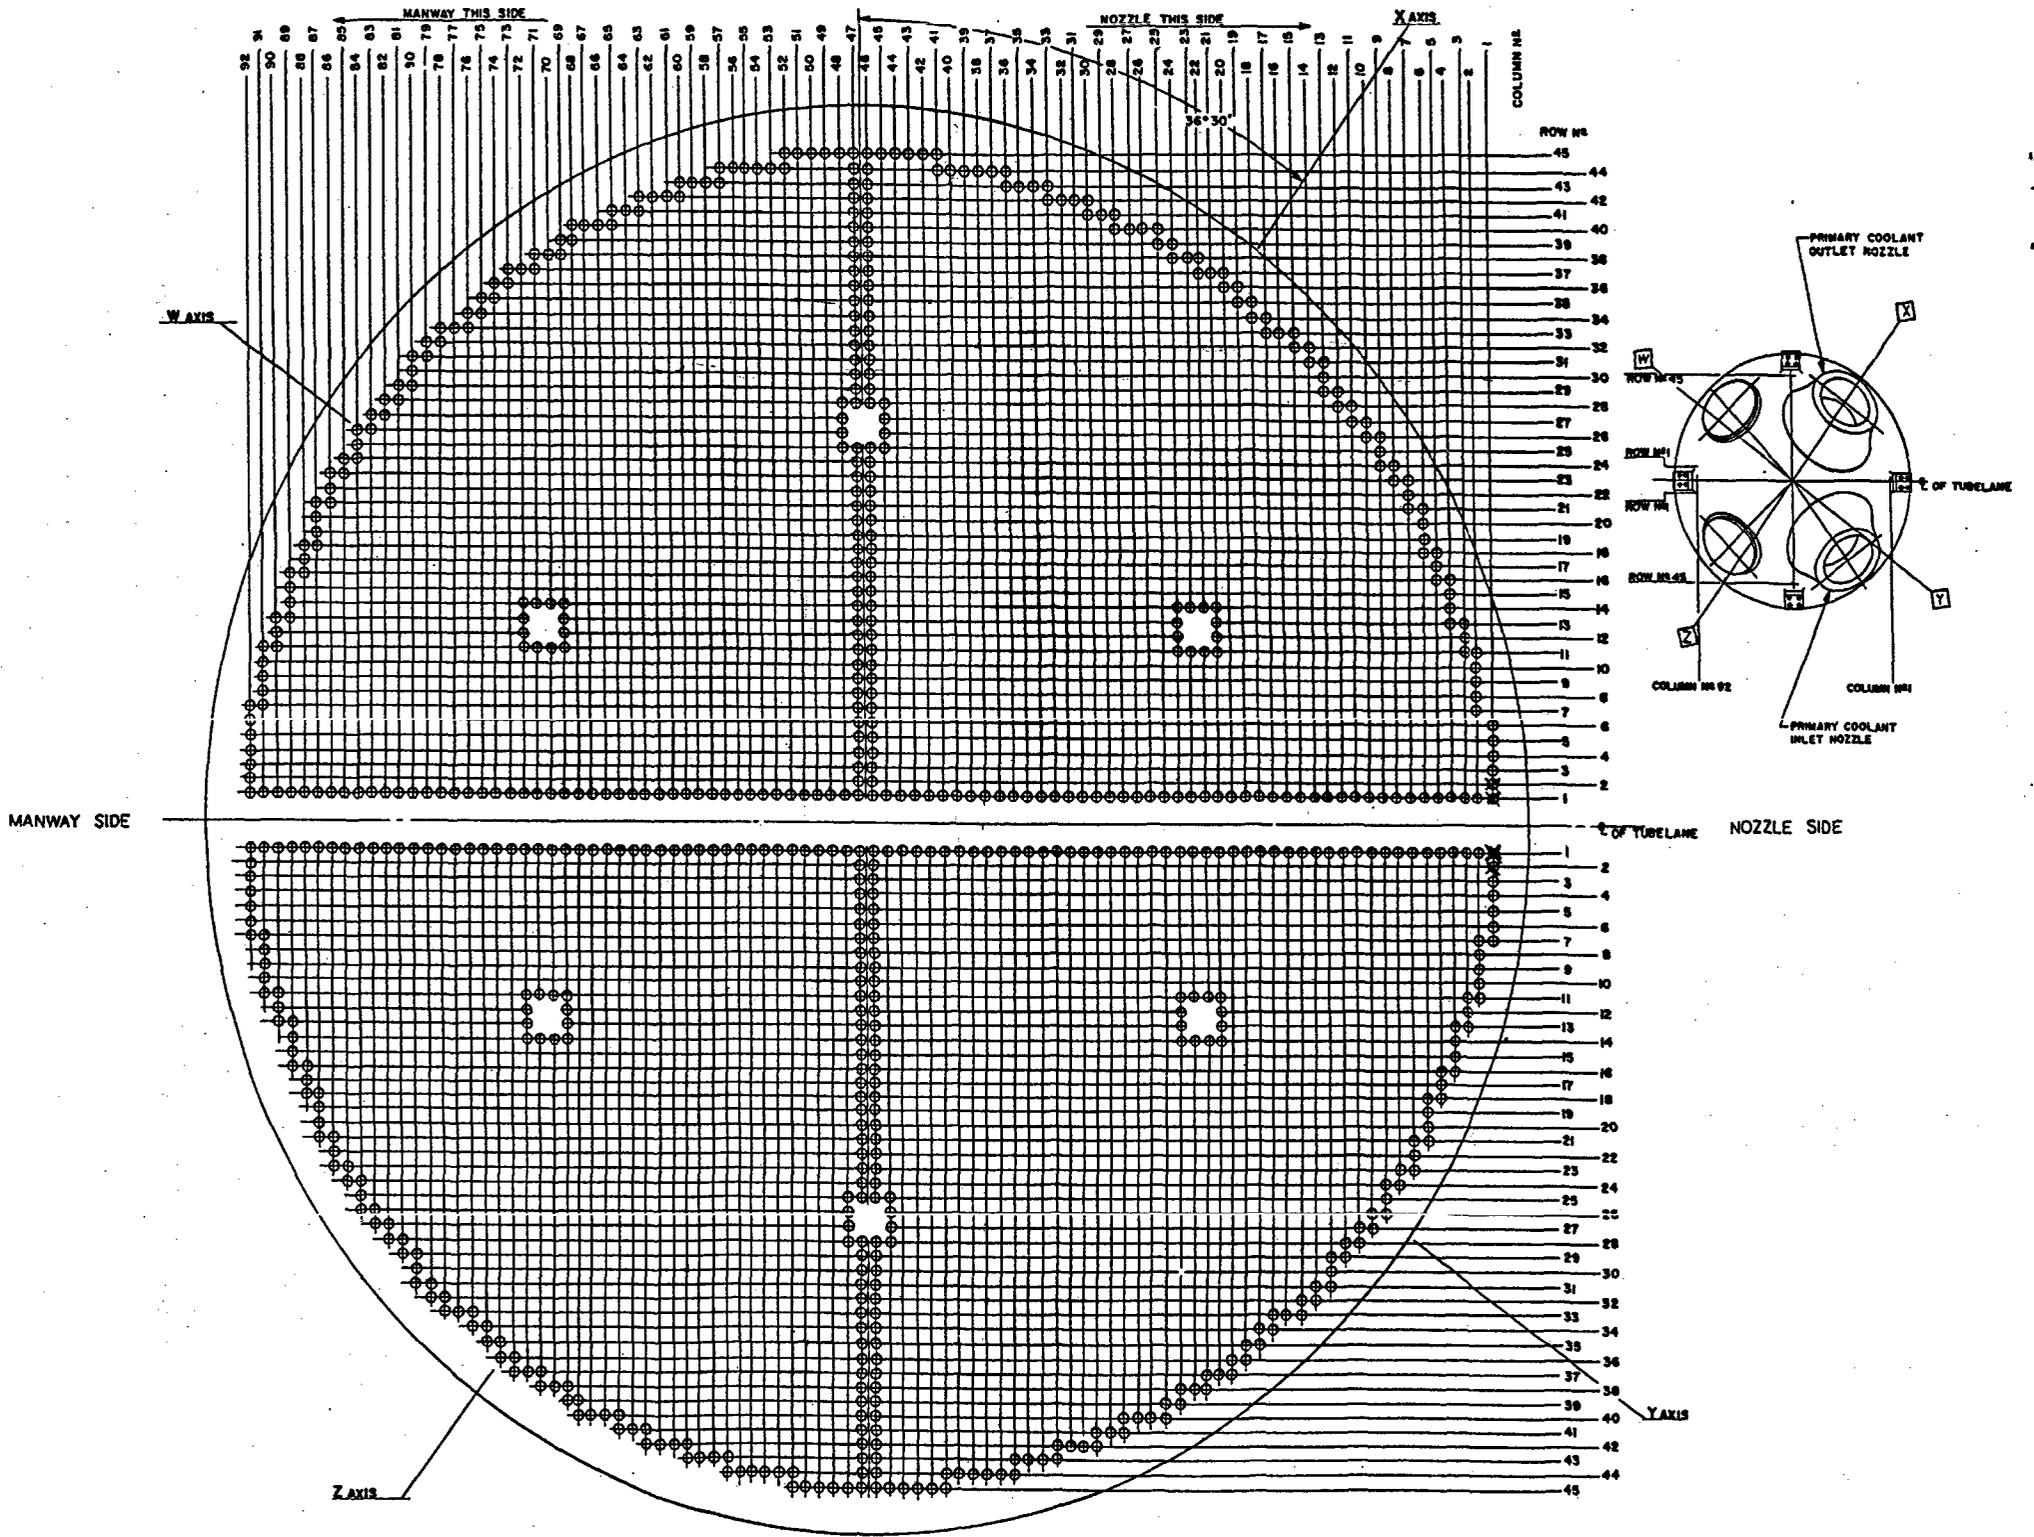
Fifty-two wear indications in 31 tubes were found in the 'A' SG anti-vibration bar area. None of these indications were required to be repaired, and all tubes remained in service. Table 1 shows all anti-vibration bar wear indications along with an historical comparison. Based on the growth rate of the wear indications, no indications are expected to exceed the plugging criterion during the next two cycles.

Nineteen wear indications in 16 tubes were found in the 'A' SG peripheral hot leg tubes at the top of tubesheet. Table 2 lists the percent through-wall of these indications. All of these indications were reported in 2004, except a 1% indication in row 33/column 78 and a 5% in row 41/column 28. Both of these minor indications were present in 2004 data but not reported by eddy current. These indications first appear in the U1R28 inspection data, and this wear was concluded to be the result of damage from maintenance equipment during U1R26. Secondary side visual inspection during U1R28 and the current inspection confirmed that no objects that could cause continued wear are present. Comparison of the 2004 and 2005 data supports this original conclusion. The depth of these indications is significantly below the plugging criterion, and since the source of the wear is no longer present, no growth is anticipated, and all tubes remained in service.

Four wear indications in 4 tubes were found in the 'A' SG at cold leg supports. Three of these were reported in 2004, but had never been reported previous to 2004. When compared to 1995 inspection data, these indications showed no significant change. Table 3 lists the percent through-wall of these indications. The depth of these indications is significantly below the plugging criterion, and all tubes remained in service.

The 'A' steam generator has one manufacturing anomaly. The tube at row 38/column 69 is not expanded the full length of the tubesheet. This tube is routinely inspected by rotating pancake coil from the tube end to the top of tubesheet and during U1R29, as in the past, no degradation was found. The tube remains in service.

One possible loose part indication was reported by eddy current in SG 'A' at 0.36 inch above the hot leg top of tubesheet in row 8/column 25. No degradation was observed in conjunction with the indication. However, all tubes adjacent to this indication were also tested with rotating pancake coil. Secondary side visual inspection verified that no loose part was present, and this indication was subsequently dispositioned, and the tube remains in service.

A small foreign object was found and retrieved during the secondary side visual inspection near cold leg row 1&2/column 78. The object was a small steel pin approximately 1-1/4" long by approximately 1/4" diameter. Subsequently, 18 tubes in the vicinity of this location were inspected with rotating pancake coil. No degradation was observed in conjunction with the loose part in any of the tubes. The site investigated possible sources of the part and concluded that the object was not transported to the steam generator, but may have been from steam generator maintenance equipment.
