Braidwood Station, Unit 2
Facility Operating License Number NPF-77
NRC Docket Number 50-457

Subject: Response to Request for Additional Information Regarding the Braidwood Station
Unit 2 Spring 2005 Steam Generator Inspection

**Response to NRC Request for Additional Information Regarding the Braidwood
Station Unit 2 Spring 2005 Steam Generator Inspection**

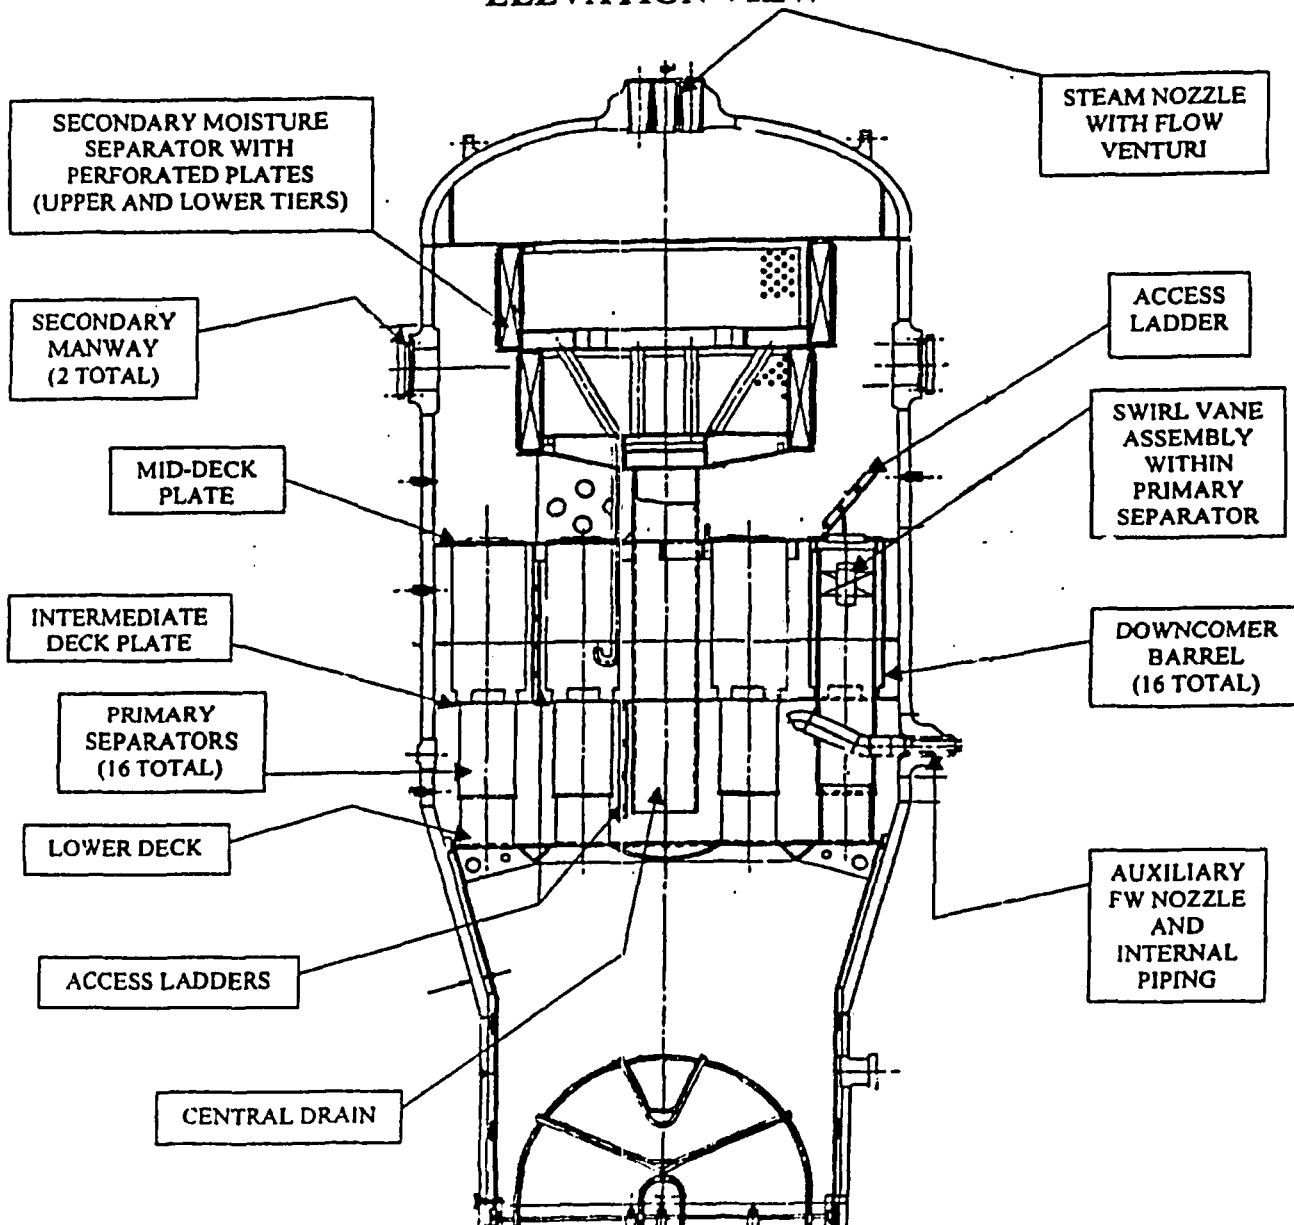
Figure 3a-1

During the Braidwood Unit 2 A2R11 refueling outage, visual inspection of the 2D SG secondary side moisture separator region was performed. All areas that are accessible through the upper manways were visually inspected down through the lower deck plate (refer to Figure 3a-1). No degradation, erosion, corrosion, deformation or weld cracking was observed other than the erosion identified in the primary moisture separator region as described below.

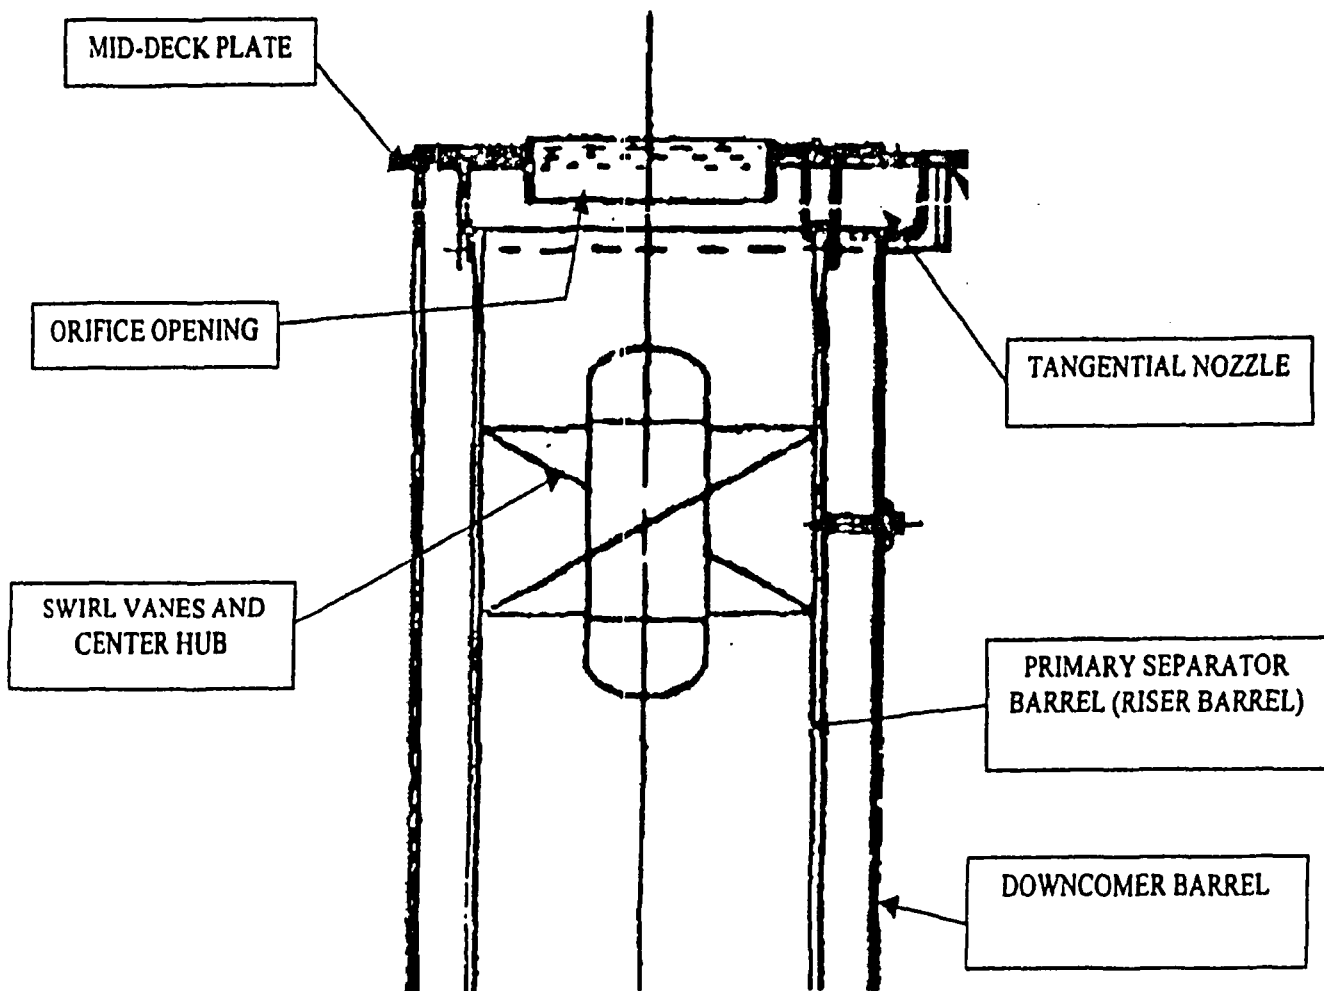
Figure 3a-2

During visual inspection of the primary separator assembly region, visual inspection identified that there were areas where the normally present magnetite layer was missing, thus providing areas for erosion to develop. The areas included portions of the tangential nozzles, portions of the inner surface of the primary moisture separator barrels and a number of swirl vanes within the primary separator assemblies (refer to Figure 3a-2). This condition existed in varying degrees on 12 of the 16 primary separators assemblies. The components identified with the magnetite layer missing are carbon steel, typically American Society for Testing and Materials standard specification A-285, "Pressure Vessel Plates, Carbon Steel, Low and Intermediate-Tensile Strength," Grade C, material. The manufacturing nominal wall thickness for these components was 0.250-inch. To supplement the visual inspection observations, ultrasonic (UT) thickness measurements were taken in areas of magnetite loss with most apparent erosion.

Two of the tangential nozzles with the most apparent erosion were UT inspected. The minimum thickness reading for the horizontal region of the tangential nozzles was 0.234-inch. The minimum thickness reading for the vertical region of the tangential nozzles was 0.177-inch.

Three of the riser barrels with the most apparent erosion were UT inspected. The minimum thickness reading was 0.183-inch.

Three of the swirl vanes with the most apparent erosion were UT inspected. The minimum thickness reading was 0.184-inch.

In summary, the overall nominal thickness value for the primary separators assemblies is 0.250-inch with a minimum UT thickness reading for the components inspected of 0.177-inch. No areas of through wall erosion were identified.
