Subject: **Docket No. 50-361**  
**Licensee Event Report No. 2006-001**  
**San Onofre Nuclear Generating Station, Unit 2**

**4. TITLE**  
Both trains of Shutdown Cooling Declared Inoperable Due to the Discovery of a Through Wall Pipe Crack in Common Header

Plant: San Onofre Nuclear Generating Station (SONGS) Unit 2  
 Discovery Date: January 11, 2006  
 Reactor Vendor: Combustion Engineering  
 Mode: Mode 5 – Cold Shutdown  
 Power: 0 percent

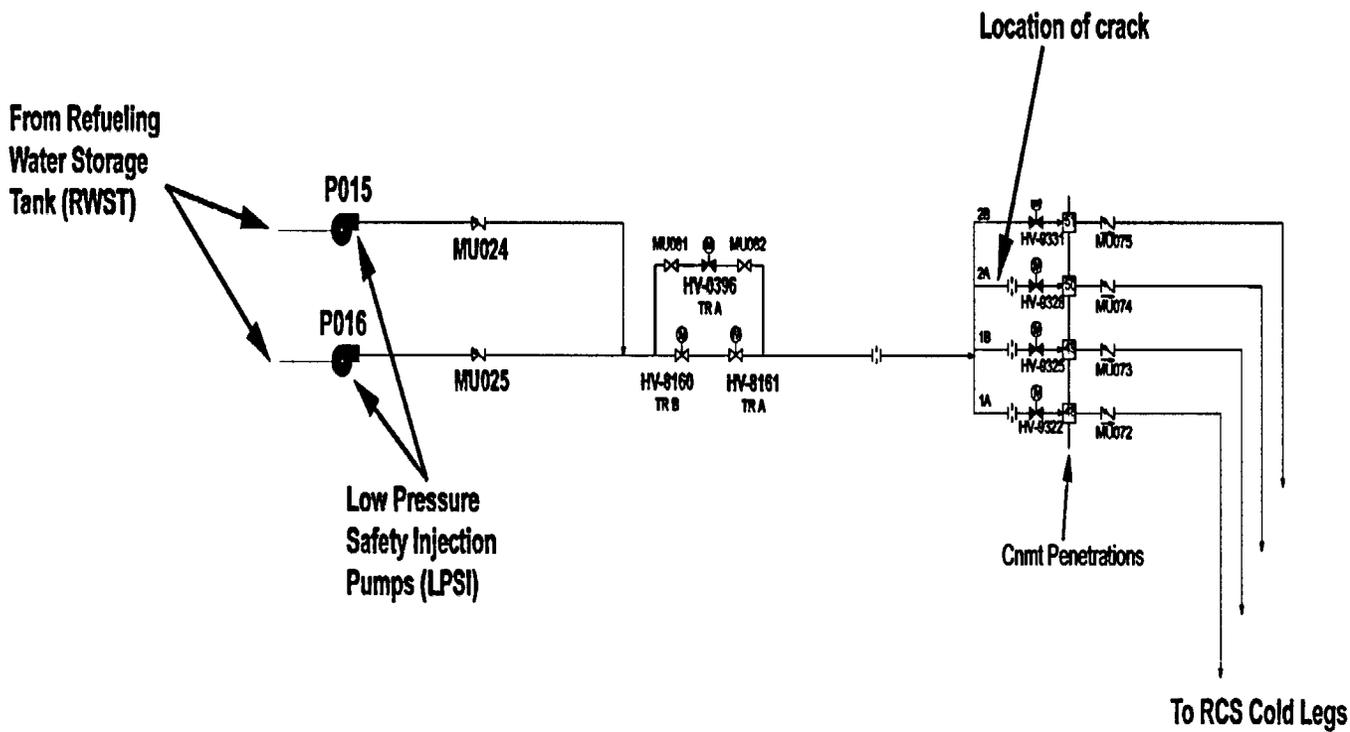
### Low Pressure Safety Injection System & Shutdown Cooling System (Simplified Diagram)

The LPSI/SDC system contains two trains, each with its own pump [P], but sharing a common discharge line. This common line is then split into four individual pathways; each provides a flow path to one of the four RCS cold legs (see attached diagram).

On January 11, 2006, after removing the pipe insulation, SCE determined the source of the leak to be a small through-wall crack in the 8-inch LPSI system Class 2 pipe [PSP] at the toe of the weld to a 1-inch drain line, (just upstream of valve 2HV9328 [ISV] low pressure cold leg injection isolation valve for RCS branch line 2A). Since the crack was located in the common discharge header and could not be isolated, SCE declared both SDC trains inoperable. This action is consistent with the guidance in Regulatory Issue Summary (RIS) 2005-20, (Appendix C.12 of the NRC Inspection Manual Part 9900), which states in part,

Based on laboratory analysis, SCE determined the crack was caused by high cycle fatigue. The crack initiated at a small weld discontinuity on the outside diameter surface of the eight-inch LPSI discharge header pipe at a branch fitting that connects to a one-inch drain line. SCE is continuing to evaluate the cause of the high cycle fatigue (reference AR 060100463-12).

- The affected section of pipe was replaced with new pipe and the cracked pipe was sent offsite for analysis.
