Palo Verde Nuclear
Generating Station

**Subject: Palo Verde Nuclear Generating Station (PVNGS)
Unit 1
Docket No. STN 50-528
"APS' 60-Day after Plant Restart Letter in Response to First Revised NRC Order EA-03-009, Item IV.E, NRC Bulletin 2003-02, Commitment No. 3 and NRC Bulletin 2004-01, Commitment No. 2 – U1R12"**

**PVNGS' Unit 1 60-day after Outage Report
for the 12th Refueling Outage**

U1R12 60-Day After Outage Report

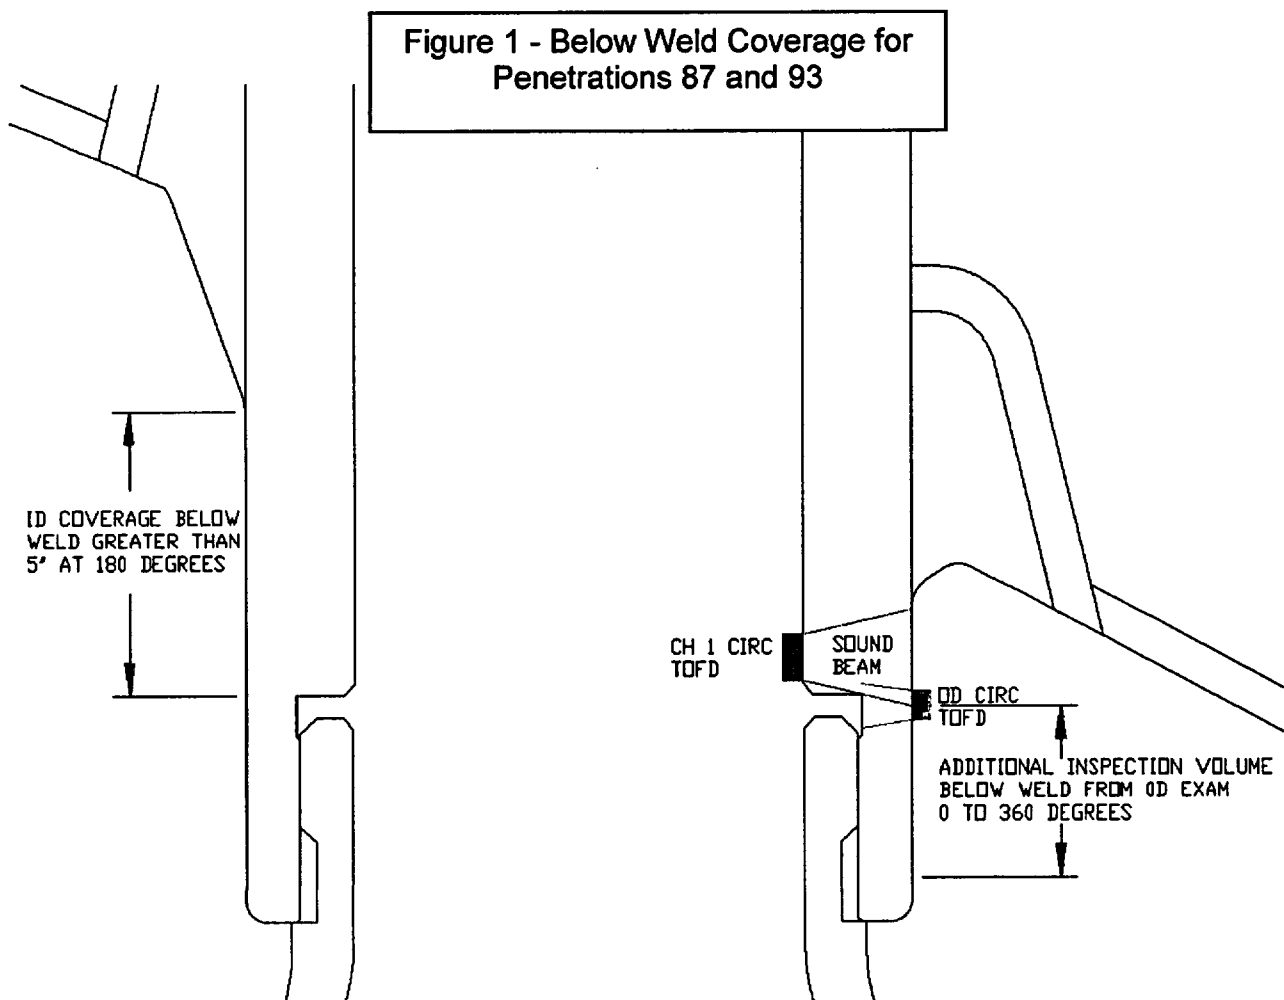
The ultrasonic examination of penetrations 87 and 93 did cover the available distance on the inside diameter of each nozzle leaving no additional distance for examination. To meet this commitment, penetrations 87 and 93 were also examined from the outside diameter using a qualified surface exam. Penetration No. 87 was examined an additional 0.885” below the inside diameter chamfer and penetration No. 93 was examined an additional 1.000” below the inside diameter chamfer. Figure 1 in the attachment to this enclosure shows the overlap. No indications were identified.
