L-2006-062
10 CFR 50.36

Subject: Turkey Point Unit 3
Docket No. 50-250
Response to Request for Additional Information
Regarding Steam Generator Tube Plugging
Inservice Inspection Report (TAC NO. MC8112)

Response To Request For Additional Information
Regarding Turkey Point Unit 3 Steam Generator Tube Inspection Report

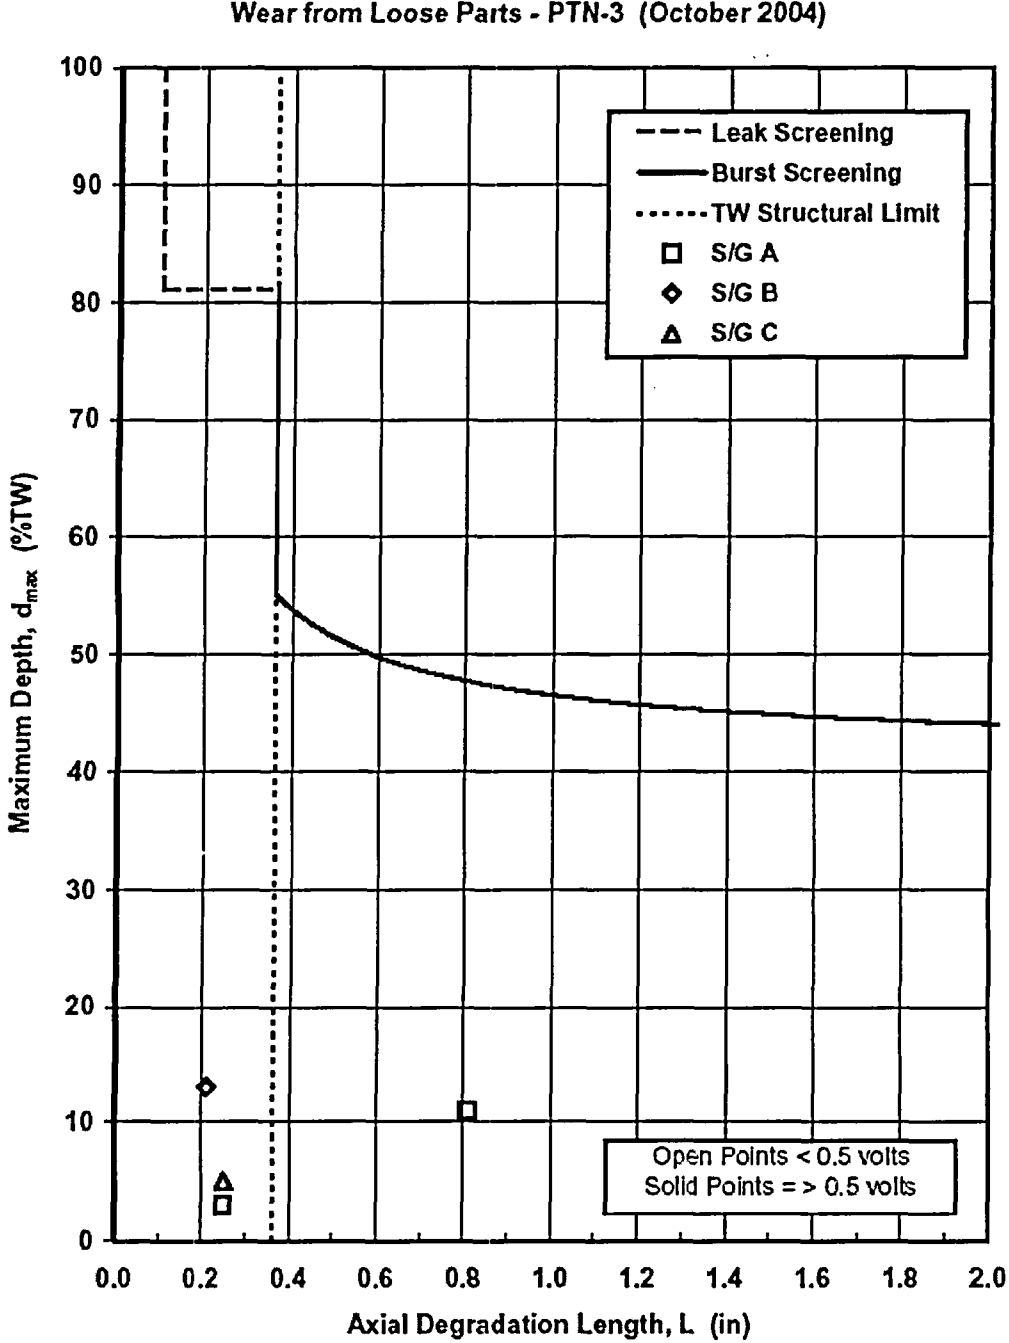
Figure 4-3 — Condition Monitoring Results for Loose Part Wear at EOC 20.

Four of the seven mechanical wear indications reported were associated with wear from foreign objects, and are identified in Table 1 as possible loose part (PLP) wear. A summary of the Condition Monitoring and Operational Assessment analysis performed for tubes associated with wear from foreign objects is provided in Attachment 2. Three of the four possible PLP wear indications were detected near the top-of-tubesheet; two in SG3A and one in SG3C. These wear indications were shallow, and PLPs were not detected during the ECT examination. A Foreign Object Search and Retrieval (FOSAR) examination was performed at the three top-of-tubesheet locations, and no foreign objects were identified. Since no PLPs were detected during the ECT examination and no foreign objects were identified during the FOSAR examination, tube integrity is not affected.

There were four indications detected associated with wear from foreign objects. A comparison of these wear indications with the CM structural limits is given in Figure 4-3. Three of these indications were detected at the top of tube sheet. The wear damage was shallow and there was no evidence that the loose part was still present. The other wear indication was detected at a TSP and is due to a probable loose part. All loose part wear met the NEI 97-06 structural limit performance criterion for burst and leak integrity. No tubes required to be plugged. These tubes remain in service and will be tracked during future inspections.

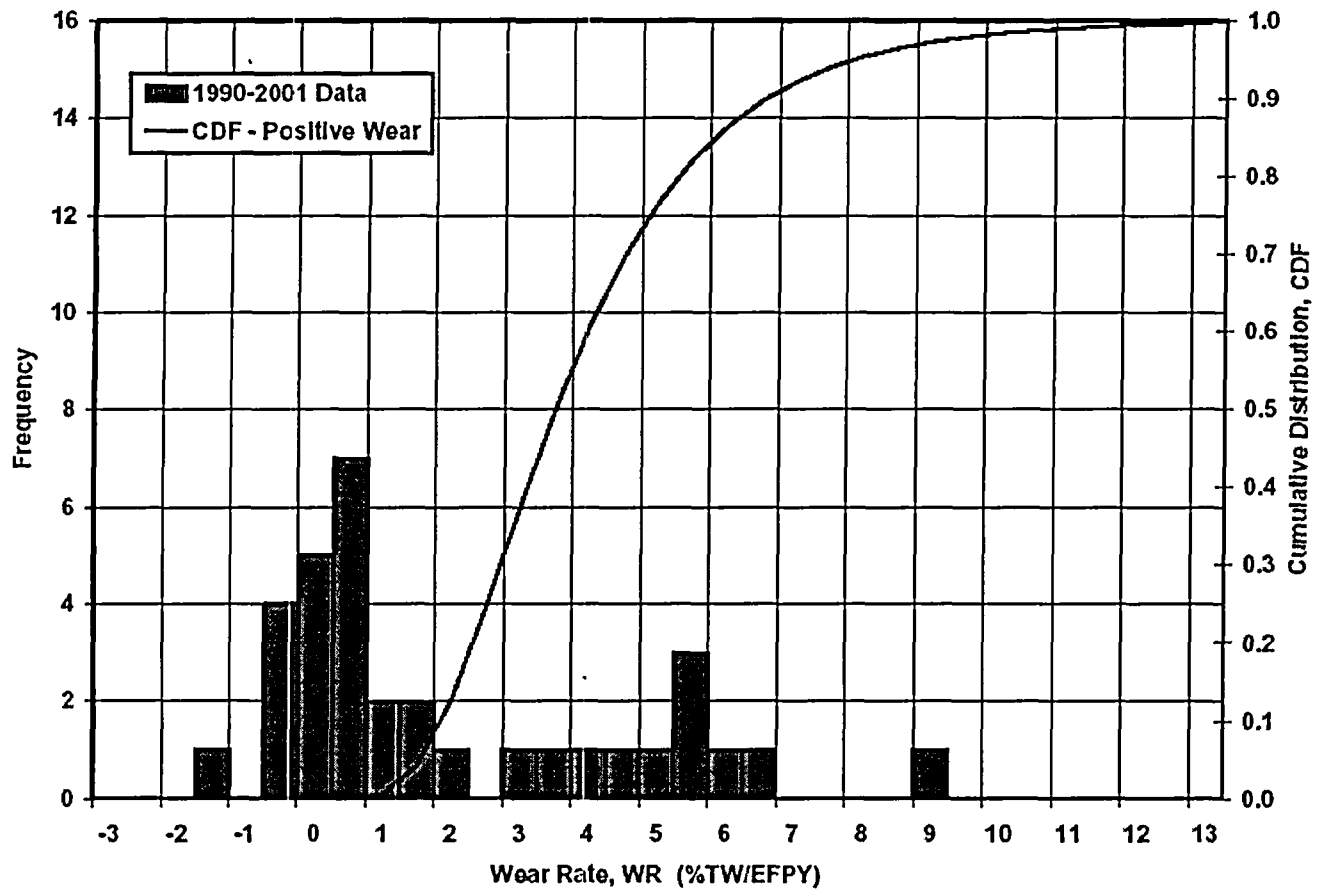
Figure 5-5 — Wear Rates at TSP Tube Intersections from PTN-3 October 2001 Examination Data.

The rates determined for wear at TSPs from the October 2001 are shown in Figure 5-5. These rates are based on two cycle calculations. Due to the limited data, the growth rates for all TSP indications (including those identified as wear from foreign object) were used to establish a wear rate by TSP contact. Lumping the apparent loose-part wear data with the other wear tube-to-TSP contact data is conservative. The average wear rate was about 2.7% TW/EFPY and a standard deviation of about 2.5% TW/EFPY. The tube exhibiting the largest wear rate was used to define the wear rate to apply in the OA. That wear rate is 8.8% TW/EFPY.
