WATTS BAR NUCLEAR PLANT (WBN) - UNIT 1 - FACILITY OPERATING LICENSE
NPF-90 - LICENSEE EVENT REPORT (LER) 50-390/2006-001

Enclosure:
LER 390/2006-001

LICENSEE EVENT REPORT (LER)

4. TITLE
Entrained Air in Essential Raw Cooling Water (ERCW) Piping

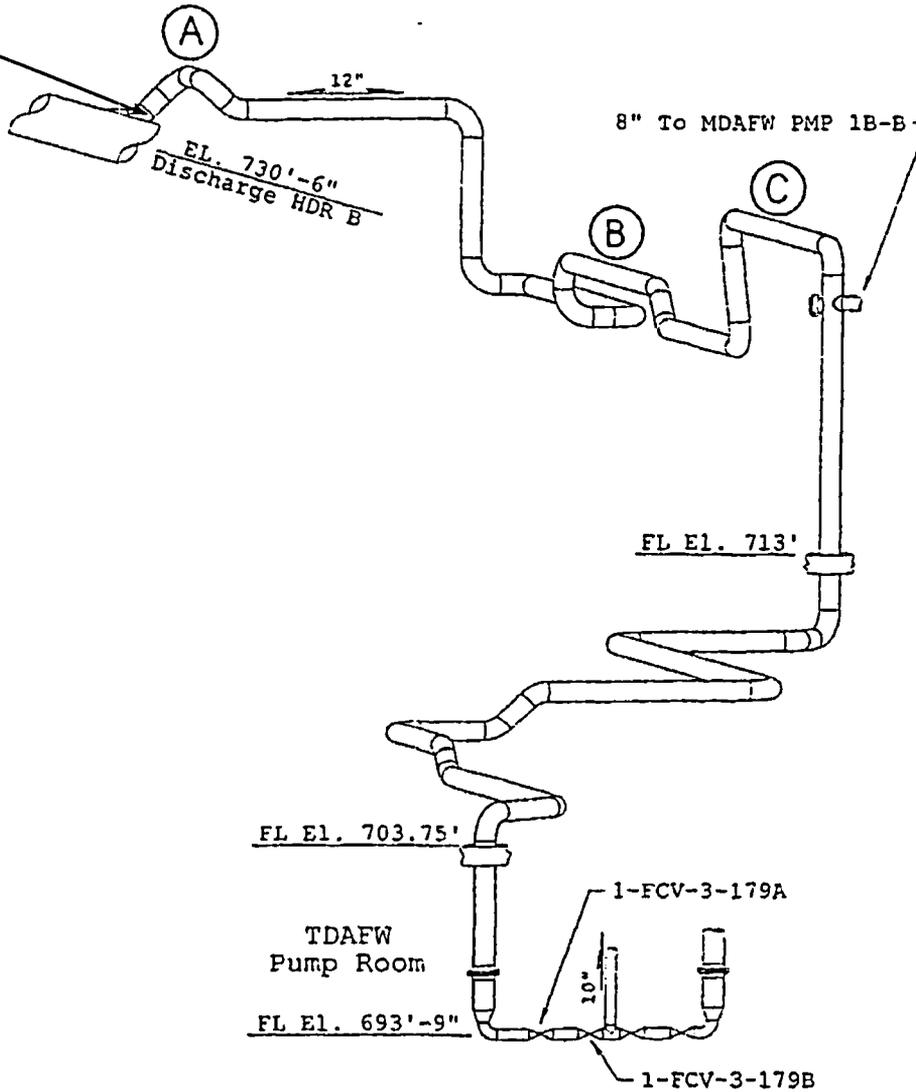
Diagram of Train B ERCW Supply Piping to AFW System

Provided on the following page is a diagram of the Train B ERCW supply piping to the AFW system. The three high points in this piping segment are marked as A, B, and C. Varying amounts of air were found at each of the three points. The evaluation of this condition determined the principal cause to be the inadequate filling and venting of the piping during the Cycle 6 refueling outage. The venting during the outage was performed after radiographic testing and the flushing of the pipe.

Note - Isolation Valve 1-ISV-67-924B is located between the discharge header and high point "A".

1. As stated previously, action was taken to vent the 12 inch supply line to the AFW pumps and to vent the 30 inch discharge header. UT measurements were taken of both lines to verify the piping was properly filled.
2. The Train A ERCW supply to the AFW system was verified to be operable.
3. Action was initiated to determine the cause of the gas voids and to establish the proper actions to prevent recurrence of voids.
