Subject: 30-Day Written Follow-up Report to NRC event Number 42377  
Reported 2/28/2006 to NRC Operations Center.  
Docket No. 04003392, License No. SUB-526

**Report to the NRC Event Number 42377 Reported on 2/28/2006:**

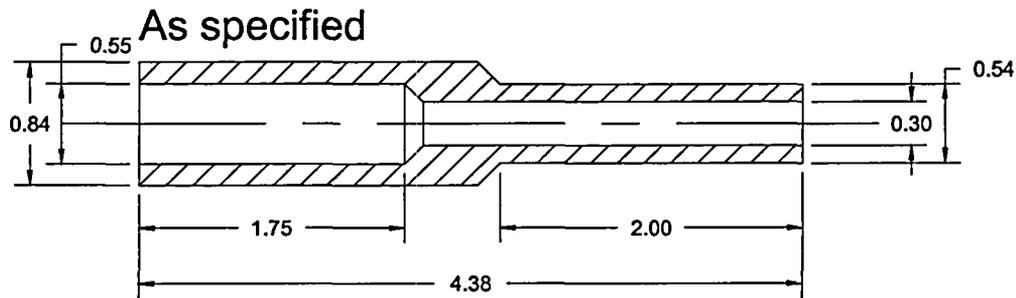
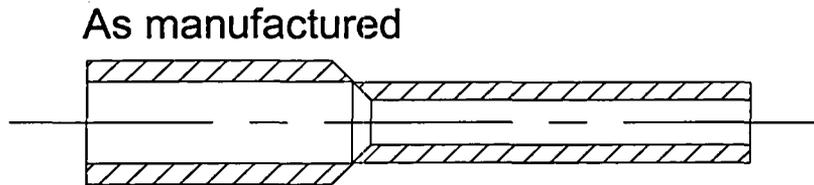
On inspection a fabrication flaw was found in the port reducer. The large end of the port reducer has an I.D. of 0.55 inches and the small end has an O.D. of 0.54 inches, machined down from the O.D. of 0.84 at the large end. The small O.D. section was specified to be 2.00 inches long. It was improperly machined approximately 2.63 inches long so that the 0.55 I.D. came within a very small distance of the 0.54 O.D. When the gauge was being hand tightened, the port reducer broke at this thin wall point.

The supplied component included a port reducer that allowed ¼ inch and ½ inch pipe to be connected to meet plant requirements. This port reducer had to be made of Monel, so it was custom fabricated. The ½ inch end of the reducer had an outside diameter (OD) of 0.84 inches and an inside diameter (ID) of 0.55 inches. The ¼ inch end of the reducer had an OD of 0.54 inches and an ID of 0.30 inches. During machining, the 0.54 inch OD portion of the reducer was made too long and the 0.54 inch outer wall was machined very close to the section with the 0.55 inch ID. See diagram. The component broke under hand pressure while being installed. If this failure occurred coincident with a rupture disc burst during operation, Uranium Hexafluoride would have been released directly to the atmosphere.

- The failed assembly was removed from service.
- MTW verified none of the new assemblies were in service and reverted to the previous design.
- MTW is verifying heads' dimensional information for all related safety heads. Craig Flannery, Project Engineer, is responsible for this action and target completion date is March 31, 2006.
- Five (5) of the heads in question have already had a Hex valve already welded in place as part of the pre-installation assembly. To verify their

integrity, they will be analyzed using X-ray methods. Craig Flannery is also responsible for this action and target completion date is March 31, 2006.

- BS&B has been contacted. Ken Richardson with BS&B is working with MTW on resolution.
- The defective part was returned to BS&B.
- As the new heads pass dimensional or x-ray inspection, they are being installed per the approved design change.
