Specialty Materials
Honeywell
P.O. Box 430
Highway 45 North
Metropolis, IL 62960
618 524-2111
618 524-6239 Fax

Subject: 30-Day Written Follow-up Report to NRC event Number 42377
Reported 2/28/2006 to NRC Operations Center.
Docket No. 04003392, License No. SUB-526

Honeywell Chemicals, Specialty Materials, Metropolis Works (MTW) facility reported to the NRC Operation Center as per 10 CFR 21 a basic component, rupture disc and corresponding safety head, failure that could present safety hazards. This letter is a required follow-up report to address specific items required by the regulations.

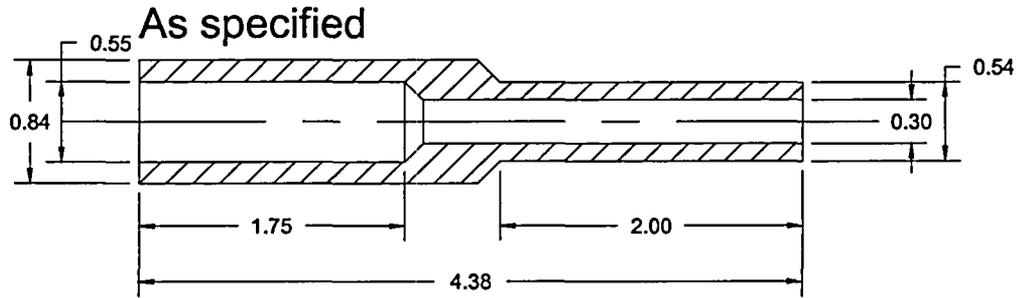
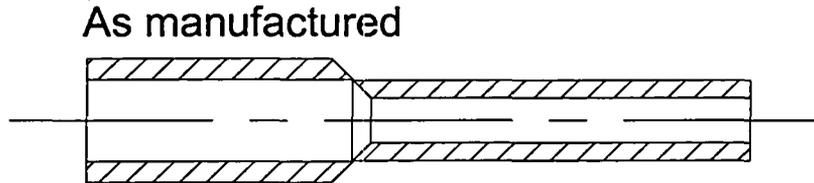
On inspection a fabrication flaw was found in the port reducer. The large end of the port reducer has an I.D. of 0.55 inches and the small end has an O.D. of 0.54 inches, machined down from the O.D. of 0.84 at the large end. The small O.D. section was specified to be 2.00 inches long. It was improperly machined approximately 2.63 inches long so that the 0.55 I.D. came within a very small distance of the 0.54 O.D. When the gauge was being hand tightened, the port reducer broke at this thin wall point.

The supplied component included a port reducer that allowed ¼ inch and ½ inch pipe to be connected to meet plant requirements. This port reducer had to be made of Monel, so it was custom fabricated. The ½ inch end of the reducer had an outside diameter (OD) of 0.84 inches and an inside diameter (ID) of 0.55 inches. The ¼ inch end of the reducer had an OD of 0.54 inches and an ID of 0.30 inches. During machining, the 0.54 inch OD portion of the reducer was made too long and the 0.54 inch outer wall was machined very close to the section with the 0.55 inch ID. See diagram. The component broke under hand pressure while being installed. If this failure occurred coincident with a rupture disc burst during operation, Uranium Hexafluoride would have been released directly to the atmosphere.

Upon identification of the issue, a team was formed to evaluate the situation and define corrective actions. The defect was determined to be a flaw machining of the port. The following actions taken:

- The failed assembly was removed from service.
- MTW verified none of the new assemblies were in service and reverted to the previous design.
- MTW is verifying heads' dimensional information for all related safety heads. Craig Flannery, Project Engineer, is responsible for this action and target completion date is March 31, 2006.
- Five (5) of the heads in question have already had a Hex valve already welded in place as part of the pre-installation assembly. To verify their
