Palo Verde Nuclear
Generating Station

**Subject: Palo Verde Nuclear Generating Station (PVNGS)
Units 1, 2 and 3
Docket Nos. STN 50-528, 50-529, and 50-530
Response to NRC Request for Additional Information Regarding
PVNGS Units 2 and 3 Steam Generator Tube Inspections**

**ARIZONA PUBLIC SERVICE COMPANY
RESPONSE TO NRC REQUEST FOR ADDITIONAL INFORMATION
REGARDING PVNGS UNITS 2 AND 3 STEAM GENERATOR TUBE
INSPECTIONS**

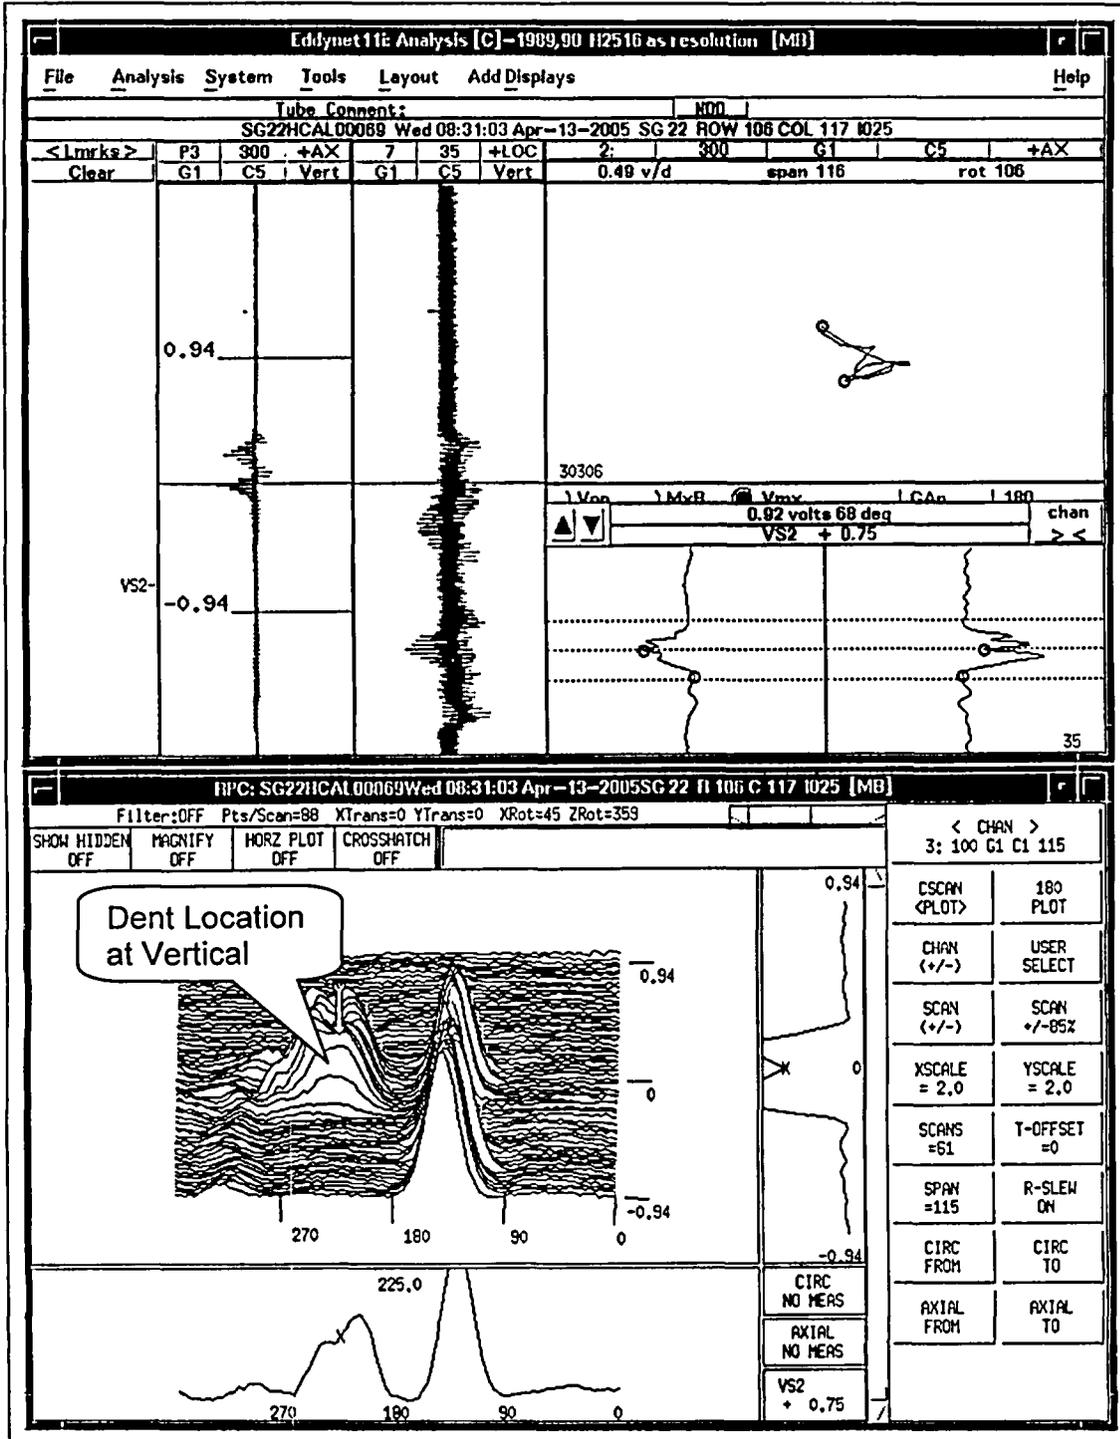
Figure 1
MRPC Graphic "Abnormal" Dent

All of the dent indications listed in Section 4.0 of the October 24, 2005 letter were present during the pre-service examinations (PSE). No changes were noted in any of the dent rotating coil examinations. The source of these abnormal dents was most likely the product of the initial steam generator assembly. All four abnormal dent indications (three in SG 21 and one in SG 22) appear to be directly associated with a vertical strap support bar. Note the NDE graphic in attached Figure 1 which indicates that the location of the rotating coil dent indication is at the vertical strap (VS2).

These dents were considered "abnormal" by APS because they exhibited vertical amplitudes higher than typical dent indications. This condition/classification is one of the lessons learned during the 2004 midcycle (leaker) outage and subsequent dent evaluations. The PVNGS Analysts' Technique Sheet for the +Point examination of dents requires the analysts to record any dent with a vertical amplitude over 0.2 volts with the +Point 300 kHz channel. These are then reviewed by the APS Level III for location, appearance, and the potential for masking of other types of flaw indications.

The abnormal dent indications were similar to the dent indication in SG 21 Row 156 Column 143 that leaked during Cycle 12 in that they had higher vertical voltage than other typical dent indications. Using the +Point 300 kHz channel, the vertical amplitude of the leaking tube was 0.94 volts compared to voltages of 0.29, 0.30, 0.67 and 0.92 for the tubes listed in Section 4.0. As indicated above, the four tubes in U2R12 were associated with a support bar, whereas the dent in the leaking tube was not directly associated with a support bar and the dent in the leaking tube was attributed to damage caused by a packing crate screw.

Although it is unlikely that these dents were caused by crate screw damage, APS took the conservative action and removed the affected tubes from service by plugging.

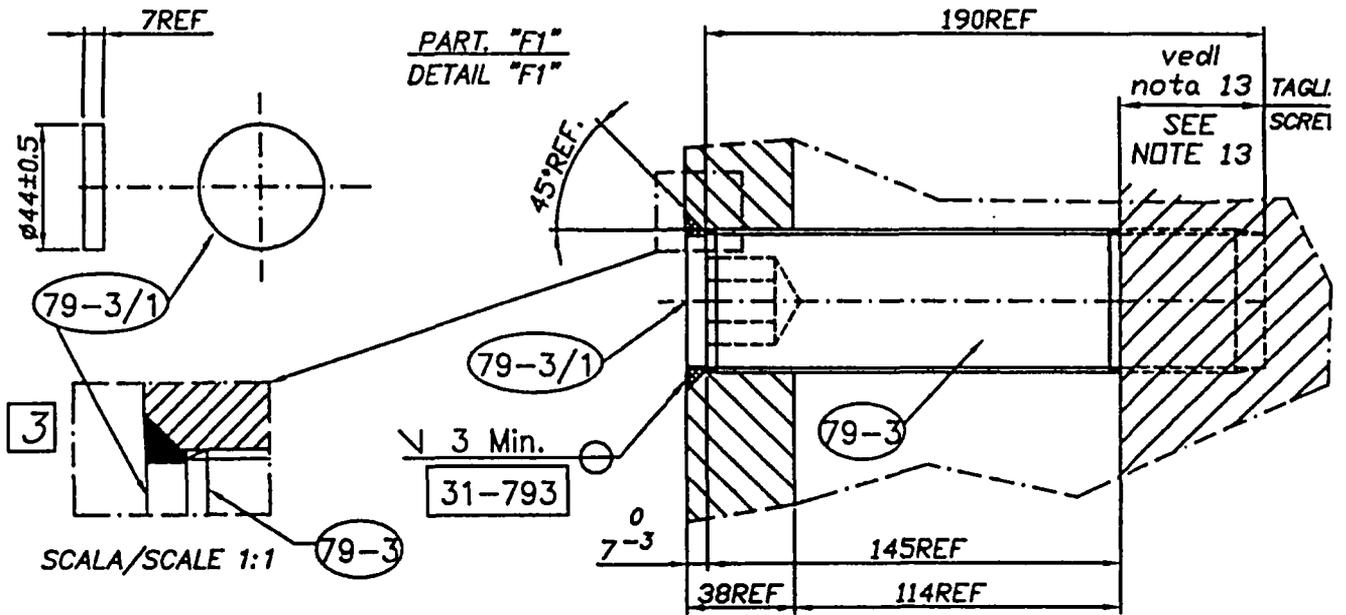
Figure 2
Set Screw Installation Unit 1 and 2 RSG

The main design differences between the original steam generators (OSGs) and RSGs with respect to the feedwater box include; the set screw length exposed to feedwater flow, the gap setting against the shell and the set screw installation technique. The difference in set screw material (SAE Gr.5 vs. SA-193 Gr. B7) was not judged to be a significant difference.

The increased set screw length exposed to feedwater flow was evaluated with respect to the possible negative effect of increased flow forces on the set screw. The increased force on the set screw was calculated to negligibly increase by approximately 3% in the RSGs. Alternatively, the increased length permitted setting the gap between the set screw and the shell at 0.06 inches in the RSGs vs. 0.25 inches in the OSGs. This was evaluated to have a positive effect during accident

conditions. Although not likely to help limit the erosion or wear of the feedwater box at the set screw location, if erosion does occur, the combination of the smaller gap and the seal plate on tube side of the feedwater box would limit the movement of the set screw. As a result, it is less likely that the same amount of erosion as seen in the Unit 3 OSGs would lead to a set screw failure.

The most significant difference between the OSGs and the Unit 1 and 2 RSGs is the installation of a seal plate. In the OSGs the set screws were welded to the tube-side face of the feedwater box then ground flush. Because of the hardness of the set screw material, very little of the weld metal adhered to the set screw. As a result, there was a small leak path through the threads that allowed water to leak from the feedwater box to the economizer region of the steam generator. Conversely, the Units 1 and 2 RSGs have a 0.25-inch carbon steel plate that is groove-welded flush to the tube-side face of the feedwater box (see attached Figure 2). This seal plate is a significant design improvement in the RSGs. Although the primary purpose of the seal plate was to avoid welding to hardened bolting material, it has the secondary effect of eliminating the jetting flow through the set screw hole if the set screw falls out. While this change might not significantly affect the probability of a set screw failure in Units 1 and 2, it will have a significant effect on the consequences of a failure.

Based on this evaluation, APS concluded that the probability of a set screw failure is marginally lower in the Unit 1 and 2 RSGs than in the OSGs. It should be noted that the erosion/corrosion that led to the set screw failure in the Unit 3 OSG occurred after 11 operating cycles. As such, the mechanism is not considered to be a near term issue. To ensure that the condition does not manifest itself in the Units 1 and 2 RSGs, a routine Preventative Maintenance Task to inspect the RSGs in this region on a 6Y (six year) frequency has been implemented for Units 1 and 2, and the condition has been incorporated into the PVNGS Degradation Assessment.

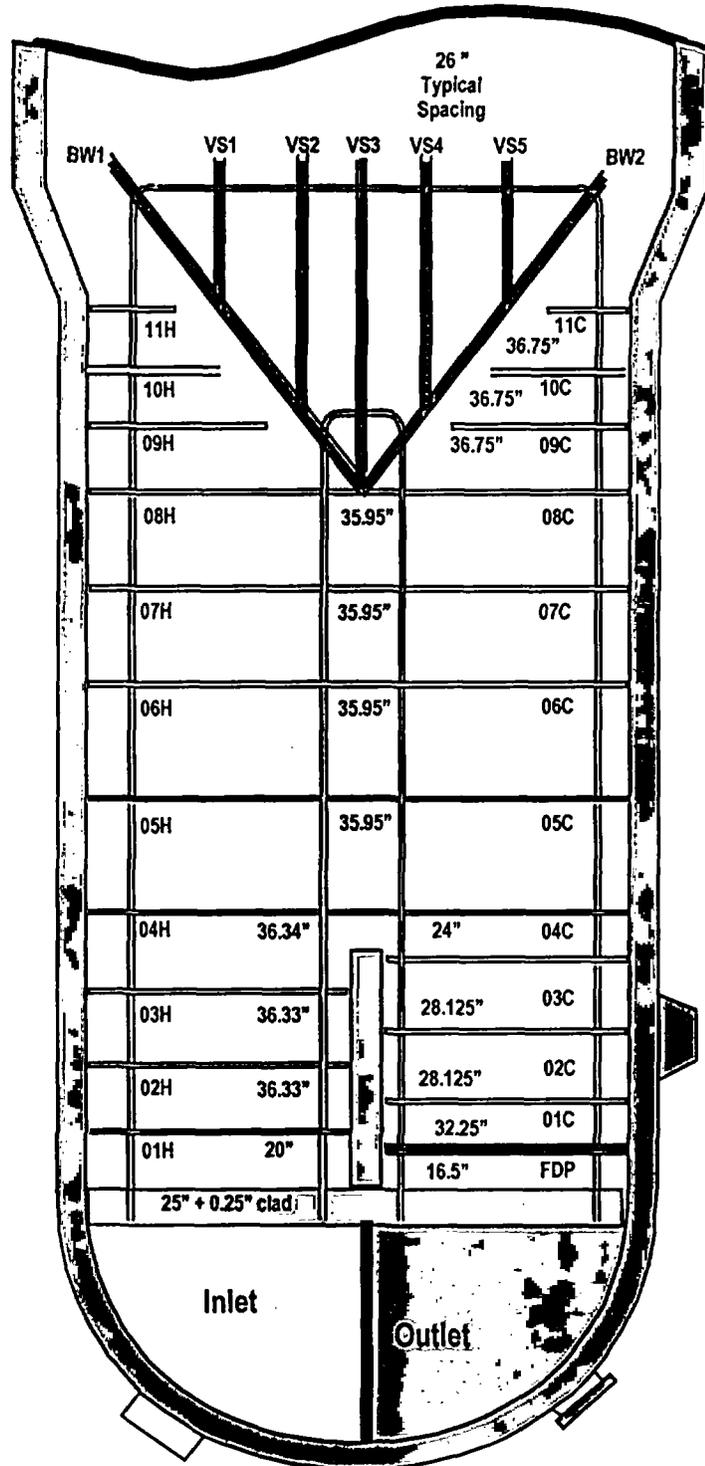
Figure 3
Support System - PVNGS Replacement Steam Generators

The horizontal tube supports located along the vertical section of the tubes are of an eggcrate design. The eggcrates are comprised of alternating one and two inch strips, 0.090 inch thick, arranged in two directions that intersect at 60°. The bend and horizontal regions of the tubes are supported by batwing and vertical lattice supports, respectively. The primary difference from the OSG design are that the batwing and vertical lattice supports are perforated to improve thermal-hydraulic conditions in the upper bundle region to prevent crevice dryout and reduce secondary fouling. The batwing and vertical support structures are now unitized and fabricated from two inch wide, 0.090 inch thick 409 SS strips. The batwing supports which minimize out-of-plane movement have been relocated to bisect the tube bends.

- BW in center of Bends**
- 3 Partial Eggcrates**
- No FDP on Hot Leg**
