**U.S. NUCLEAR REGULATORY COMMISSION
Office of Nuclear Material Safety and Safeguards
Spent Fuel Project Office**

**CONFIRMATORY ACTION LETTER 97-7-001
TECHNICAL EVALUATION**

Docket No. 72-1007

Certificate Holder: Sierra Nuclear Corporation
One Victor Square
Scotts Valley, CA 95066

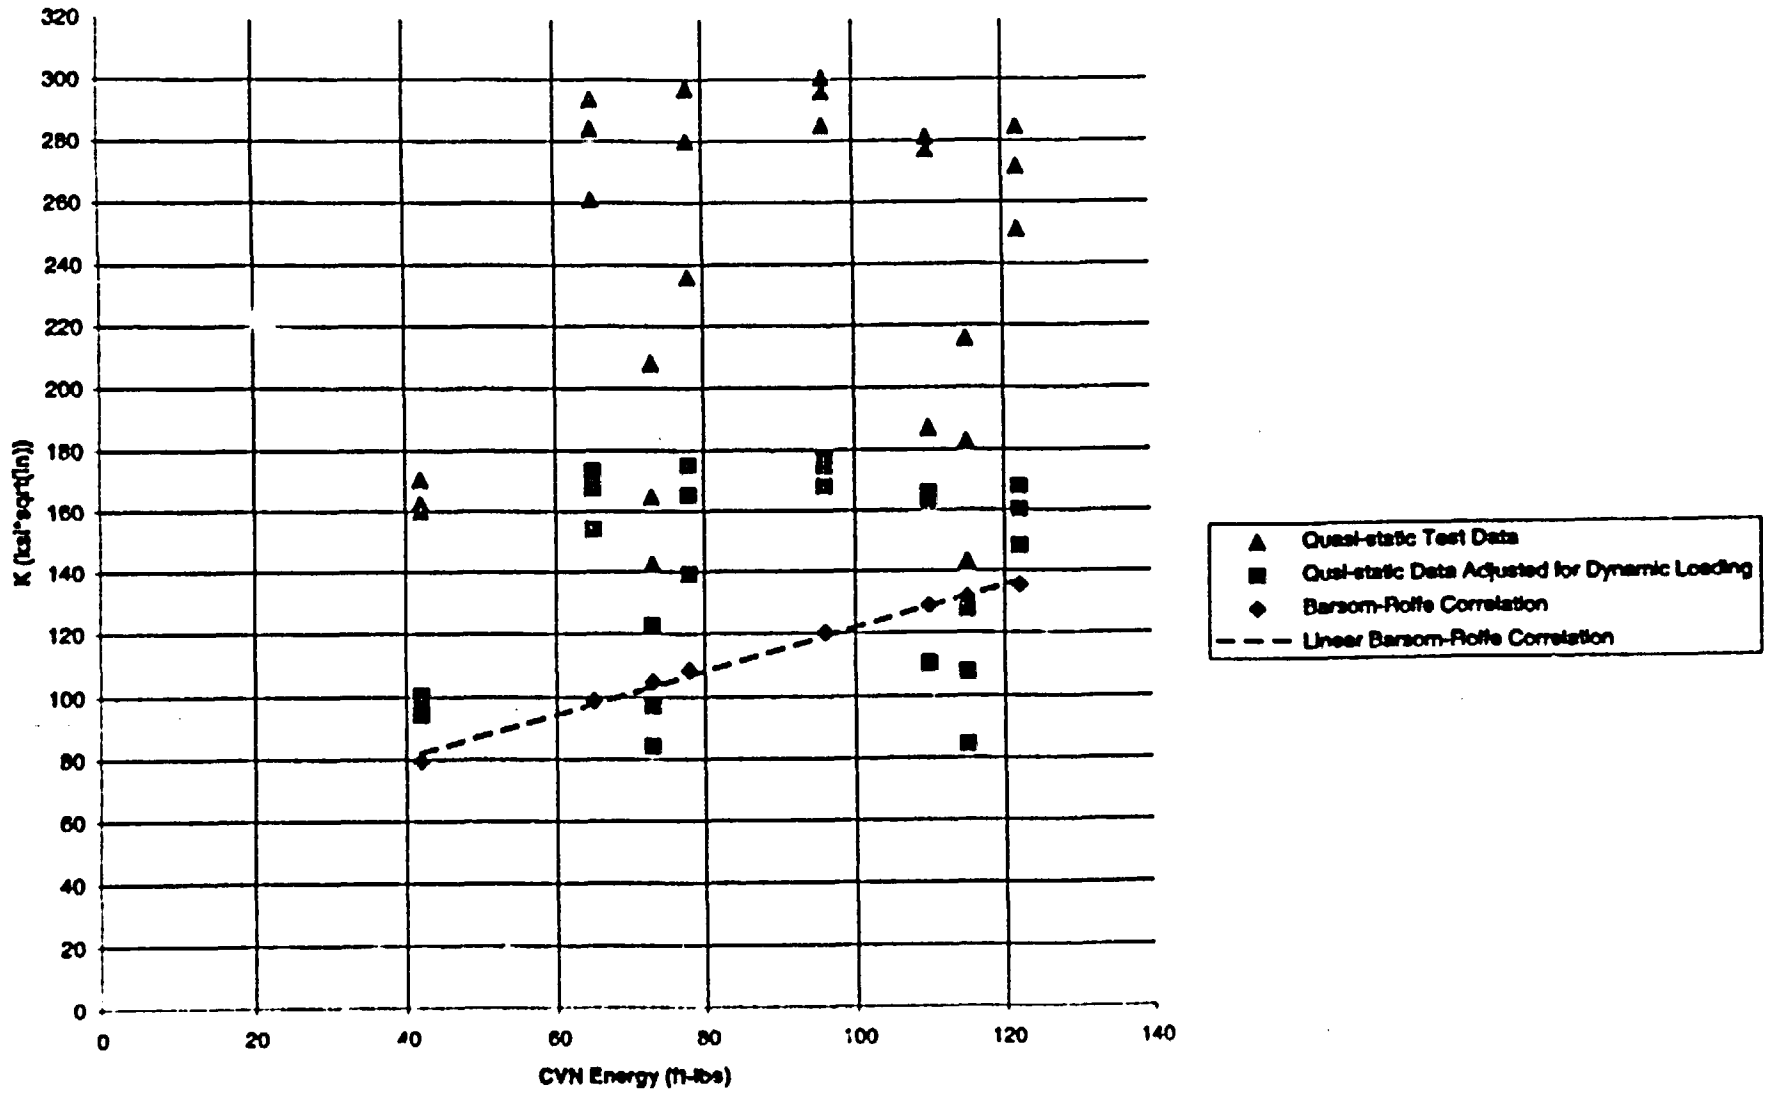
Figure A1

The staff plotted the data for fracture toughness and CVN provided by the Owners Group (Figure A1). The staff did not observe any relationship between K_{Ic} and CVN in the data presented and concluded that the Barsom-Rolfe correlation for the MSB material was inappropriate. This staff position was documented in the May 21, 1998, letter from NRC to SNC.

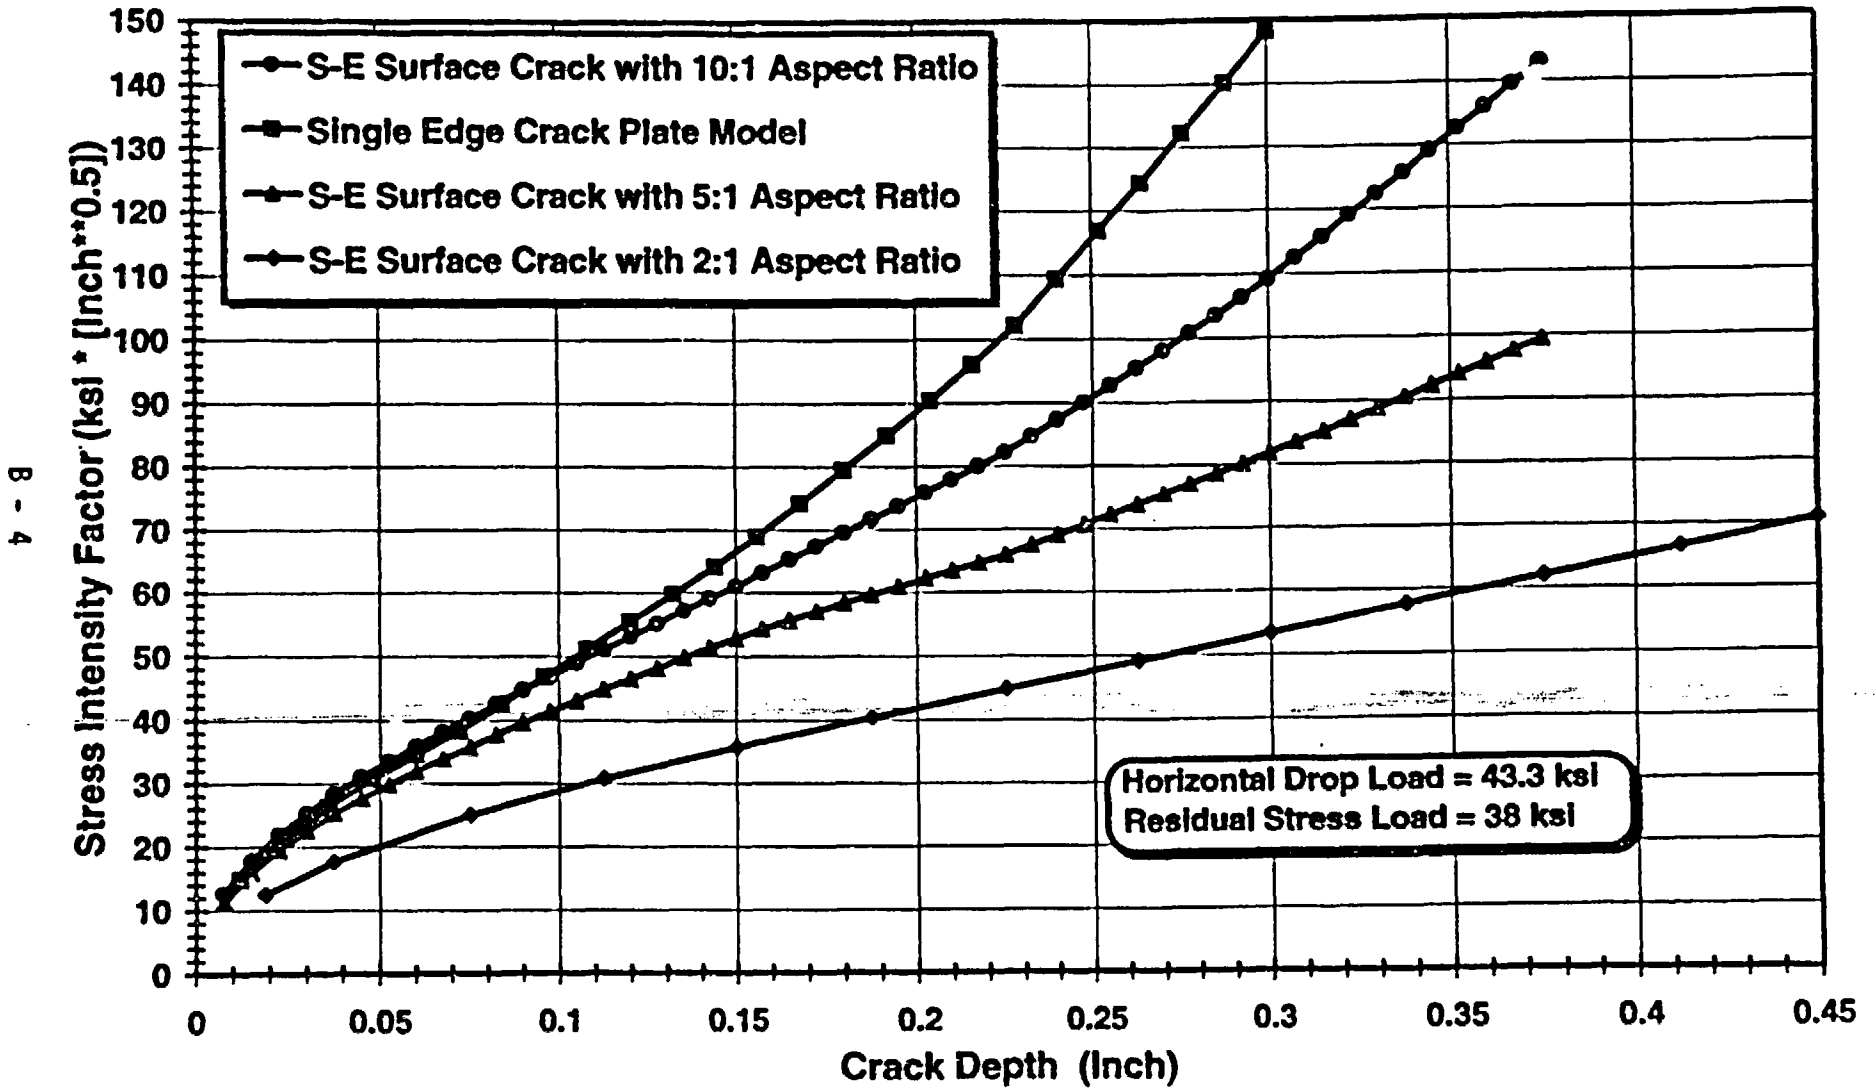
Figure B1

Applied K versus Crack Depth for (Horizontal Drop + 0.707*Weld Residual Stress)
Loading

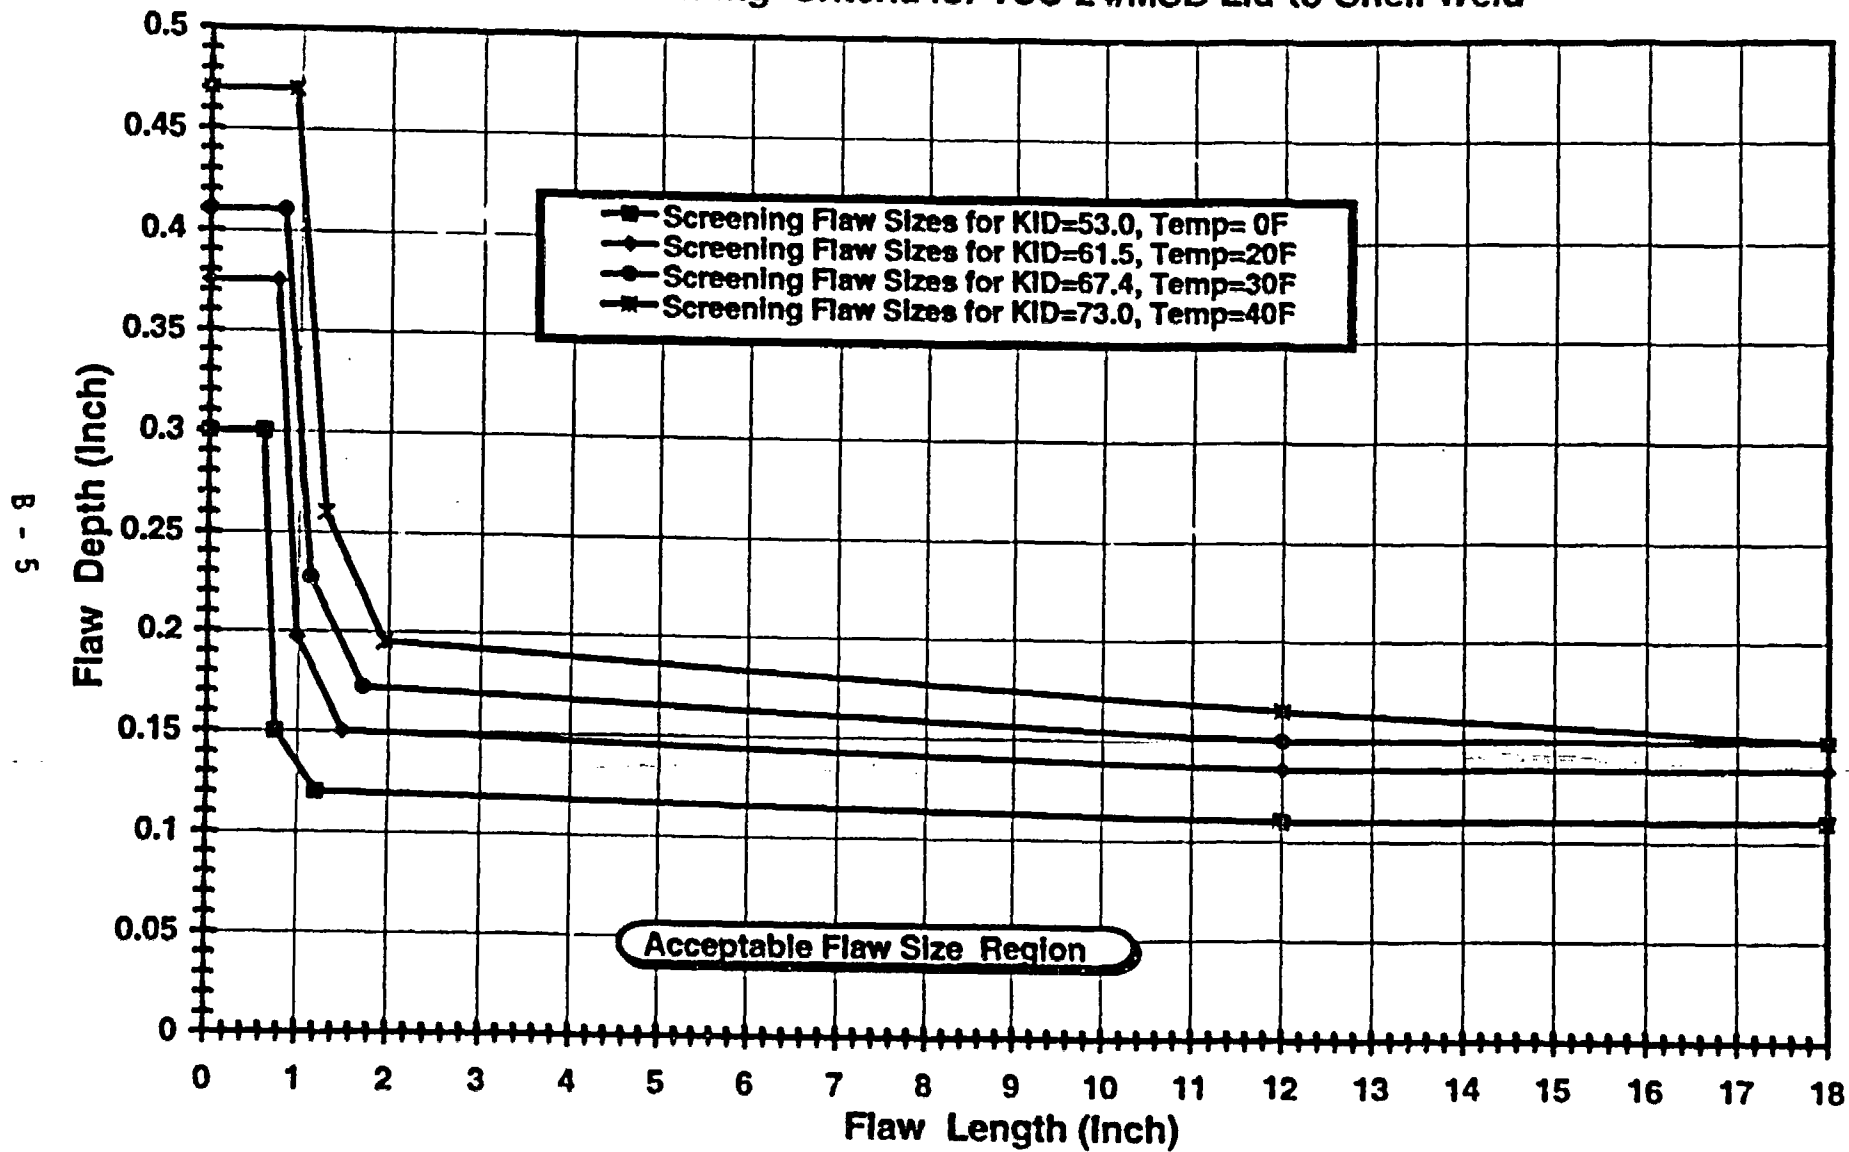
Figure B2

NRC Flaw Screening Criteria for VSC-24/MSB Lid-to-Shell Weld
