Characterization Report for Vacuum Breaker 1 and Ditch East of Switchyard

Characterization Report for Vacuum Breaker 7

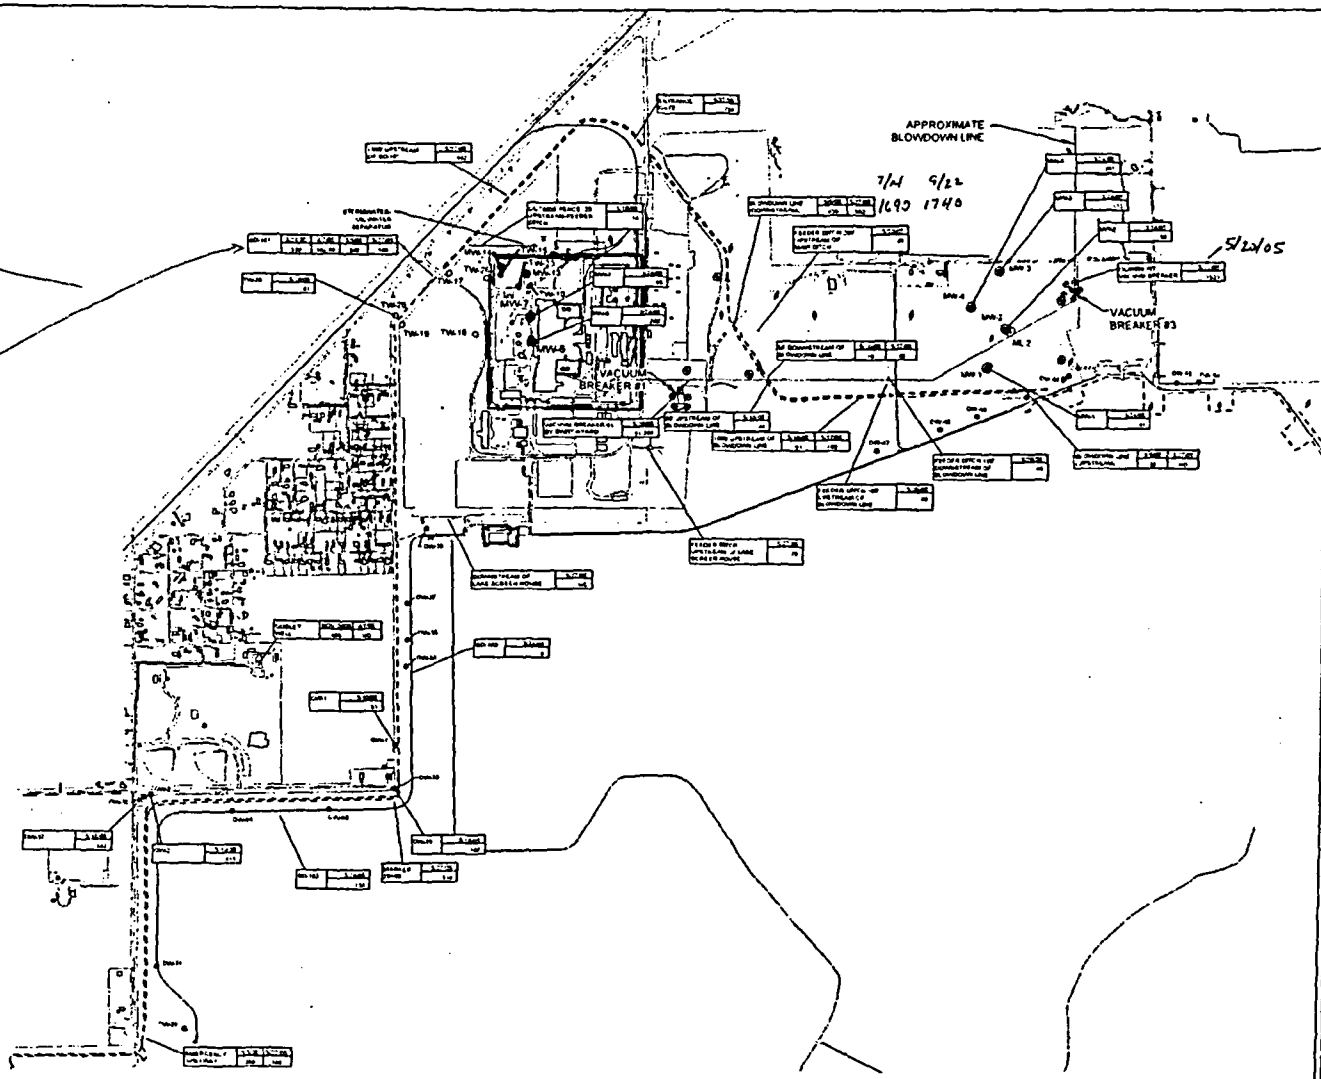
Figure 1

While the shallow VB1-X wells had not yield tritium concentrations as large as the ditch, these deeper wells, drilled to the underlying clay layer about 25 feet below the surface, yielded the results that the team expected for the 1996 spill. See CRA figures 1 and 2 for a graphical depiction of the shallow and deep plumes. This, and all the sample data are summarized on table 1. The plume found at depth is centered about 600 feet down gradient from vacuum breaker 1, placing it in the range of expected distance from the vacuum breaker.
