From: Richard Skokowski *RSK*
To: Steven Orth
Date: Wed, Nov 30, 2005 3:58 PM
Subject: Fwd: CRs re: tritium leak frm vac brkrs

Exelon Nuclear Issue - Statement of Confirmation

Affected Facility: Braidwood
 Discv Date: 11/30/2005 11:50
 How Discovered Code: H02
 Event Date: 11/30/2005 11:50
 Affected Unit: 00
 Affected Sys: --
 Subject: ELEVATED TRITIUM LEVELS IN ON-SITE MONITORING WELLS

Title : Failed Circ Water Blowdown Vacuum Breaker Caused Unplanned Flooding Outside of the Power Block

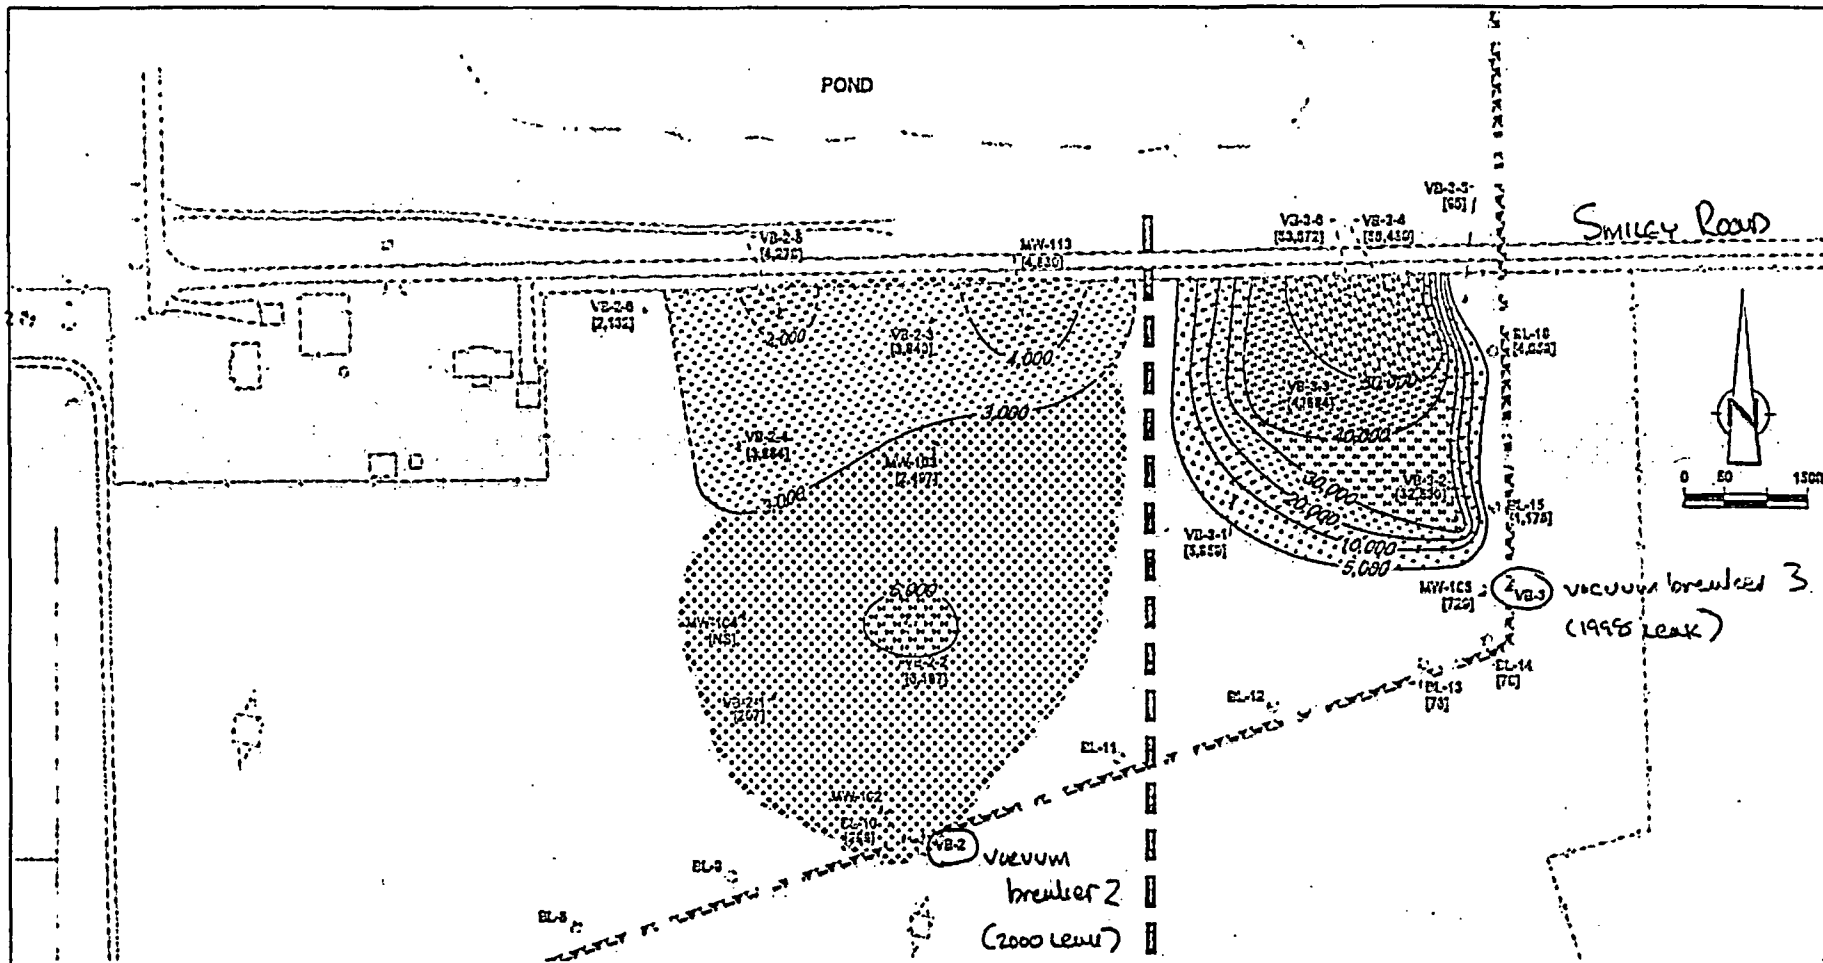
figure
TRITIUM CONTOURS
NOVEMBER 2005
BRAIDWOOD STATION
Braceville, Illinois

Condition Description: Elevated levels of tritium have recently been identified in certain on-site groundwater sampling wells. The exact source has not been located nor has the source been determined to be active or historical.

Why did the condition happen? Unknown. It is believed the source may be from historical vacuum breaker leaks, but this needs to be confirmed.

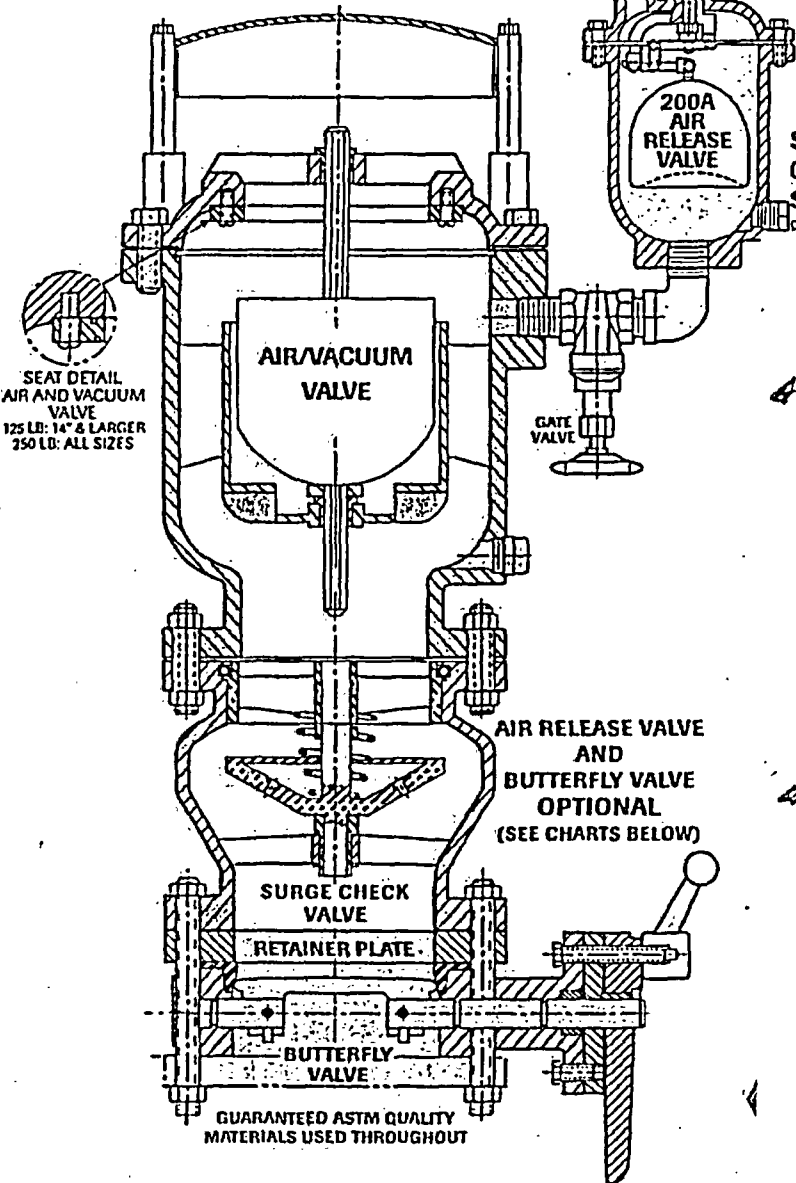
← THIS THE "float" VALVE THAT SEALS the vacuum breaker. This float failed causing the 2000 GVENT.

In 2000 the licensee experienced a failure of the #2 vacuum breaker(VB) in the CW blowdown system which resulted in flooding of the area in the vicinity of the VB. The licensee determined that the VB failed to due to fatigue failure (# of cycles over lifetime) of the valve float assembly. This was exacerbated by the lack of surge protection for the float assembly which seals the valve shut when the piping is full of water. A water hammer appears to have damaged the unprotected float preventing it from sealing shut, allowing an estimated 3 million gallons of water to escape. The CAPR's included installing a surge protection feature on the VB's and modifying the preventative maintenance program for the VB's.

← THIS SURGE VALVE DID NOT EXIST PRIOR TO 2000. It was added as a corrective device after the 2000 event to protect the float valve.
