## INSPECTION REPORT

Spent Fuel Project Office  
Office of Nuclear Material Safety and Safeguards

Inspection Report: 72-1007/97-204

Certificate Holder: Sierra Nuclear Corporation

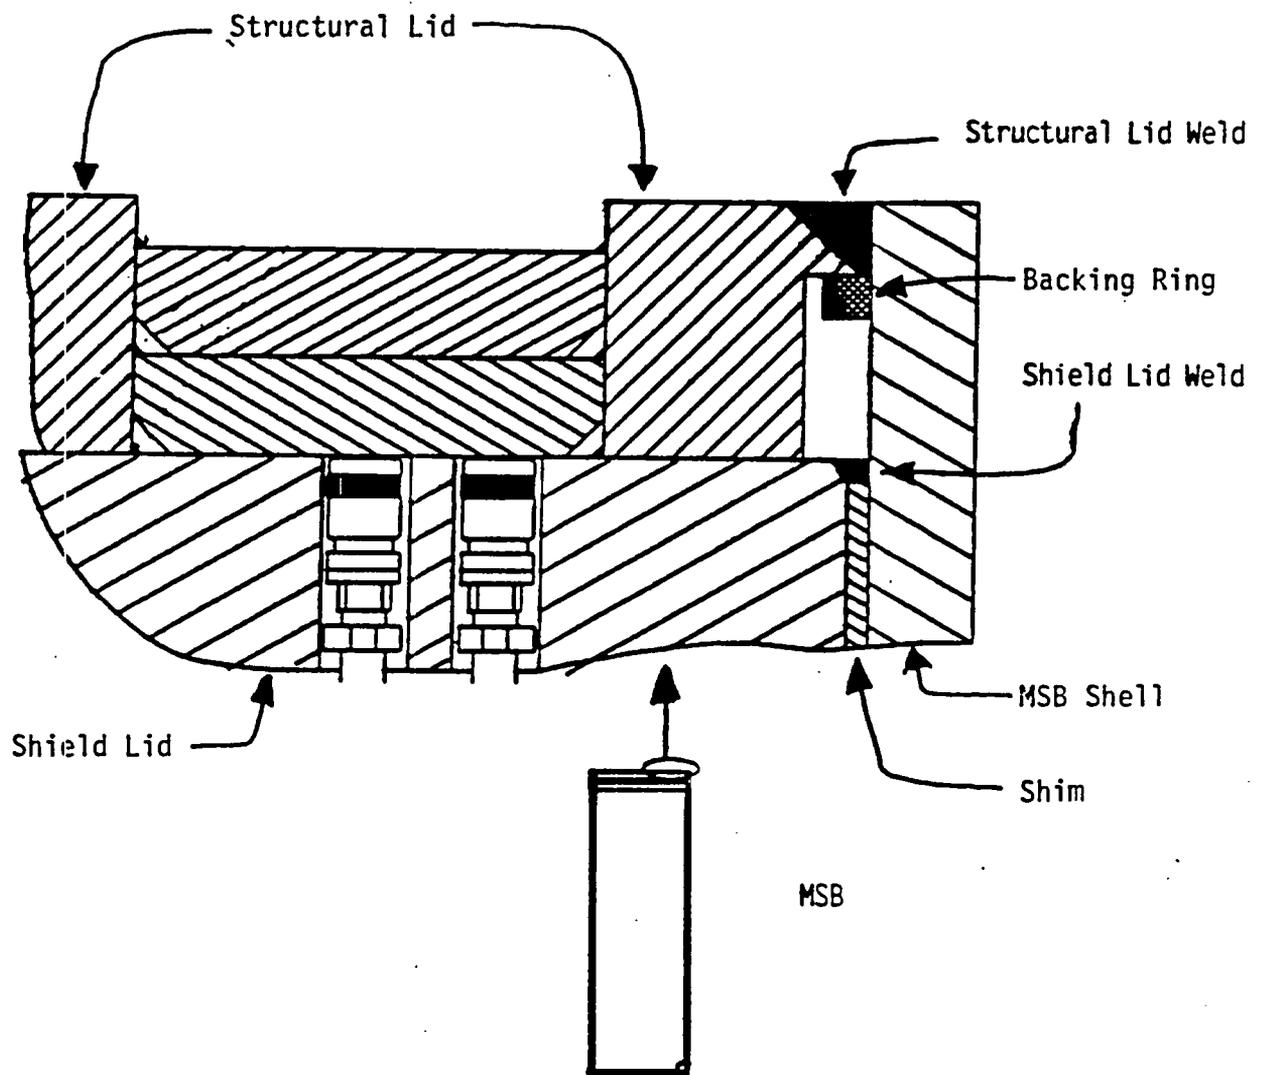
FIGURE 1

The purpose of the shield-lid-to-MSB-shell weld is to provide a leak-tight seal weld to contain the helium atmosphere in the MSB cask. The weld also acts as a confinement barrier to retain the radioactive materials within the MSB.

The purpose of the structural-lid-to-MSB-shell weld is to provide a strength weld between the structural lid and the MSB shell. The weld is capable of withstanding postulated accident loads. The weld also provides a leak-tight seal and a radioactive material confinement barrier.

# Multi-assembly Sealed Basket (MSB) Shield and Structural Lid Welds
