Instrumentation and Professional Services

March 16, 2006

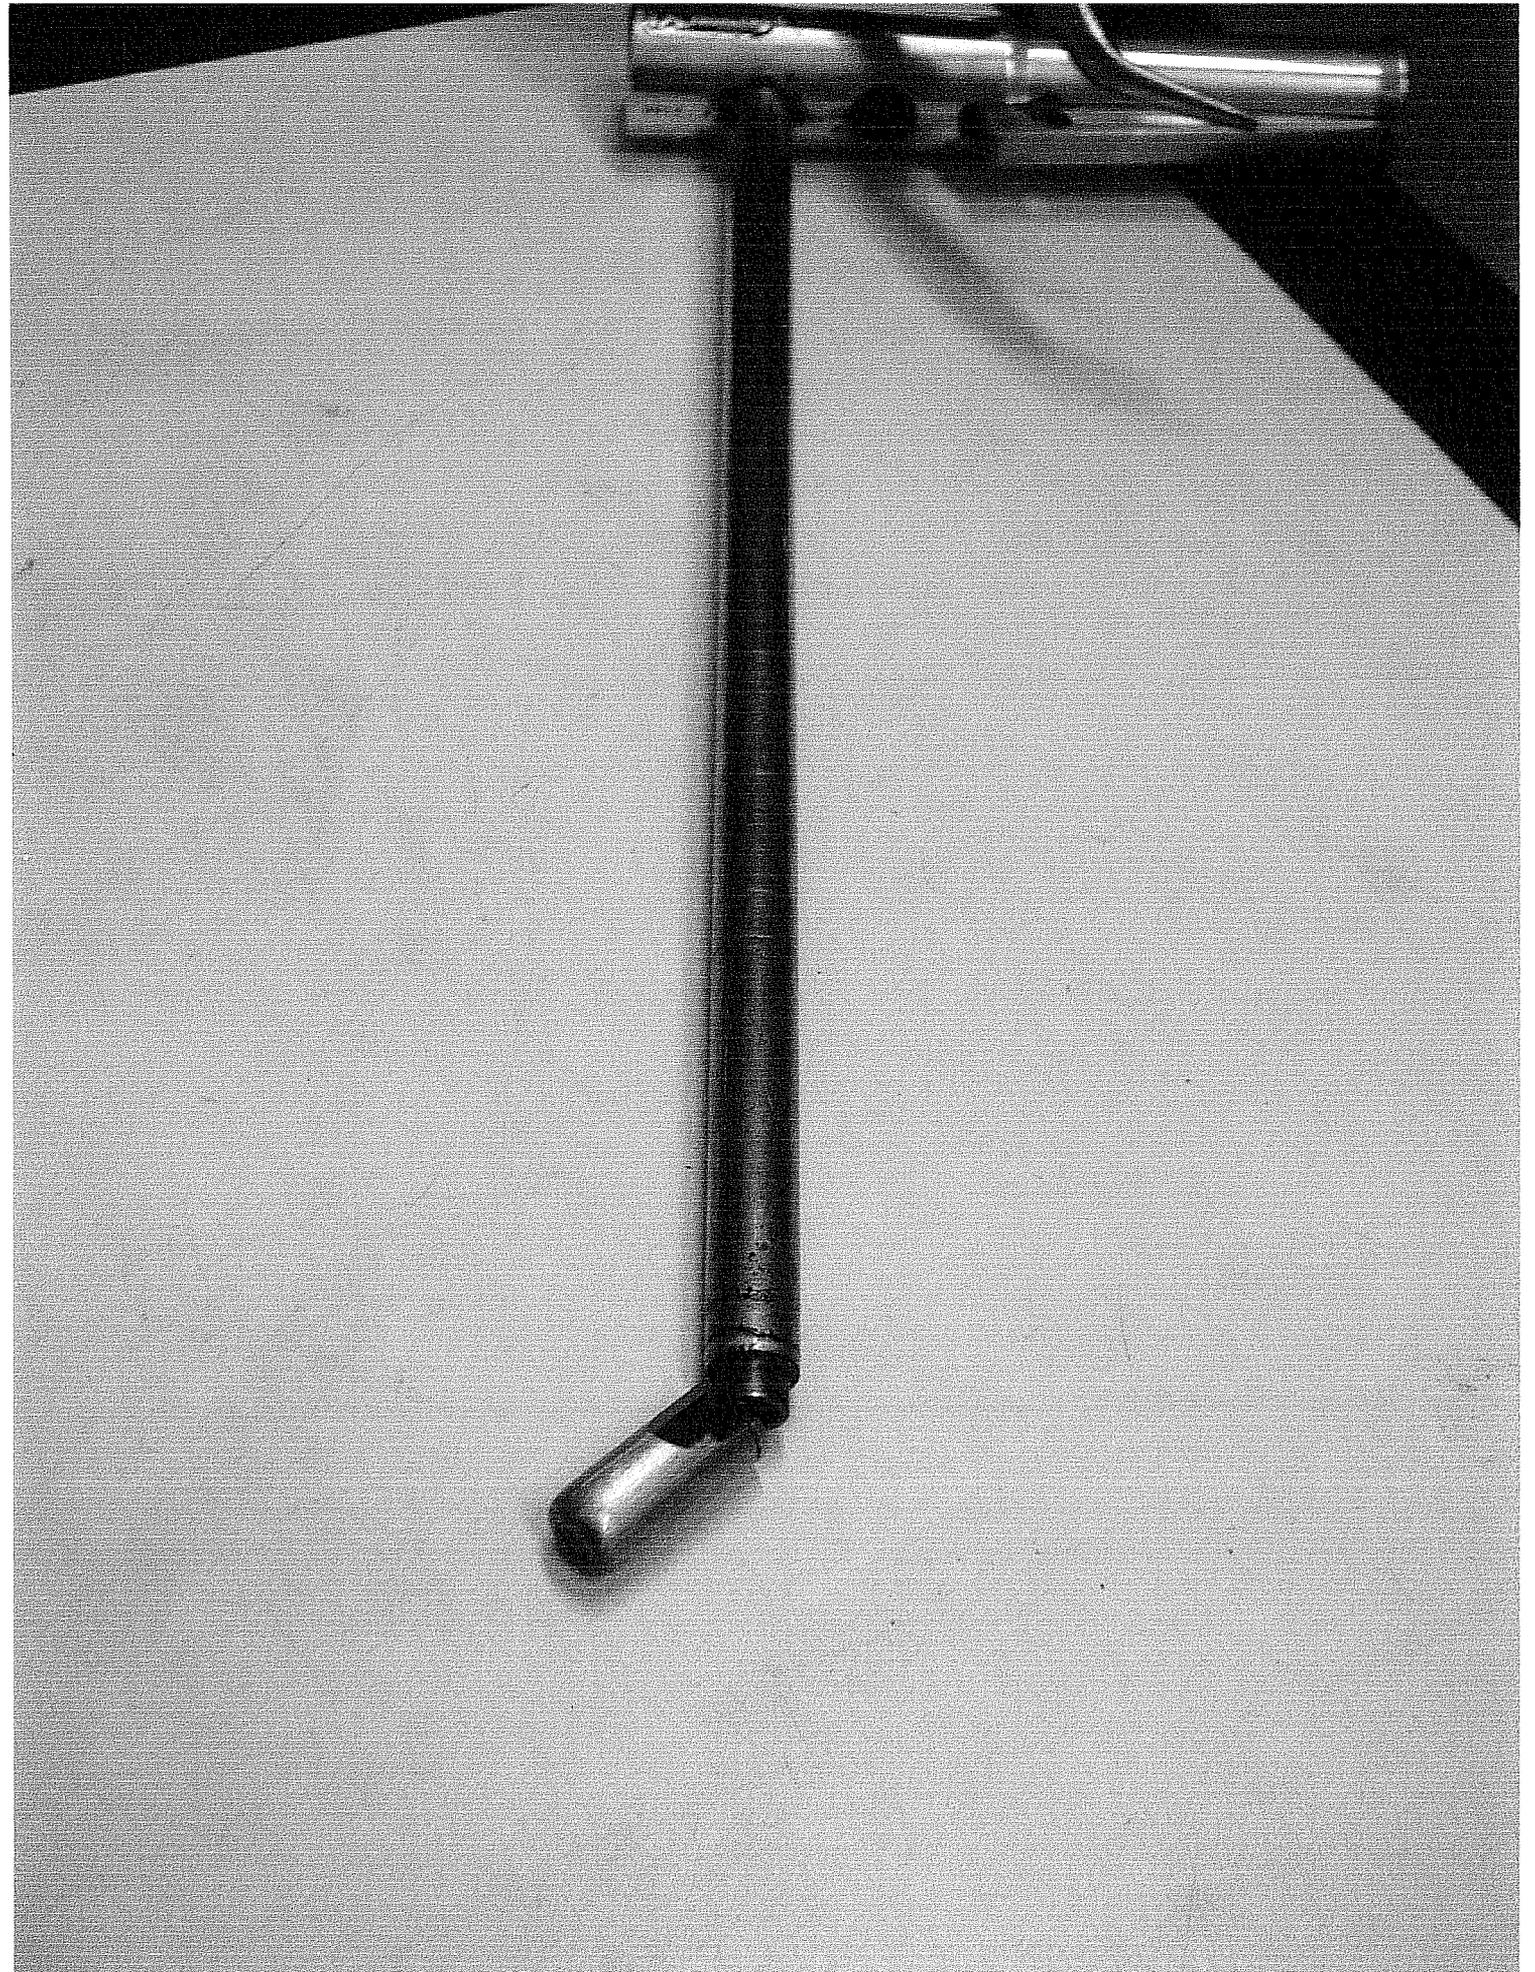
In compliance with 10 CFR 21, *Reporting of Defects and Noncompliance*, we are reporting a defect that was apparent in a Troxler, Model 3411 series, gauge that one of our techs discovered in Boise. On this particular gauge, the source rod weld had been defective, a substantial piece of the threaded source section failed, and allowed the source tip to become disengaged from the source rod. The gauge source was satisfactorily withdrawn into the shielded position and transported back to the Qal-Tek Associates facility in Idaho Falls for disposal. A picture of the defective component is attached.
