Duke Energy - Oconee
Nuclear Station Steam
Generator Wear Root
Cause Update with NRC
April 10, 2006

Topics of discussion

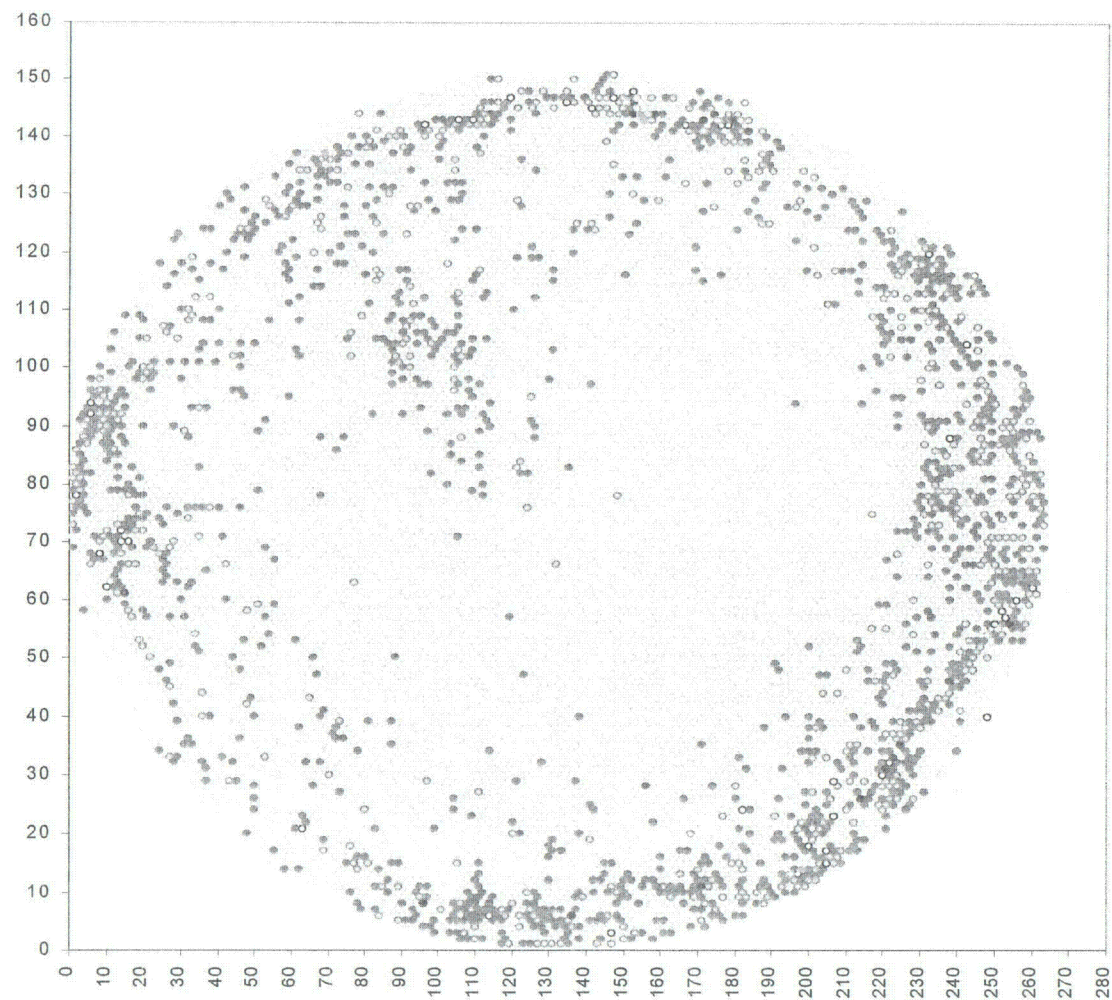
Ocone 1-A

- ONS1A, 2431 indications were found on 1797 tubes
- ONS1-B, 1749 indications were found on 1450 tubes
- Both ROTSGs 90% of the indications are less than or equal to 15% of the through wall thickness
- 50% of the indications are under 10% of the through wall thickness
- The vast majority of indications ($\approx 95\%$) are present in the superheated steam region on the 9th tube support plate and above
- All indication above the 9th support plate are predominately on the outer region of the bundle.

- The highest frequency of indications is at the 10th support plate, with the 11th and 9th showing the next highest population,
 - The bleed port is located between the 9th and 10th support plate

- the steam outlet nozzles are located at the elevation of the 11th support plate.
- Peripheral indications at the 10th TSP on both ROTSGs are more tightly distributed and show a tendency to form a “line” oriented relative to the steam nozzle orientation

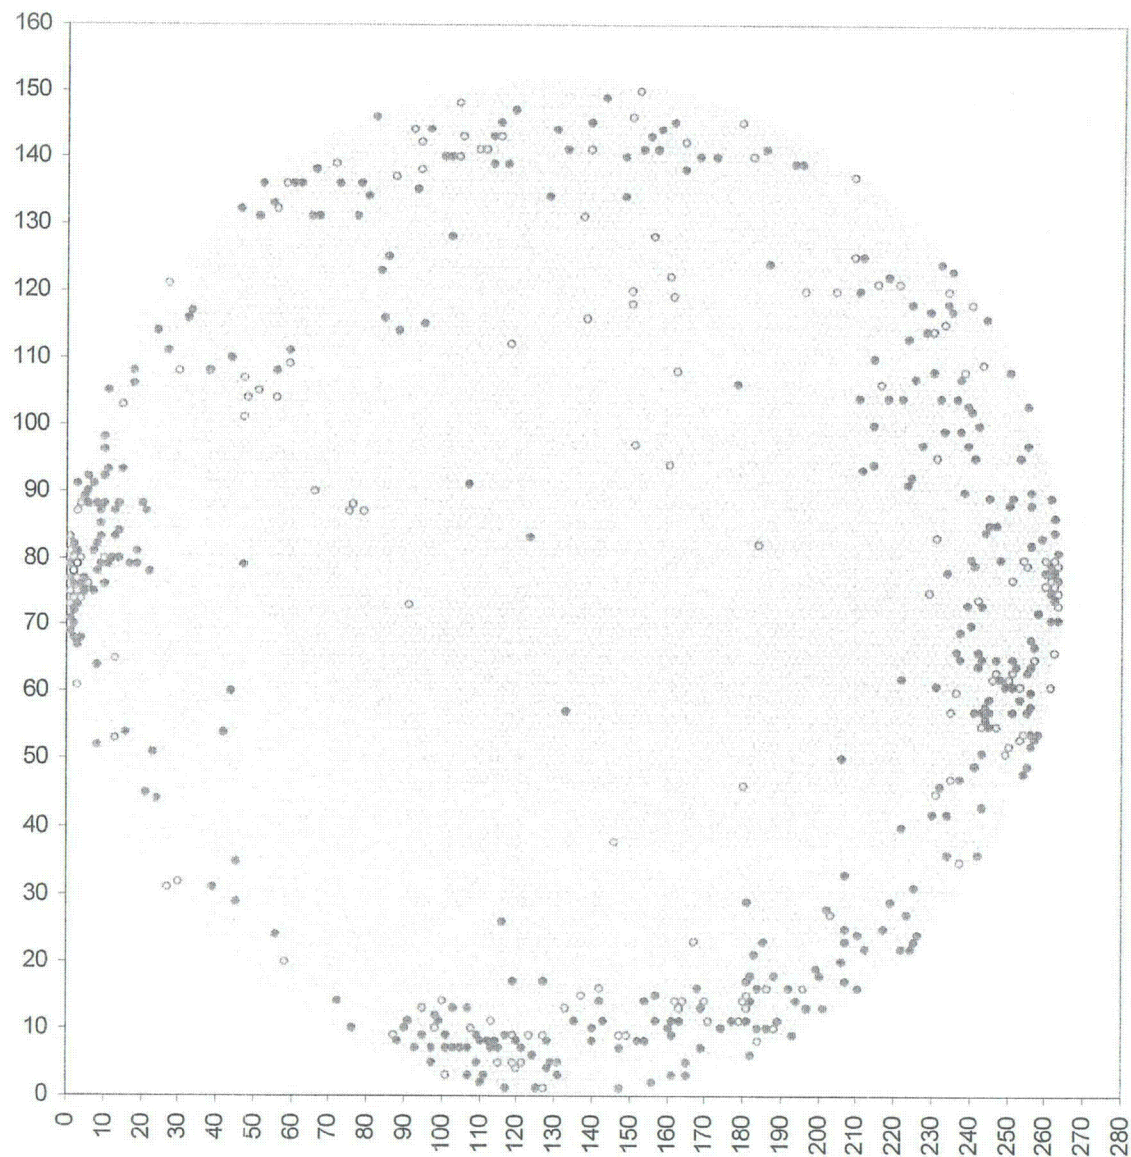
ONS2-A
11-01-05

- ONS2-A, 633 indications were found on 498 tubes
- ONS2-B, 903 indications were found on 699 tubes
- Both ROTSGs 90% of the indications are less than or equal to 13% of the through wall thickness and 50% of the indications are under 8% of the through wall thickness
- There are significantly less indications than ONS1 with a less severe wear depth distribution.
- The highest frequency of indications is at the 13th support plate for ONS2-A and the 12th support plate for ONS2-B. There is low incidence of indications on the 9th, 10th and 11th support plates when compared with ONS1.
- Relative to ONS1 there are an increased number of indications in the vicinity of the inspection ports in the lower bundle region below the 9th TSP.
- Based on ECT, wear is predominately single lobe contact similar to ONS1
- Preliminary review of X-Probe data shows no discernable orientation pattern .

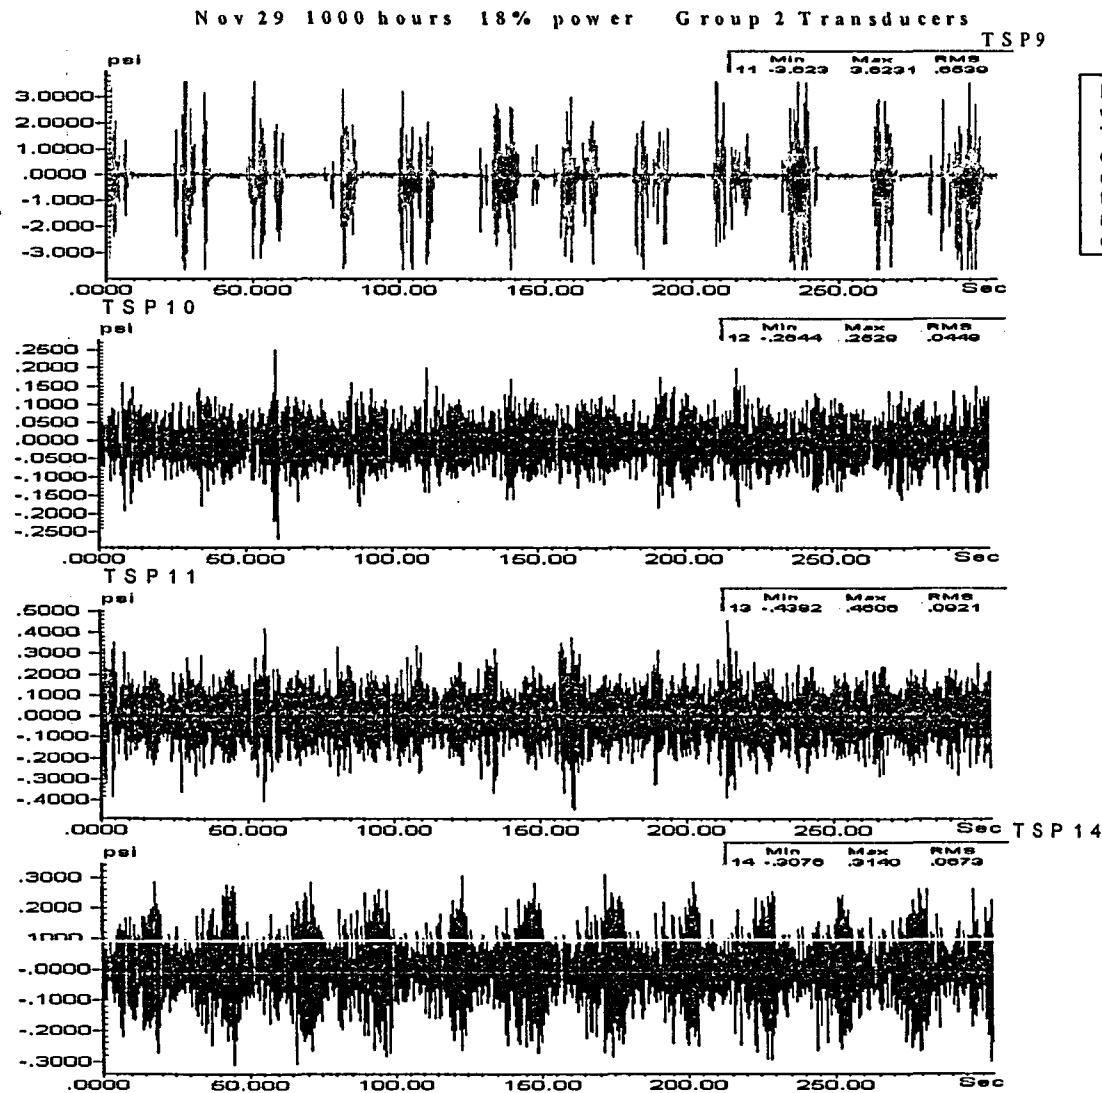
- Unexpected high pressure, low frequency signals were observed at the 9th and 10th TSP, especially at lower power during startup of unit #2 in the fall 2006
- Signals still being evaluated. There is concern that they may not represent real pressure
- Calculations by consultant indicate that energy is sufficient to cause damage if signals are real.
- Signals at low power may be related to control valve operations.

Pressure transients were initiated at TSP 9 but were detected also at the other TSP transducers. Note the magnitudes at the other locations were

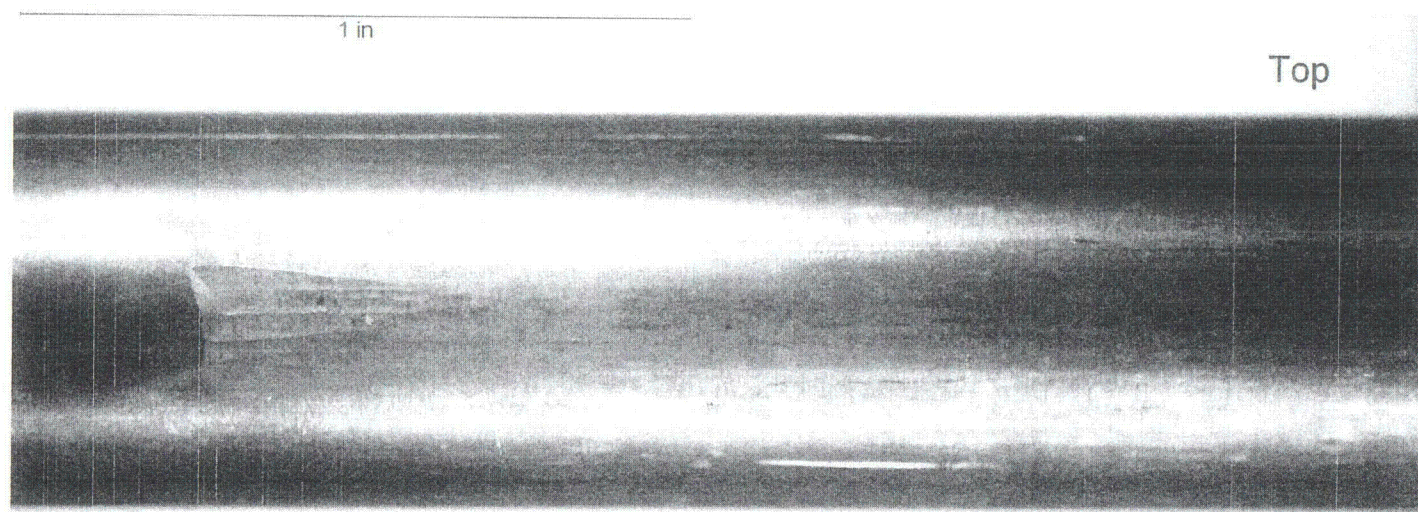
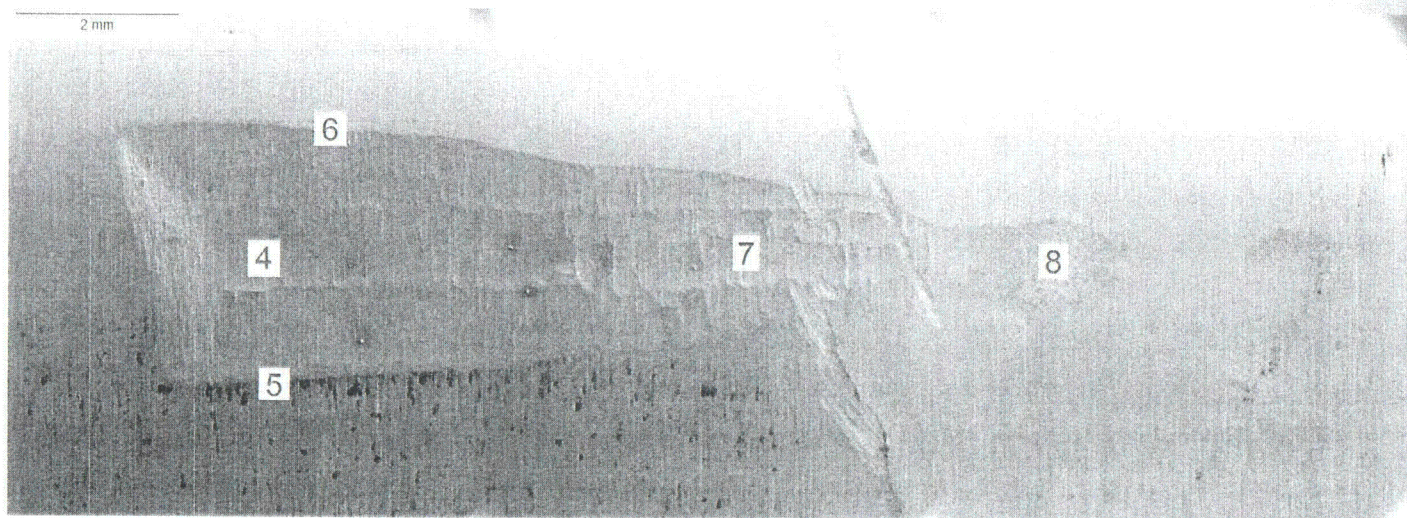
53-114, Pce 32, TSP 14, 110 Deg.

- Macro photography -complete
- Lab ECT - complete
- SEM/EDX – in progress
- Laser profilometry – in progress
- Meeting 4/11/05 to discuss results to date and future plans
- Wear tapered consistent with field ECT
- Sliding marks evident on upper bundle defects
- Preliminary observations of wear surface suggest more than one mode of tube motion likely
