Briefing on Spent Fuel Pool

Indian Point Energy Center

November 3, 2005

Spent Fuel Pool Investigation

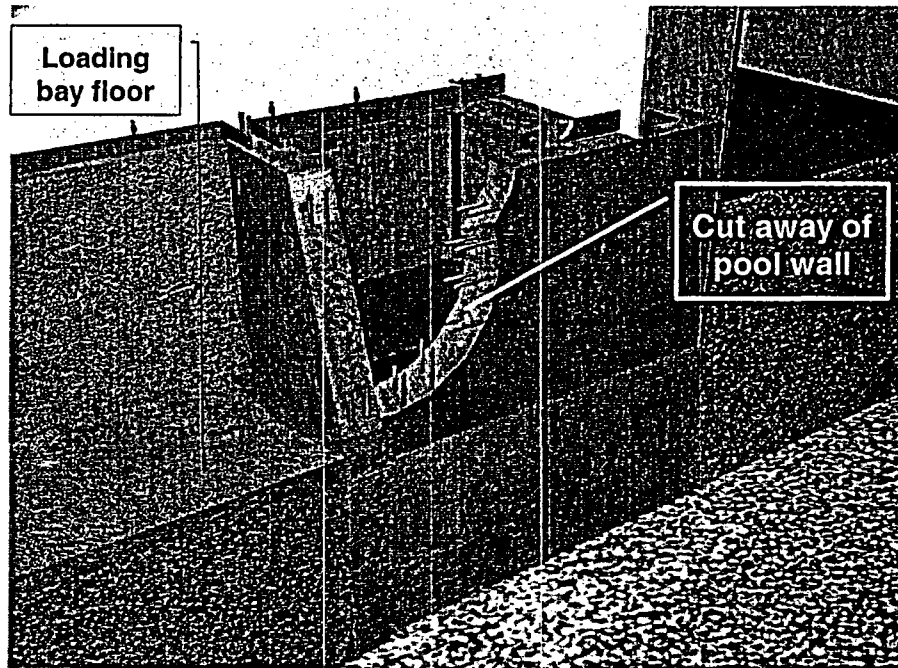
IP2 Spent Fuel Pool Area Before Excavation

Two hairline shrinkage cracks discovered on south wall of spent fuel pool during excavation for new crane

Moisture in the cracks is along a 3' and 9' long section
