**Entergy**

November 21, 2005

Spent Fuel Pool Bulletin # 2

## Second Dive in IP2 Spent Fuel Pool Does Not Reveal Leak

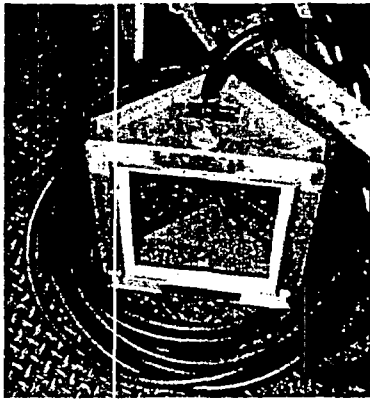
*Vacuum box that was used in the spent fuel pool dives.*

A second dive by Underwater Construction, a Connecticut company that specializes in nuclear dive services, did not reveal the source of a leak in the Indian Point Unit 2 spent fuel pool. Similarly to a dive performed last week, the diver installed a vacuum box over a small section of the southwest corner of the fuel pool where a potential flaw was identified in a video inspection of the liner. The spent fuel pool is lined with welded stainless steel plates, about 1/4 inch thick. The potential flaw is located about 18 feet from the top of the spent fuel pool. The top of the fuel racks which contain the spent fuel assemblies is about 25 feet from the top.

A number of repair options are undergoing engineering review. Although the vacuum box tests did not reveal any leaks, Entergy will apply a protective coating on the small flaws along the weld seams.

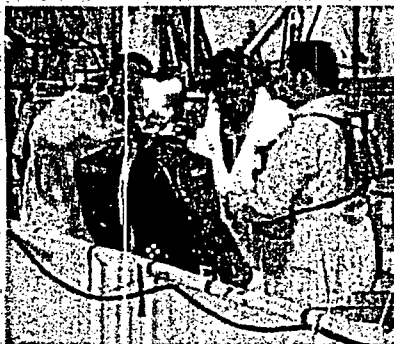
*Getting ready for dive. File photo from first dive*
