Point Beach Nuclear Plant, Units 1 and 2  
Dockets 50-266 and 50-301  
License Nos. DPR-24 and DPR-27

Supplemental Response to Generic Letters (GL) 98-04 and GL 2004-02  
Licensee Event Report 266/301/2005-006-00

## ENCLOSURE 2

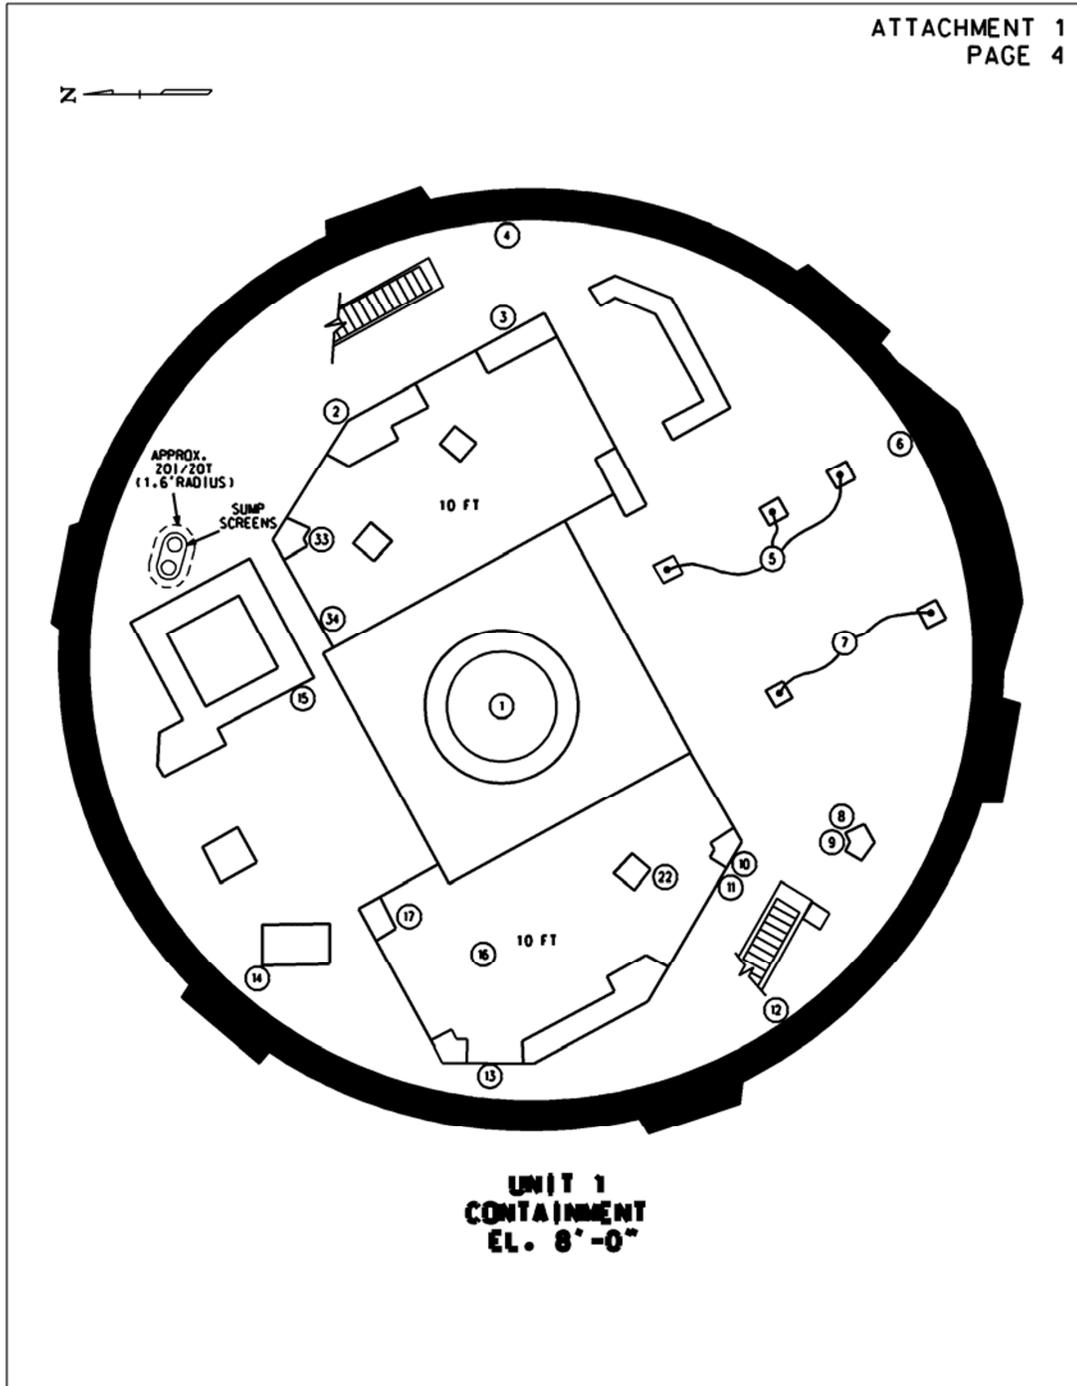
CONT08FT.dgn 2/15/2006 1:07:32 PM

Unit 1 Containment Elevations Showing  
Degraded Or Nonconforming Coatings

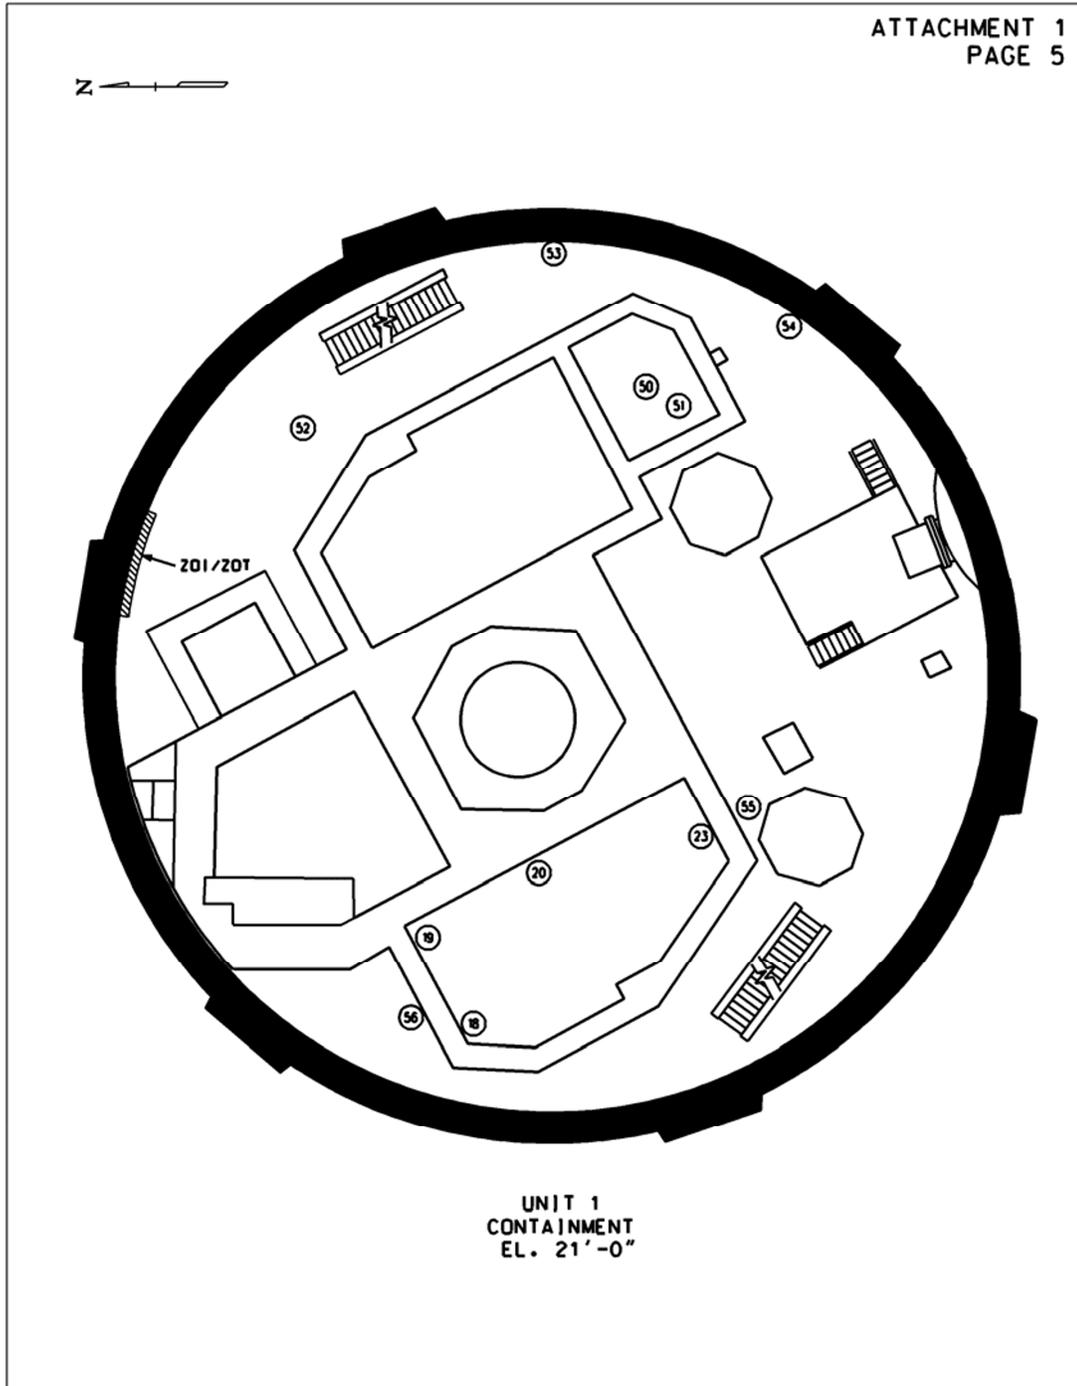
CONT26FT.dgn 2/15/2006 1:09:34 PM

Unit 1 Containment Elevations Showing  
Degraded Or Nonconforming Coatings

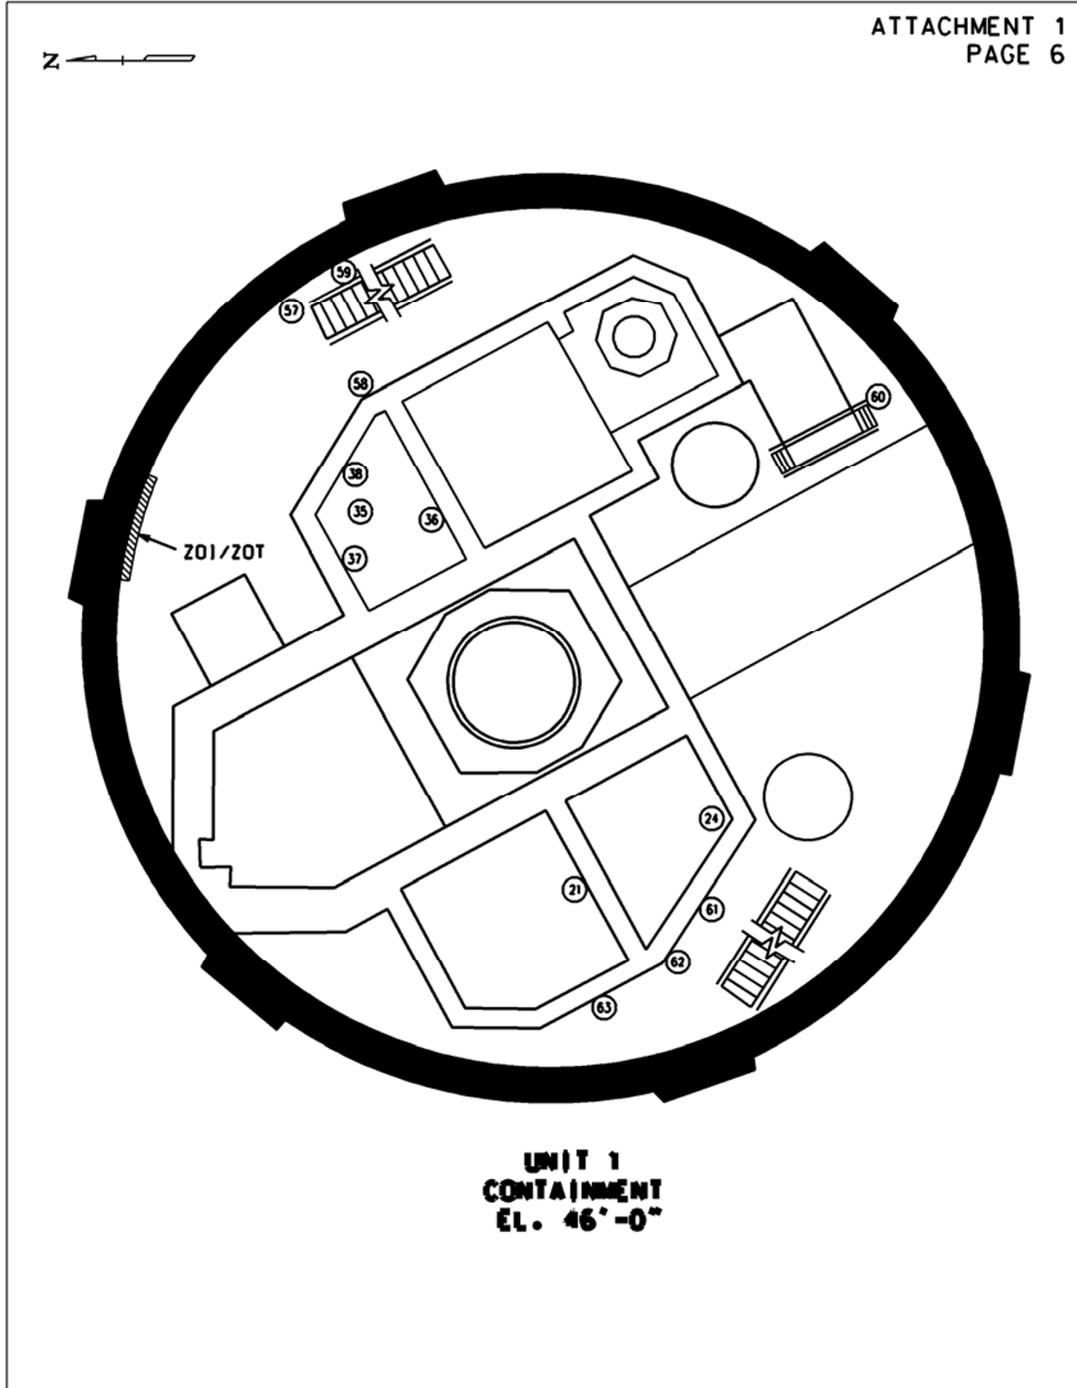
CONT44FT.dgn 2/15/2006 1:11:07 PM

Unit 1 Containment Elevations Showing  
Degraded Or Nonconforming Coatings

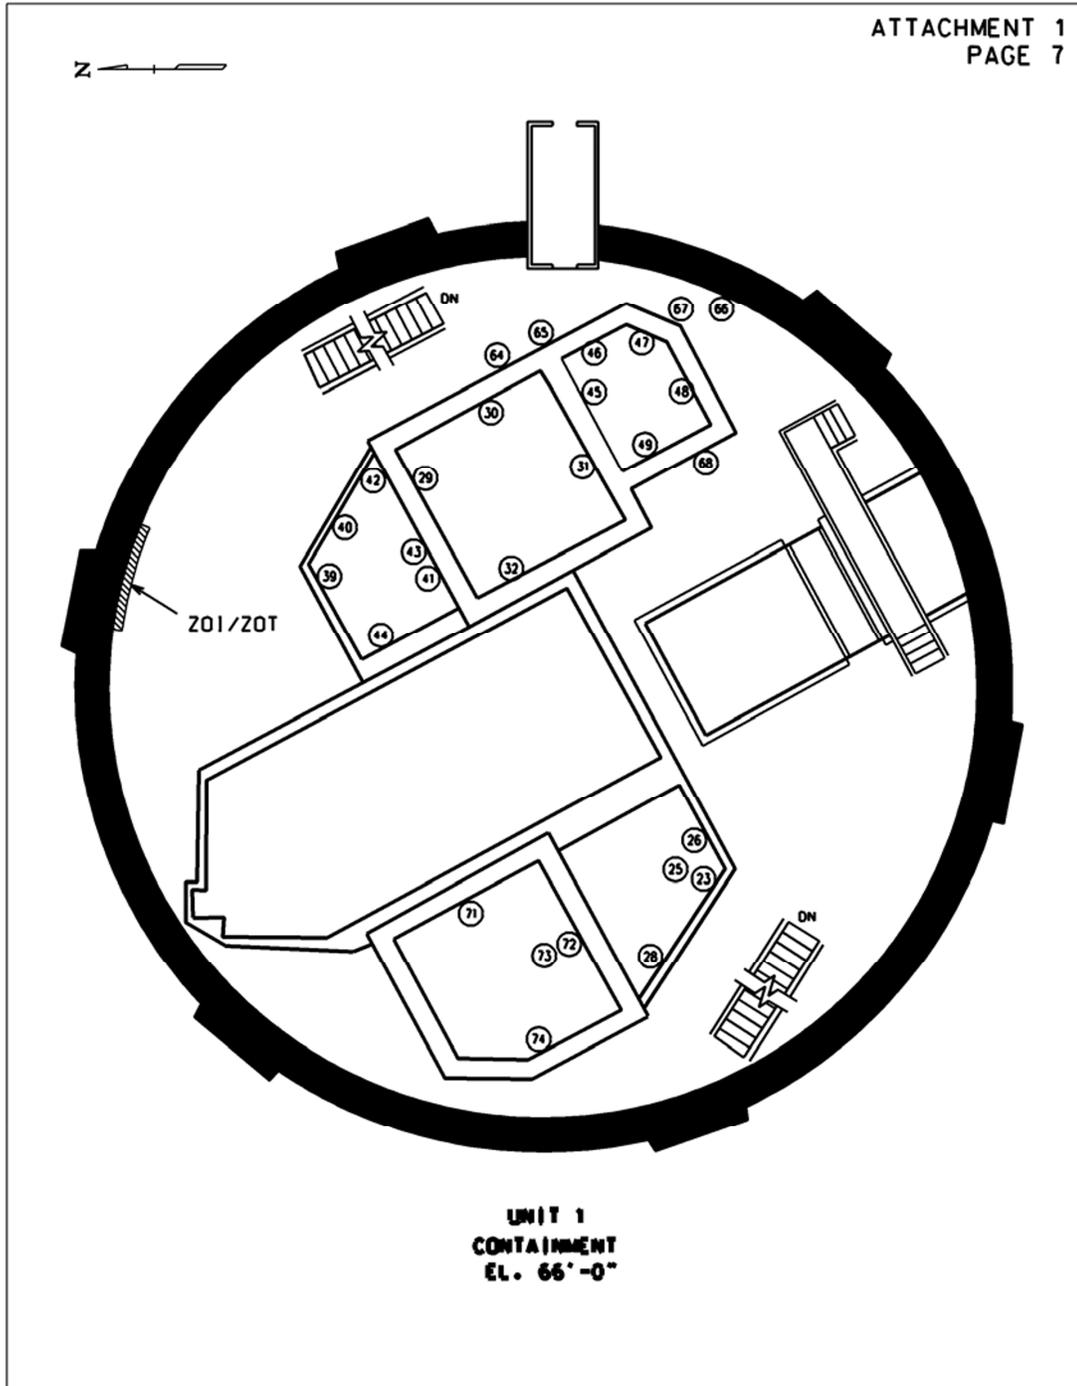
CONT66FT.dgn 2/15/2006 1:13:36 PM

Unit 1 Containment Elevations Showing  
Degraded Or Nonconforming Coatings

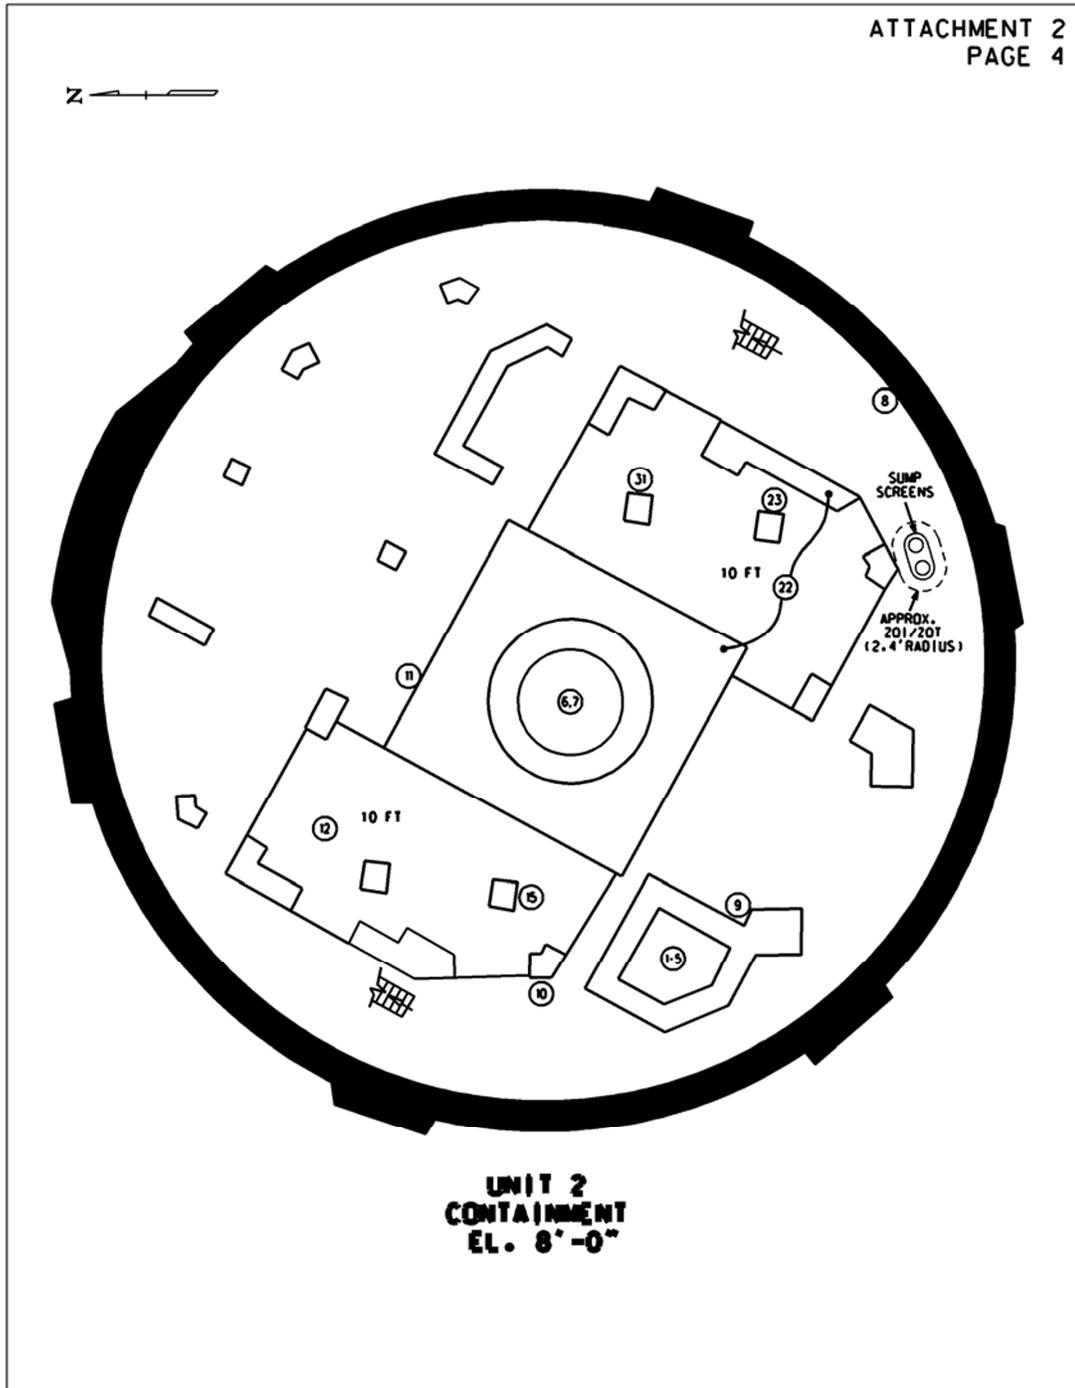
CONT08FT.dgn 2/15/2006 1:06:47 PM

Unit 2 Containment Elevations Showing  
Degraded Or Nonconforming Coatings

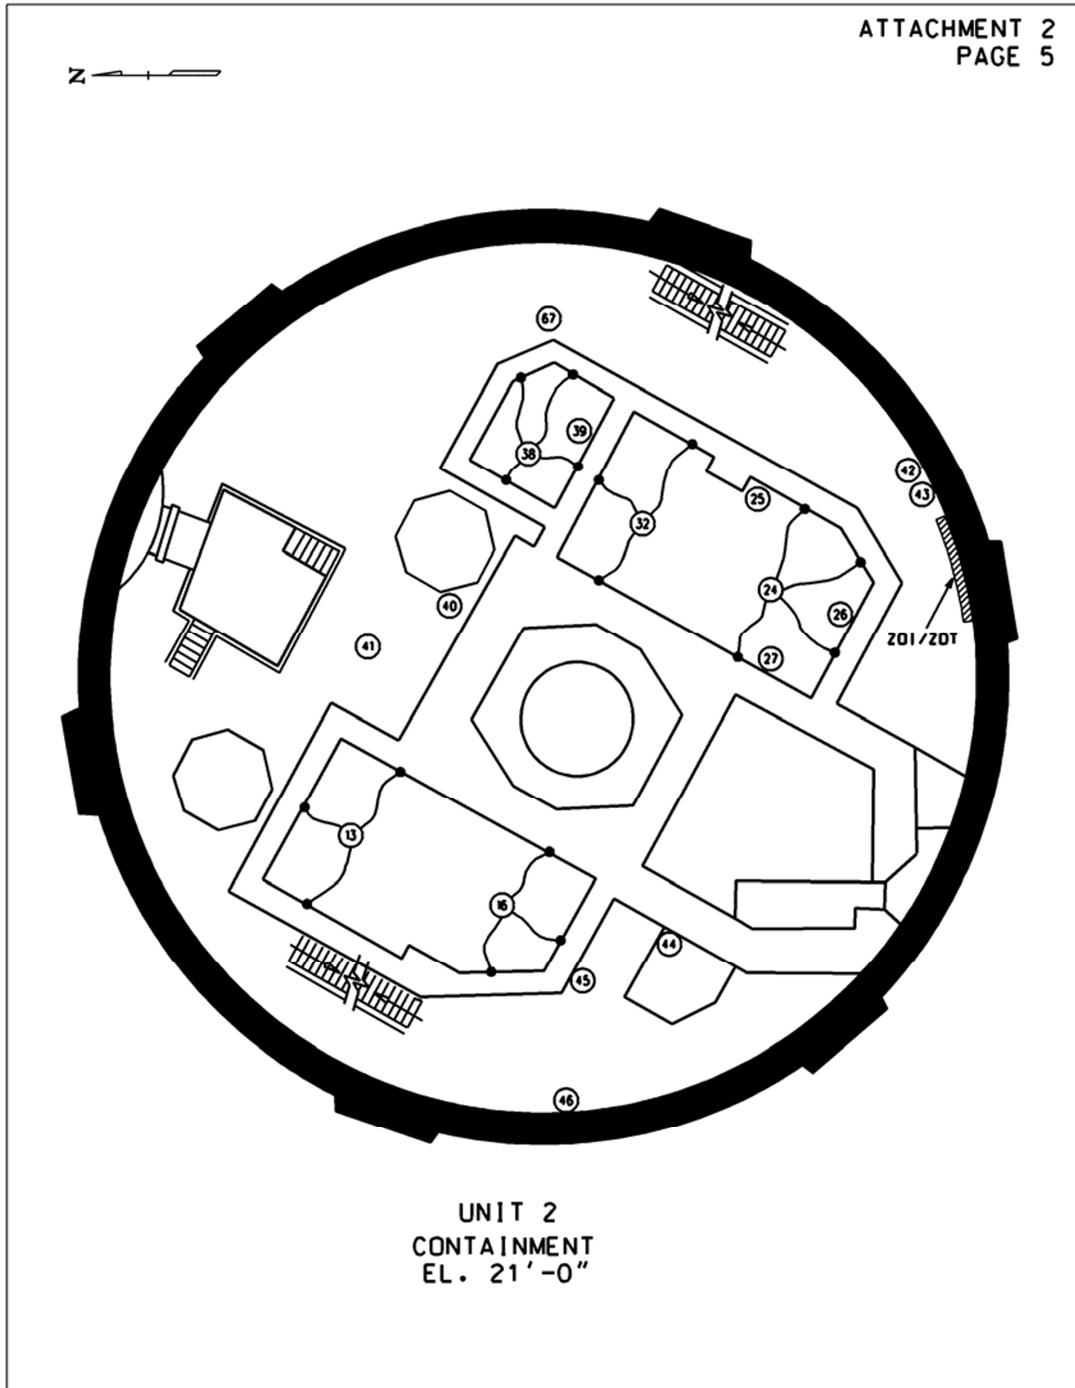
CONT26FT.dgn 2/15/2006 1:08:29 PM

Unit 2 Containment Elevations Showing  
Degraded Or Nonconforming Coatings

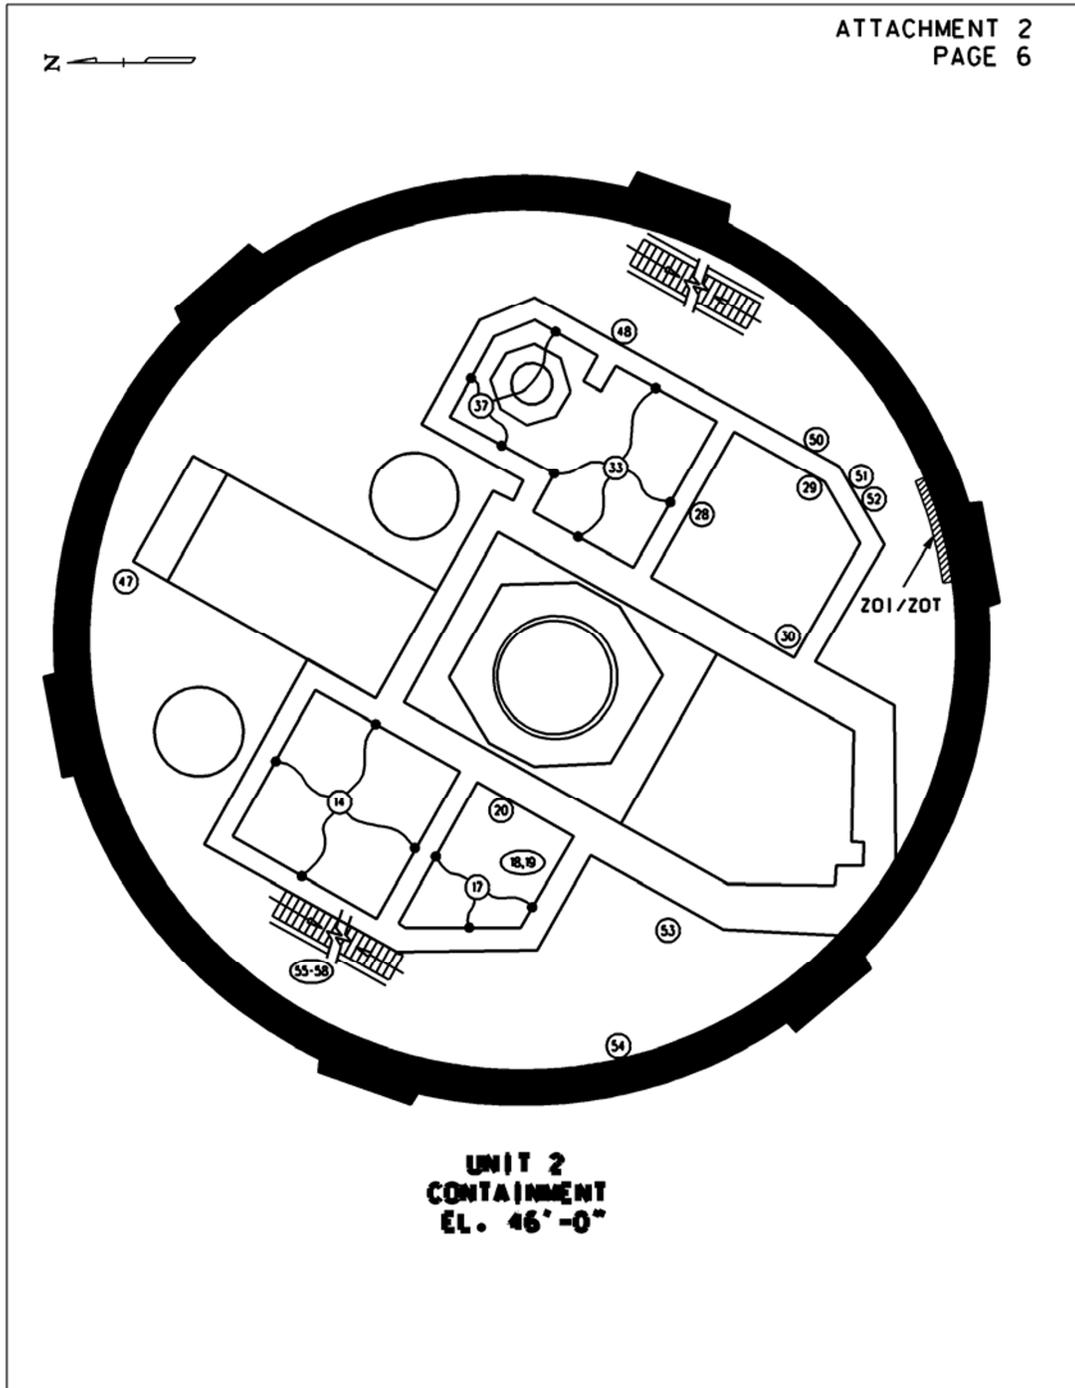
CONT44FT.dgn 2/15/2006 1:10:32 PM

Unit 2 Containment Elevations Showing  
Degraded Or Nonconforming Coatings

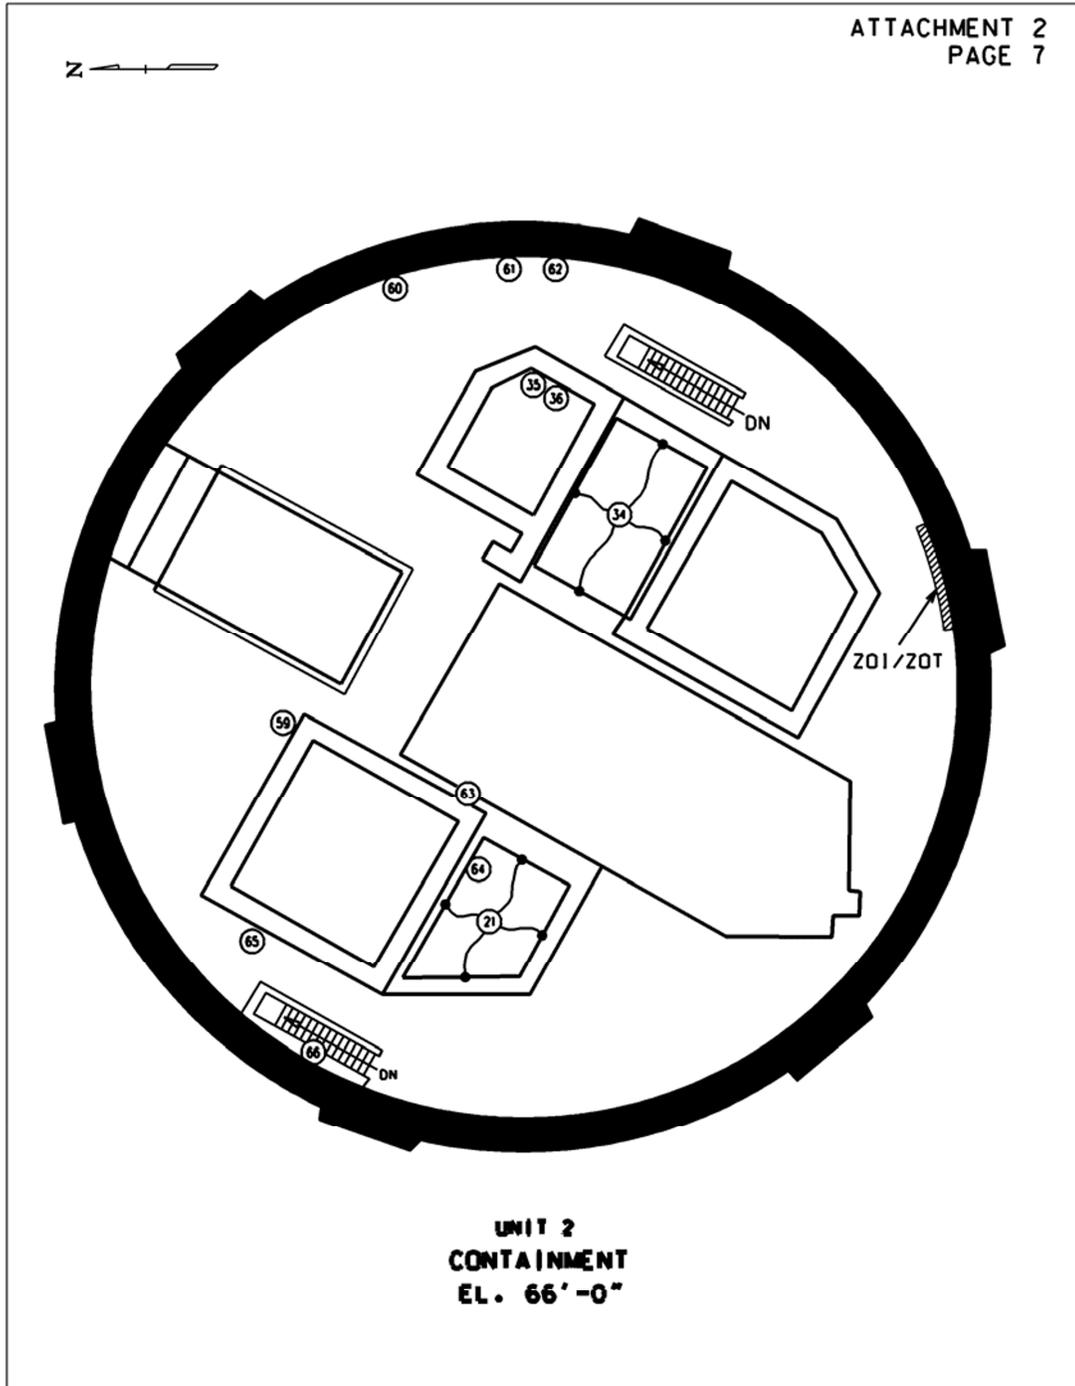
CONT66FT.dgn 2/15/2006 1:12:50 PM

Unit 2 Containment Elevations Showing  
Degraded Or Nonconforming Coatings
