**Title: Q2R18 Concerns Related to Steam Dryer**

**Unit(s):** Quad Cities Unit 2

**Action Tracking Item Number:** 472321-03

**Report Date:** 05/16/2006

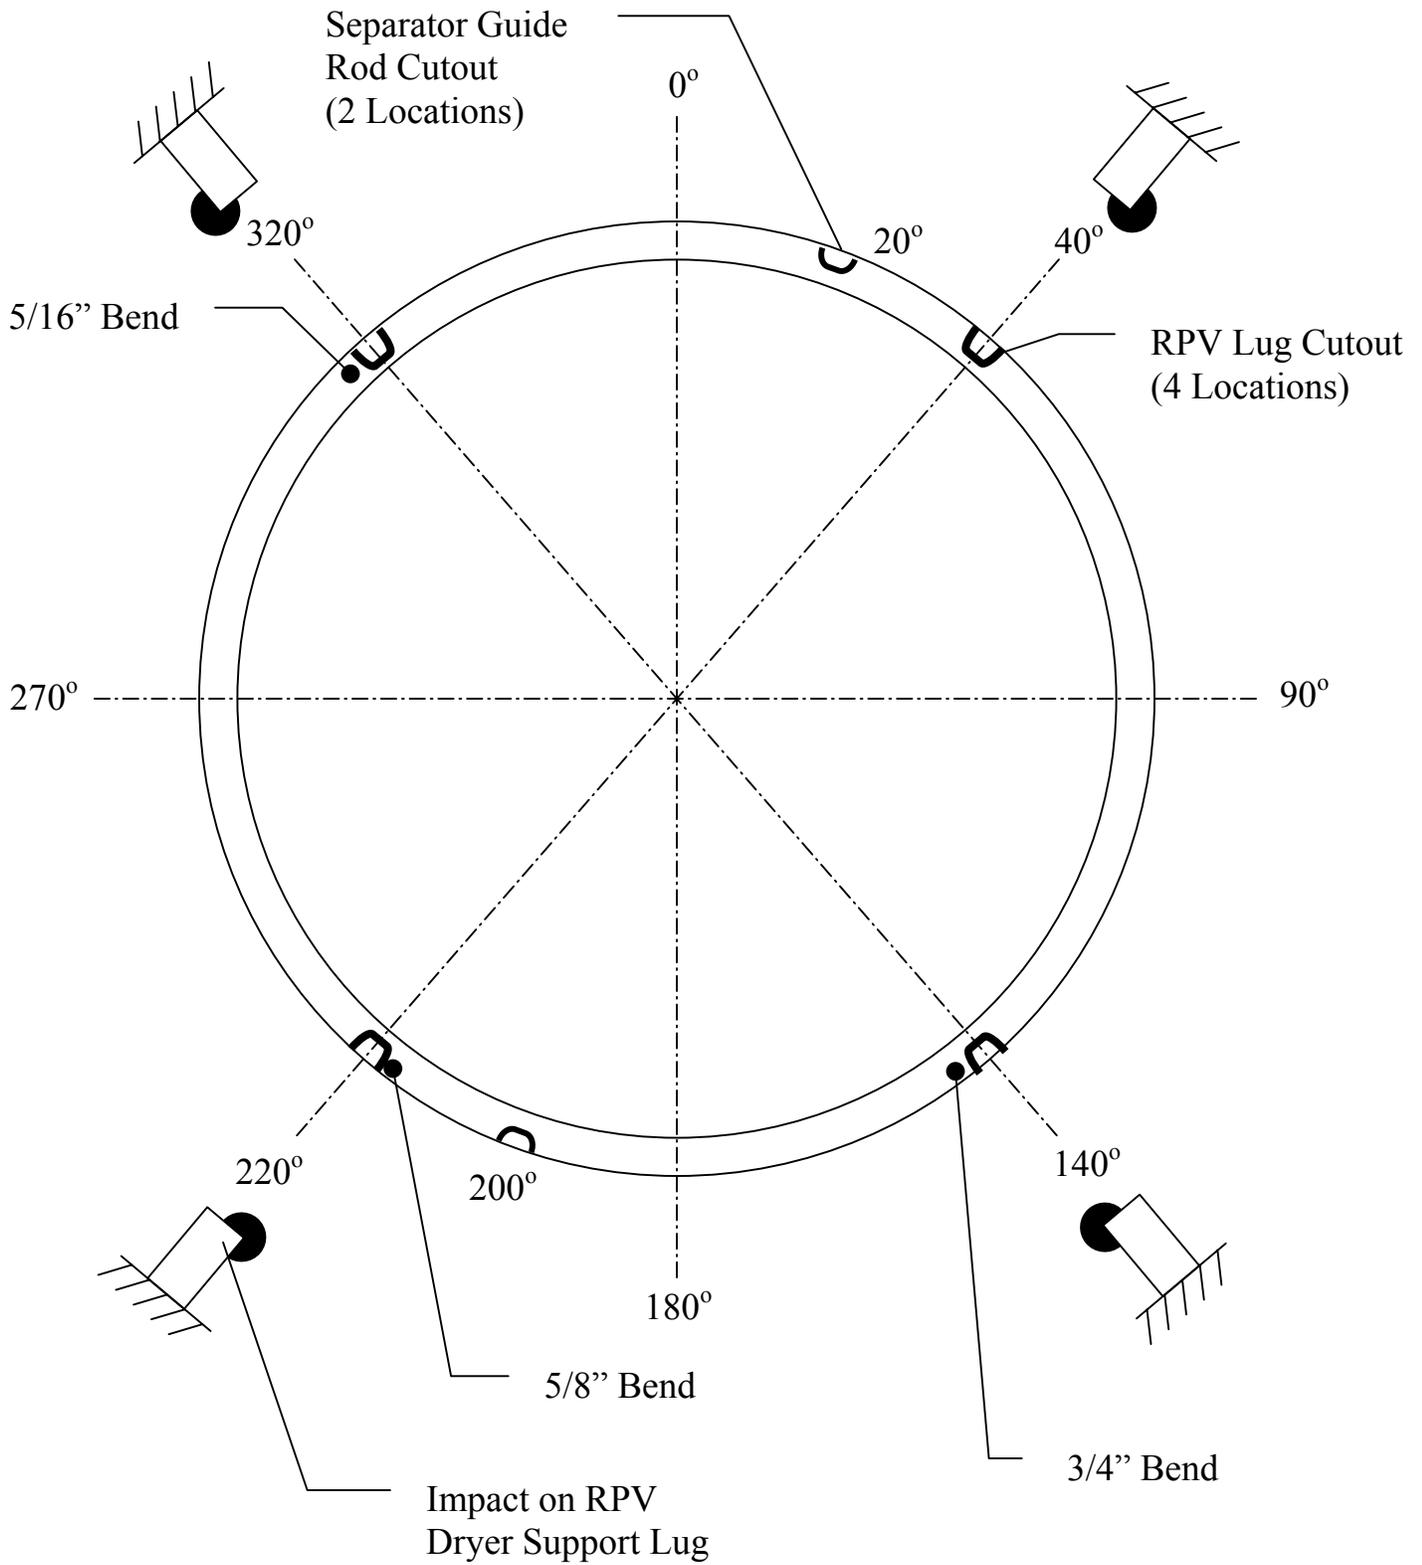
**Figure 1**  
Steam Dryer Plan – Impact Locations

8. Dryer rotates and swings into the 140 and 40° lug.
9. Dryer impacts the 140° lug below the right lower edge of the lug.
10. This impact results in a sharp crease in the dryer support lug and the formation of an edge on the base plate gusset. The corner of the 140° lug is pushed in and partially shears off.
11. During the tilt/rotation, the dryer impacts the right bottom corner of the 40° lug, shearing off the corner.
12. The dryer lift is completed without further incident.

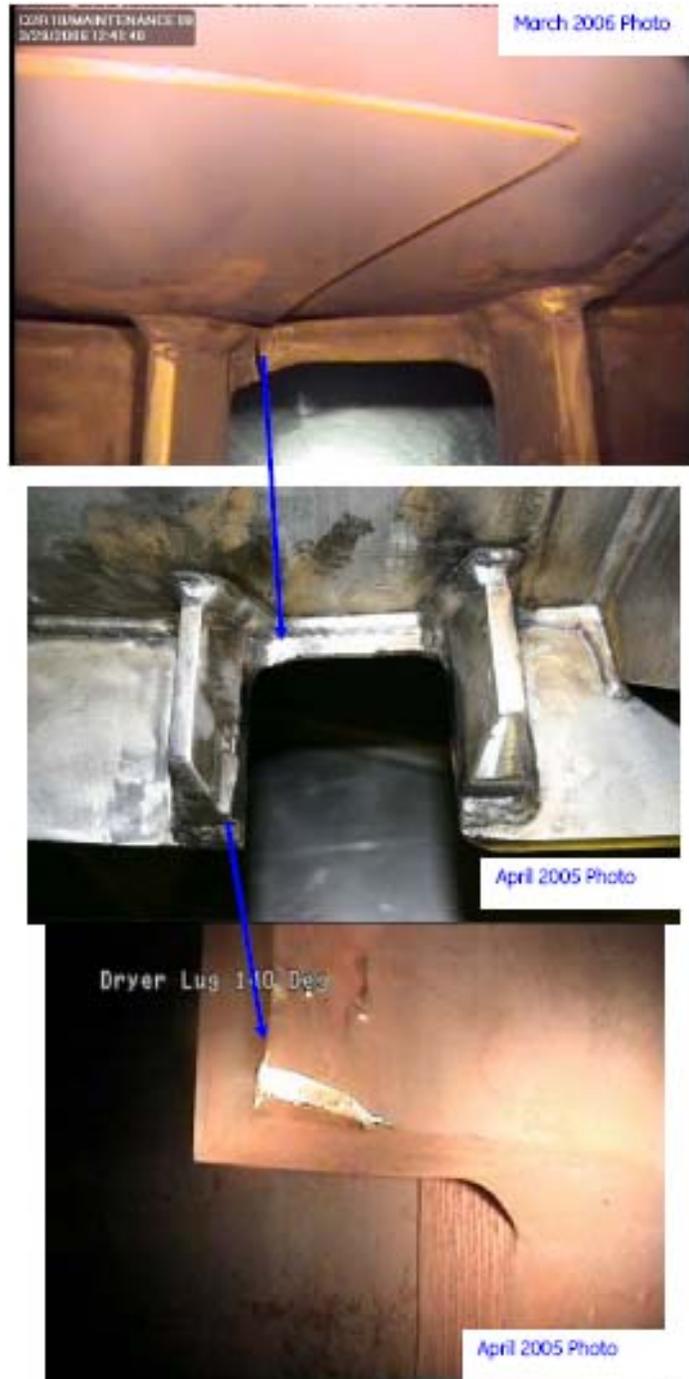
**Figure 2**

General Relationship Between Dryer Cracking (Top), Dryer Guide Slot Cutout at 140 Degrees (Center), and Dryer Support Lug at 140 Degrees (Bottom)

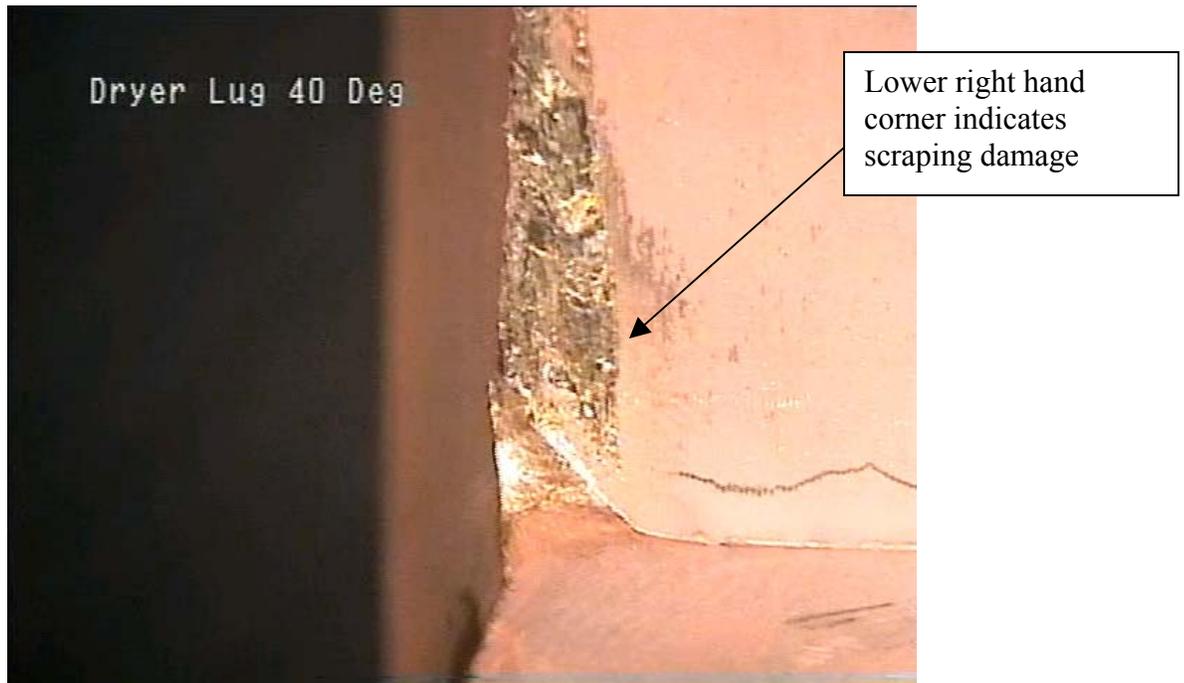
**Figure 3**

Damage to 40 Degree Lug, Lower Right Hand Corner Damaged During Impact

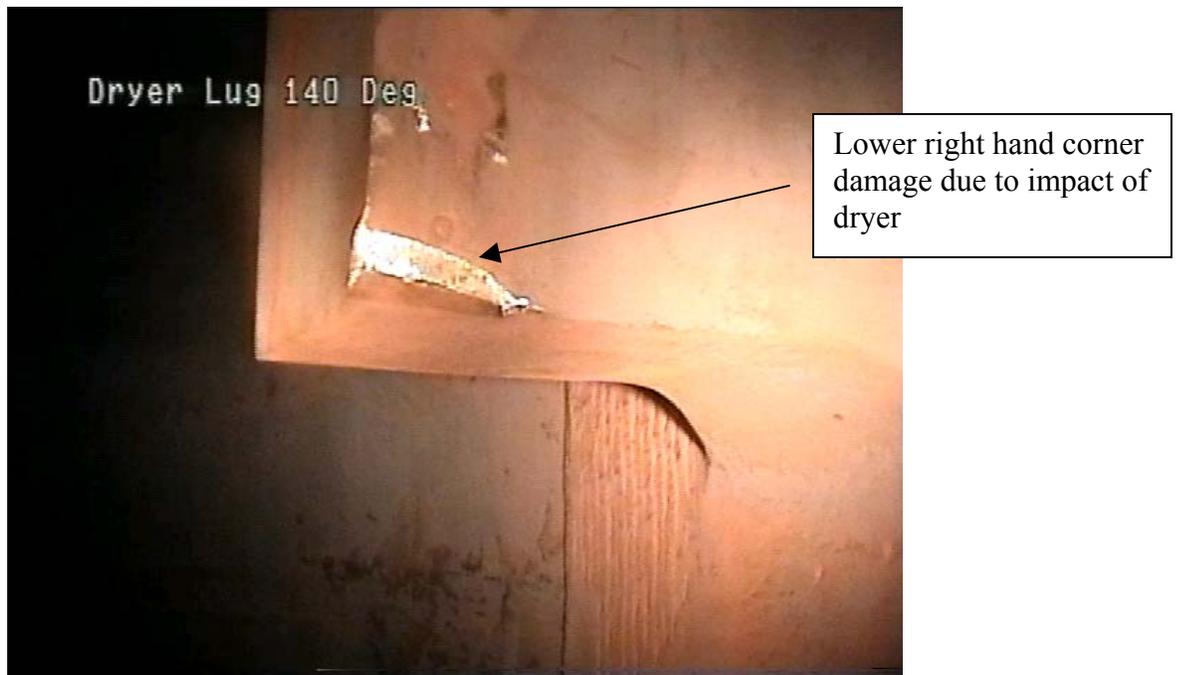
**Figure 4**

Damage To 140 Degree Lug, Lower Right Hand Corner Damaged Due to Major Impact

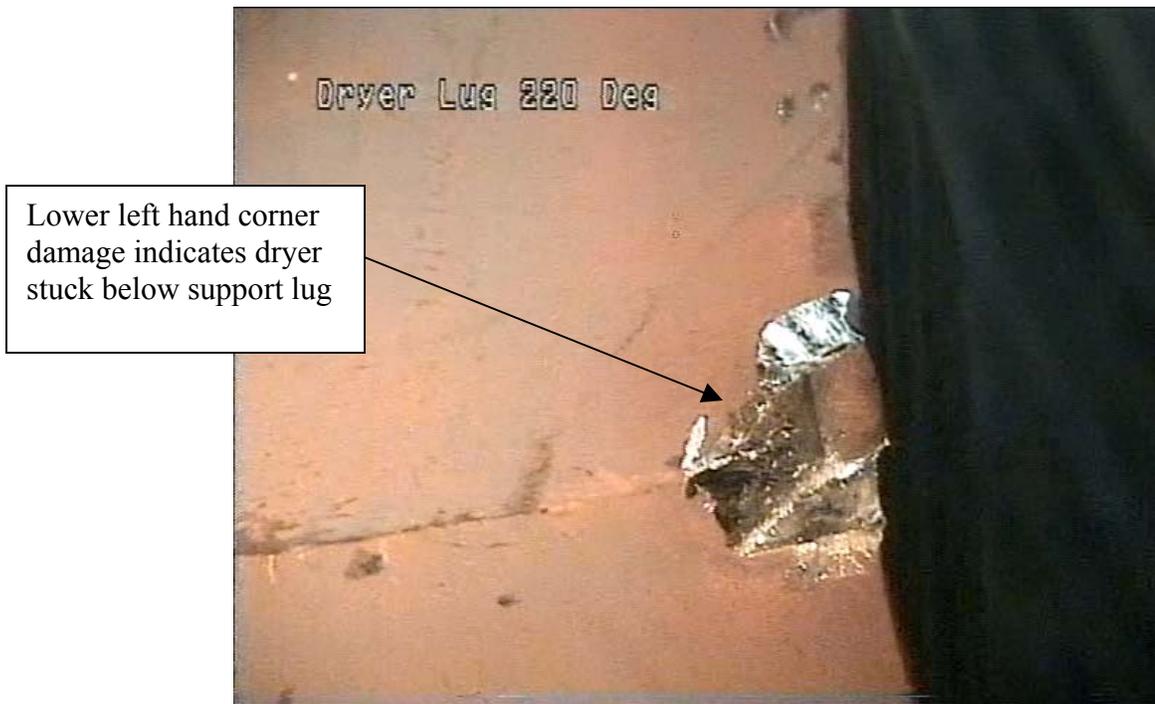
**Figure 5**

Damage To 220 Degree Lug, Lower left hand Corner

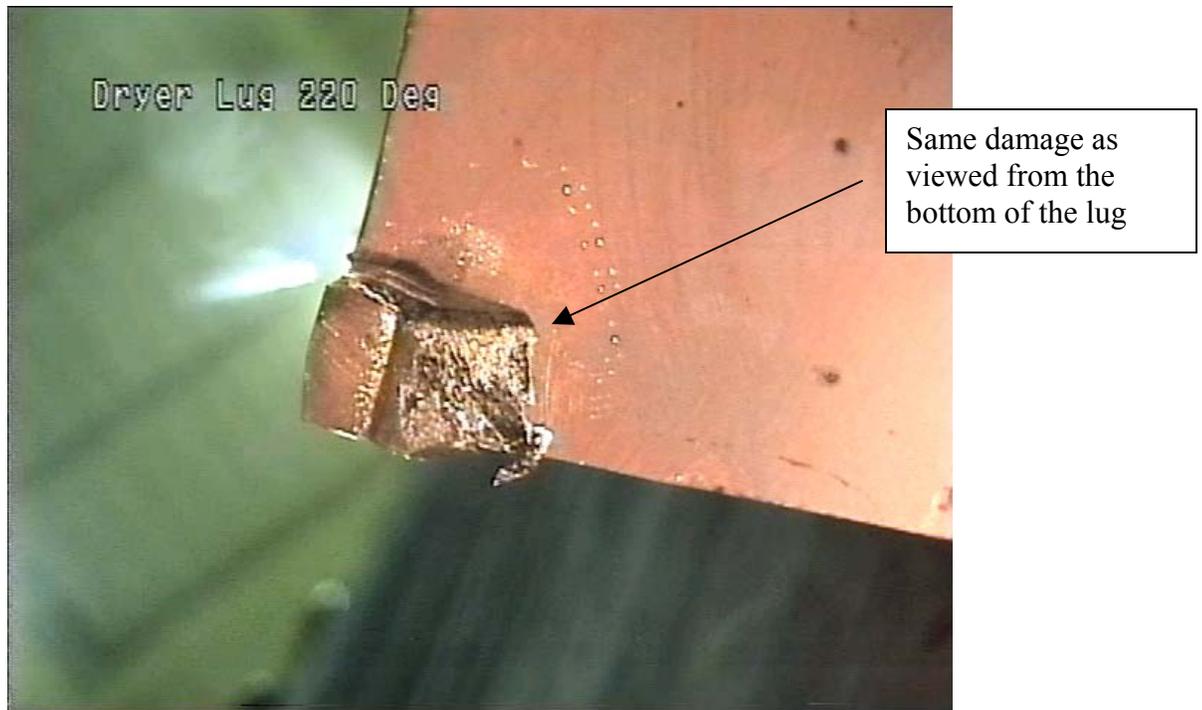
**Figure 6**

Damage To 220 Degree Lug, Lower left hand Corner (View from Bottom)

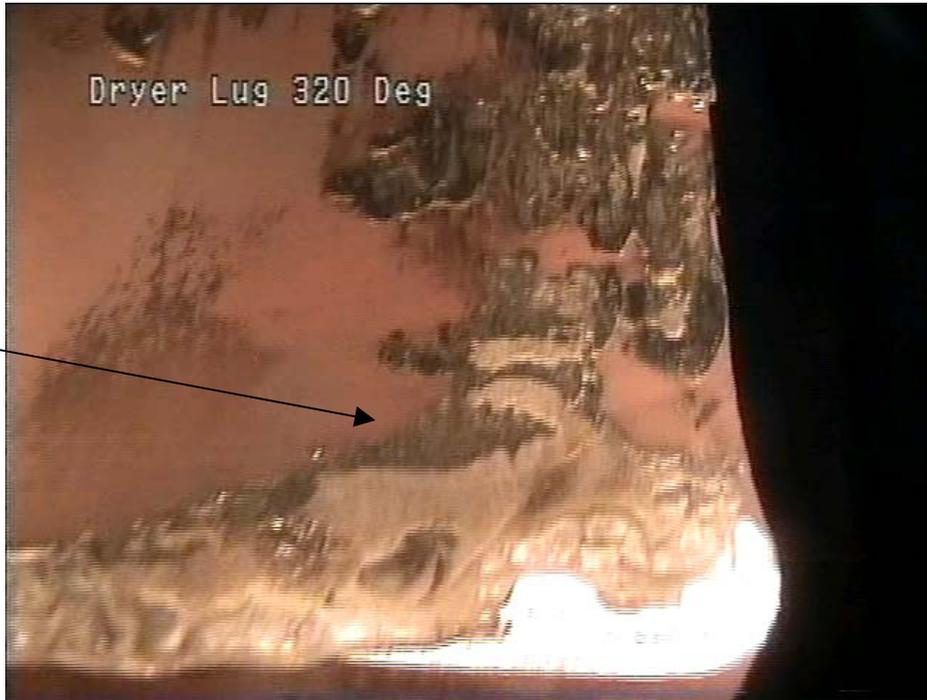
**Figure 7**

Damage to 320 Degree Lug, Lower Left Hand Corner

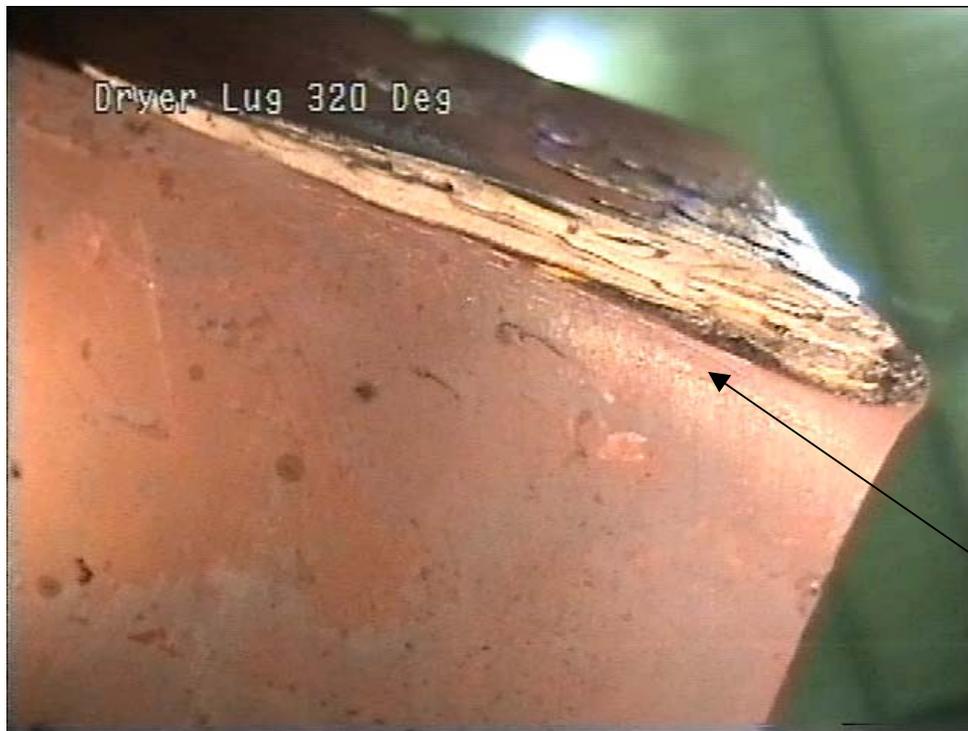
**Figure 8**

Damage to 320 Degree Lug, Lower Left Hand Corner (View From Bottom)

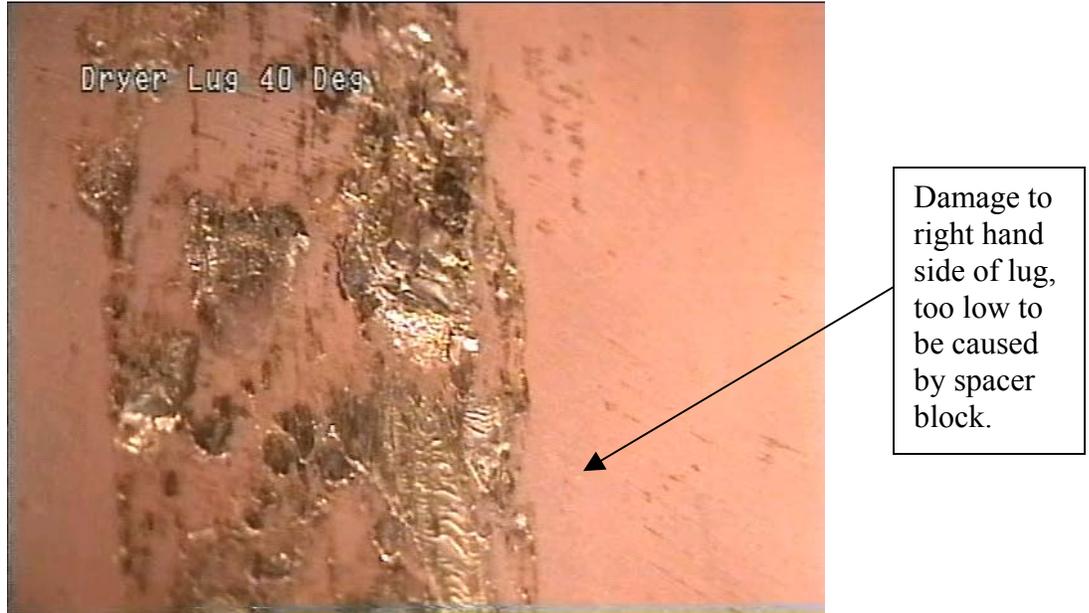
**Figure 9**

Damage to Right Hand Side of 40 Degree Lug, Due to Base Plate When Lowering
