**GROUNDWATER MONITORING WELL REPAIRS AND
RE-SURVEY REPORT**

**PILGRIM POWER STATION
PLYMOUTH, MASSACHUSETTS**

February 23, 2006

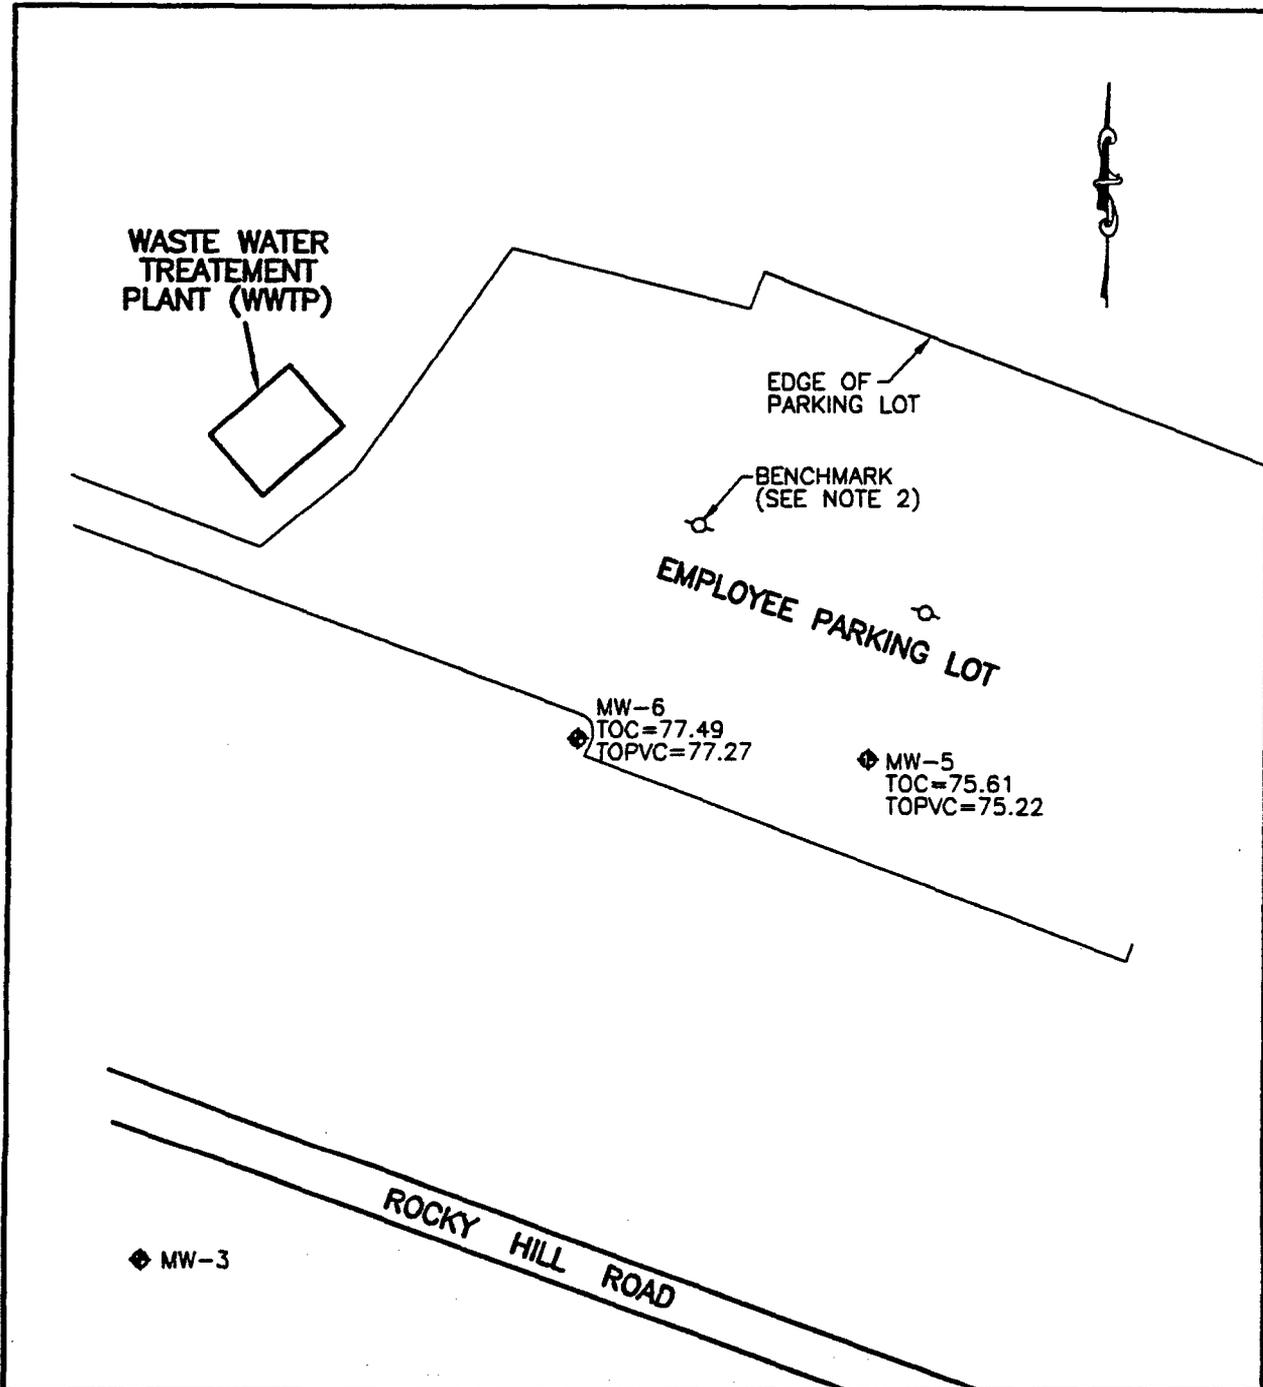
**FIGURE 1
SITE PLAN WITH
MONITORING WELLS
ENERGY**

As part of the Massachusetts Department of Environmental Protection (DEP) groundwater discharge permit, SE #2-389, groundwater sampling and groundwater level measurements are required twice a year for the three (3) groundwater monitoring wells located near the wastewater treatment plant (WWTP) at the Pilgrim Power Station. The approximate locations of these monitoring wells, MW-3, MW-5 and MW-6 are shown in Figure 1.

1. BASE PLAN DETAILS ARE BASED ON EXISTING SITE INFORMATION ON BOSTON EDISON DRAWING TITLED "SITE AND UTILITY PLAN", DRAWING NUMBER C-1186, REVISED 6/20/1990.
2. LOCATION OF MONITORING WELLS BASED ON BENCHMARK DATUM PROVIDED ON LORING H. JACOBS CO., DIVISION OF BOSTON SURVEY CONSULTANTS, INC., NORWELL, MA, DRAWING TITLED "AS BUILT LEACHING FACILITY, BOSTON EDISON CO., PILGRIM STATION NO. 600: UNIT 1, DATED MAY 17, 1982, JOB NO. J-507-22", BENCHMARK DATUM = 80.22 N.G.V.D. 1929 DATUM - NORTHERLY BOLT OF LIGHT POLE.
3. ELEVATIONS REFER TO MEAN SEAL LEVEL ELEVATION OF WELLS MW-5 AND MW-6 ARE BASED ON SURVEY CONDUCTED BY SITEC ENGINEERING, INC., ON JANUARY 13, 2006.
4. WELL COVER REPAIRS AT MW-5 AND MW-6 WERE COMPLETED BY DRAGIN DRILLING INC. ON DECEMBER 7, 2005.

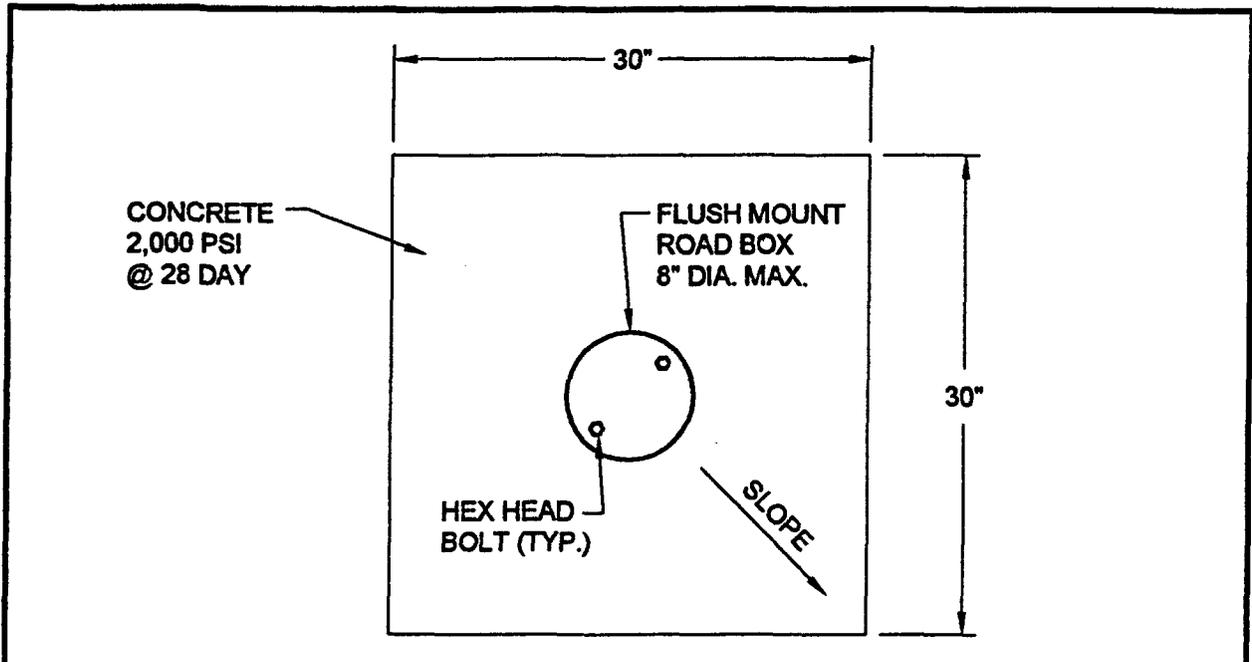
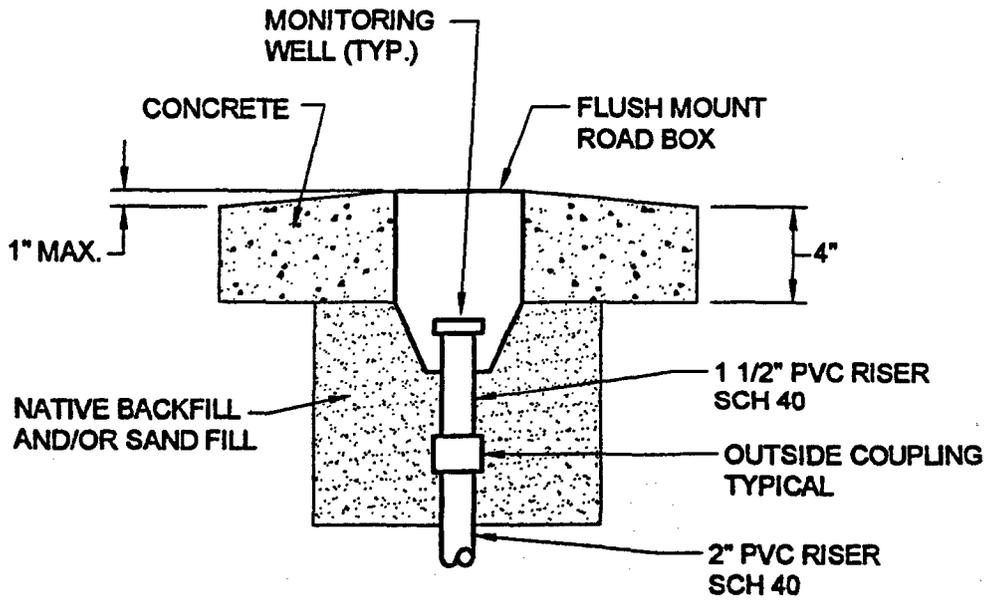
**FIGURE 2
FLUSH MOUNT ROAD BOX DETAIL
ENERGY**

- At MW-5, the flush mount road box was cracked and needed to be replaced.
- At MW-6, the top portion of the monitoring well riser was bent and needed to be replaced along with the damaged road box.

A detail of the proposed monitoring well repair is shown on Figure 2.

To remove the damaged road box at MW-5, Mr. Quagliaroli of Dragin Drilling cut the pavement with a jackhammer and hand-excavated the surrounding soil to a depth of approximately 3 ft below ground surface (bgs). The soil removed was re-used as back-fill material when the new, steel flush-mounted road box was installed. The asphalt cuttings were disposed of in a solid waste dumpster located in the employee parking area. In addition, Mr Quagliaroli constructed a 3 foot square concrete pad surrounding the repaired road box for MW-5. An anti-freeze agent was added to the cement mixture and the concrete pad was covered with a sheet of plastic to prevent the pad from freezing and cracking. An orange cone was placed in front of the monitoring well to prevent vehicles from driving over the newly repaired road box.

To expose and replace the damaged portion of the well riser at MW-6, Mr. Quagliaroli hand-excavated the surrounding soil to a depth of approximately 5 ft below ground surface (bgs). The new installed well riser was constructed with Schedule 40 1 1/2-inch PVC pipe. In addition, Mr. Quagliaroli installed a new, steel flush-mounted road box with a surrounding 3 foot square concrete pad for MW-6. To prevent the concrete from freezing and cracking, an anti-freeze agent was added to the cement mixture and the concrete pad was covered with a sheet of plastic. Asphalt cuttings were disposed of onsite in a solid waste dumpster. Approximately, 5.5 hours were required to repair the two monitoring well road boxes. Additional information is detailed in the attached Daily Record of Work Progress.
