NP-33-06-002-00

Licensee Event Report 2006-002-00
Ultrasonic Examination Identifies Axial Flaw Indication in
Reactor Coolant Pump Drain Line Weld
Davis-Besse Nuclear Power Station, Unit No. 1
Date of Occurrence – March 18, 2006

4. TITLE
Ultrasonic Examination Identifies Axial Flaw Indication in Reactor Coolant Pump Drain Line Weld

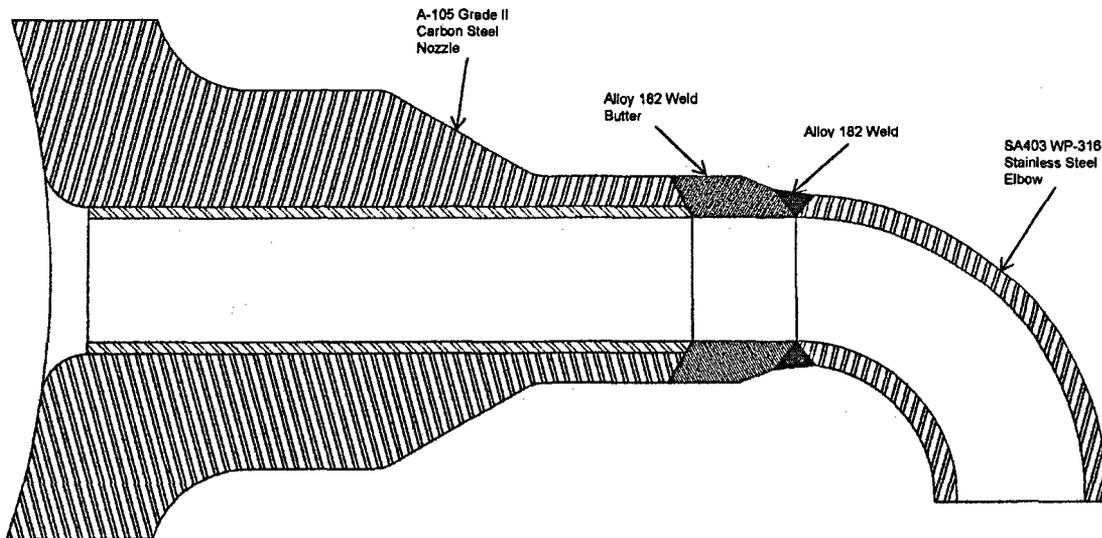
Figure 1: Reactor Coolant Pump 1-1 Cold Leg Drain Line Nozzle-to-Elbow Weld Arrangement Prior to Weld Overlay

On March 18, 2006, with the Davis-Besse Nuclear Power Station (DBNPS) shut down for the fourteenth refueling outage and in Mode 6 (Refueling), ultrasonic examination of the 2-1/2 inch diameter Reactor Coolant Pump 1-1 cold leg drain line nozzle-to-elbow dissimilar metal butt weld [AB-NZL] detected an axial flaw indication at least 0.25 inches in length. Due to the configuration of the weld joint and lack of qualified depth sizing procedures for dissimilar metal welds, the length of the indication could not be accurately determined. Ultrasonic examination of the base material on both the elbow and nozzle sides of the weld showed no evidence of propagation, so the axial flaw indication was believed to reside solely in the Alloy 182 buttering and potentially the weld of the nozzle-to-elbow dissimilar metal in close proximity to the inside surface. No evidence of through-wall leakage was observed on the previous day when an Alloy 600 bare metal examination of the piping was conducted.

The 2-1/2 inch cold leg drain line nozzles were shop fabricated of A105 grade II carbon steel with Alloy 182 buttering on the weld end and internally clad with a minimum of 1/8 inch stainless steel filler material. The nozzle was butt welded with Alloy 82/182 filler metal to a 2-1/2 inch schedule 160 long radius 90 degree elbow made of SA-403 grade WP-316 stainless steel. Refer to Figure 1 at the end of this report for a diagram of this piping. During the fourteenth refueling outage, the Reactor Coolant Pump 1-1 cold leg drain line nozzle-to-elbow weld was examined by personnel and equipment qualified to the Performance Demonstration Initiative (PDI) generic procedure for manual ultrasonic examination of dissimilar metal piping welds. The axial flaw indication discovered on March 18, 2006, was located in the Alloy 182 buttering of the dissimilar metal weld. Alloy 600 and its associated Alloy 82/182 weld filler materials are used in nuclear power plants due to a thermal expansion coefficient that is intermediate between low alloy and stainless steels. The related weld filler materials are used to join Alloy 600 parts to the ferritic steel components and also as a bi-metallic weld joining ferritic base materials to austenitic stainless steel base materials. Alloy 82 is used in the automatic welding process and Alloy 182 is used in the manual welding process.

The probable cause of this axial flaw indication on the 2-1/2 inch diameter Reactor Coolant Pump 1-1 cold leg drain line nozzle-to-elbow dissimilar metal butt weld is less than adequate welding process during initial plant construction in 1975. Residual stresses from extensive localized grinding and repair of a crack, slag, and a lack of penetration resulted in a flaw in this weld. There are two possibilities for the resultant axial flaw indication. Either a latent construction flaw remained from several localized weld repairs and was hidden in the weld butter by the radiograph penetrometer, or the weld repairs resulted in a crack initiation site. The residual stresses from the construction weld repairs when combined with the conducive environment of the Reactor Coolant System, plus the susceptibility of Alloy 600 material established the presence of the three key elements for the development of primary water stress corrosion cracking in spite of the low susceptibility (lower operating temperature) of the cold leg drain lines. None of the other three cold leg drain lines required a localized repair of the nozzle-to-elbow butt weld involving repetitive grinding like the Reactor Coolant Pump 1-1 cold leg drain line nozzle-to-elbow butt weld during initial plant construction.

A repair consisting of a full structural weld overlay of the affected area was performed to mitigate any potential stress corrosion cracking. The finished weld overlay completely covered the indication with Alloy 52 based weld material that is highly resistant to primary water stress corrosion cracking. The weld overlay also induces compressive stress in the weld, thus impeding growth of any reasonably shallow cracks. Furthermore, the weld overlay was sized to meet all structural requirements independent of the existing weld, and to facilitate ultrasonic examination. An acceptable ultrasonic examination with no recordable indications was obtained for the weld overlay repair to the Reactor Coolant Pump 1-1 cold leg drain line. No remnants of the axial flaw indication were observed after the weld overlay; however, the intent of the ultrasonic examination after the repair was not to validate previous observations.
