**Quad Cities Nuclear Power Station, Units 1 and 2
Renewed Facility Operating License Nos. DPR-29 and DPR-30
NRC Docket Nos. 50-254 and 50-265**

**Subject: Additional Information Regarding Quad Cities Unit 2 Steam Dryer
Inspection, Start-up and Power Ascension Plan**

Response to Request for Additional Information

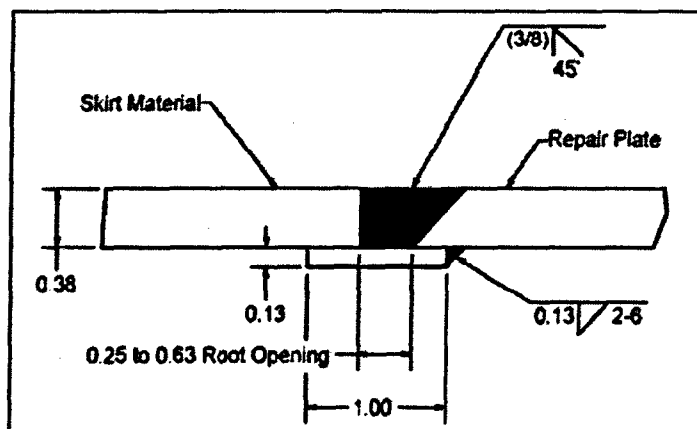
Repairs to the QCNPS Unit 2 steam dryer skirt and skirt base ring were made with full penetration welds. In consideration of diver safety and dose these welds were made from the outside of the dryer skirt. To provide for underwater welding from one side only it was necessary to use a backing strip at the weld root. The backing strip was not removed after welding. The backing strip has a 1-inch wide by 0.13-inch thick cross-section. The below figure shows a cross-section view through the completed skirt repair weld. A cross-section through the base ring would be similar except that the base ring and base ring materials are 1-inch thick. In the completed weld, the backing strip surface exposed to the root opening is fused and becomes part of the weld. Prior to welding of the joint, one edge of the backing strip is attached to the back side of the repair plate using a stitch weld technique (0.13 inch fillet welds, 2 inches in length, with a 6 inch pitch). The backing strip material used is compatible with the base metals. Also, a qualified welding procedure and qualified welders were used. Separate backing ring welds have been used in constructing many of the operating plant BWR steam dryers.

Based on an acceptable weld joint configuration; a continuous backing strip being used; the backing strip being compatible with the base metals; the use of a qualified welding procedure

and qualified welders; and previous operating plant experience it is extremely unlikely that these repair weld backing strips will ever come loose.
