Vibration Acceptance Criteria for ERV Valve Actuators

Revision 1

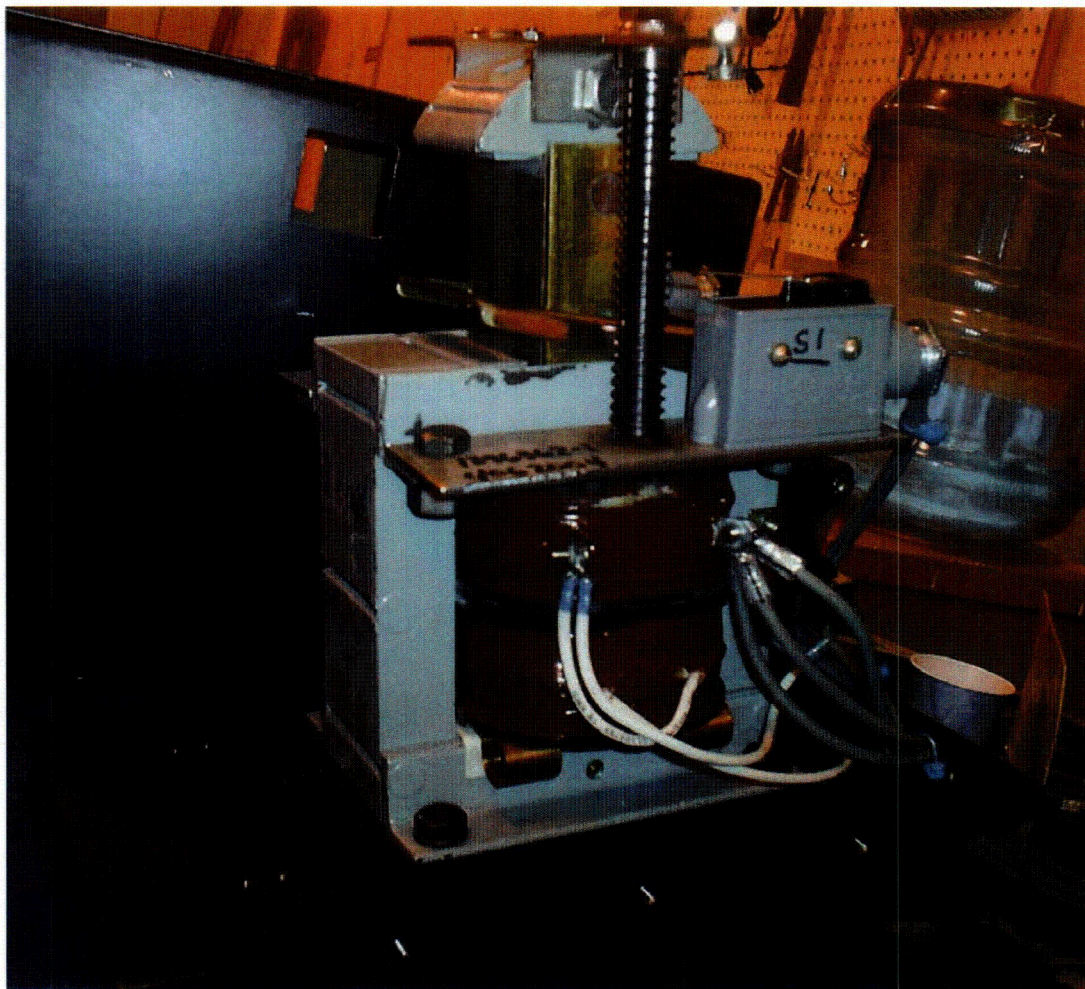
The main steam piping near the reactor at both Quad Cities units has been experiencing significant vibration for some time. This vibration has resulted in damage to the actuators on the Electromatic Relief Valves (ERVs), among other components. The vibration increased significantly (by about a factor of 2) when the plant power level was increased to Extended Power Uprate (EPU) conditions. Apparently, the dominant part of the vibration is being generated by the response of the piping to several acoustic modes that exist inside the piping. These acoustic modes are most likely standing pressure waves that form in the standpipes that attach the ERVs, Safety Relief Valves (SRVs), and Target Rock valve to the main steam piping. Most likely, the acoustic response is excited by turbulence in the main steam flow at the connecting tees to the standpipes. Since the turbulence spectrum typically increases in both amplitude and frequency with increasing steam flow, the increase in vibration at EPU power levels is significantly higher than at pre-EPU power levels.

Due to damage to the ERV actuators that was discovered at Quad Cities Unit 1 during Q1F51, Exelon decided to perform vibration testing of an ERV at the Wyle Laboratories in February 2004. These tests are described in Reference 1 and Figure 3-5 in Reference 1 shows the initial test configuration, which included an ERV with the attached pilot valve and the pilot valve actuator. The testing resulted in modifications to the actuators to “harden” them against wear by employing better materials for parts where wear was observed. The modified actuators were installed in both units at Quad Cities and after operating an extended period of time at pre-EPU levels, they were inspected and no damage was observed. However, after several months of operation at EPU power levels, significant damage was discovered on some of the actuators and all actuators had some wear in the bushings and guide posts. Figure 1 is a picture of an actuator similar to the modified actuators that were installed following the February 2004 Wyle testing. The damage to these actuators was concentrated in the guide post-spring-bushing interface due to the hardened spring getting caught between the post and the bushing, causing considerable wear to all three components due to vibratory motion. Damage also occurred to the pivot plate that opens the cutoff switch and limits the current to the solenoid when the pilot valve is open. If this switch fails to operate, the solenoid will fail in about 30 seconds due to excessive current, making the valve inoperable.

Figure 1. ERV Actuator Similar to the One that was Damaged in the Plant (No Cover)

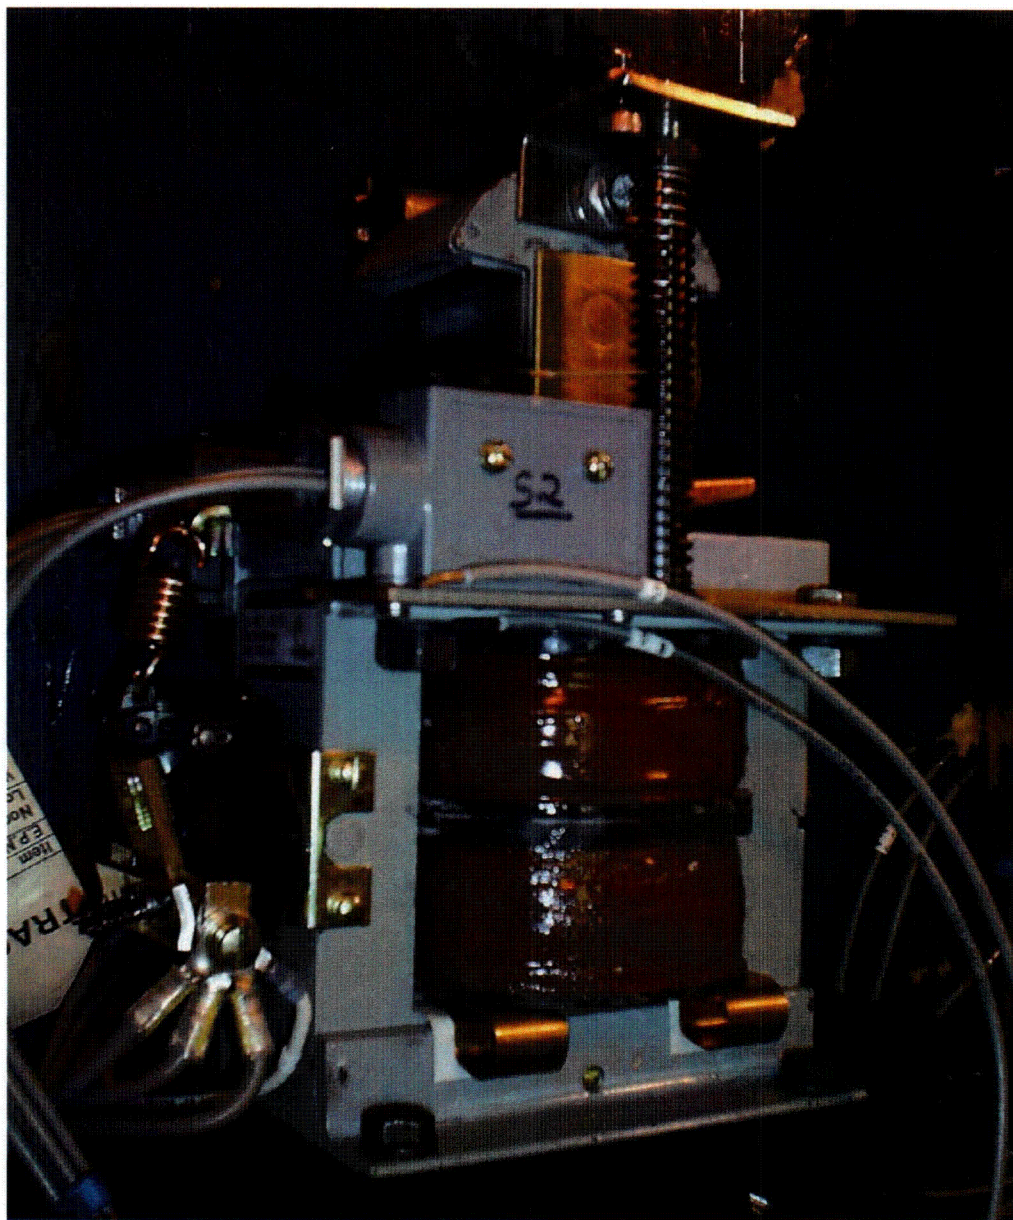
Figure 2. Modification to Post-Spring-Bushing Interface Using a Beveled Washer

Based on the observed damage, in January 2006 a beveled washer was inserted below the bushings to protect the post and bushing from the spring (see Figure 2) and the plants were restarted and operated at pre-EPU power levels while a permanent solution to the problem was being investigated. This permanent solution concentrated on the installation of acoustic side branches (ASBs) on the standpipes that support the valves to mitigate the acoustic modes in conjunction with modifications to the ERV actuators to make them considerably more resistant to the damage mechanisms that were being observed.

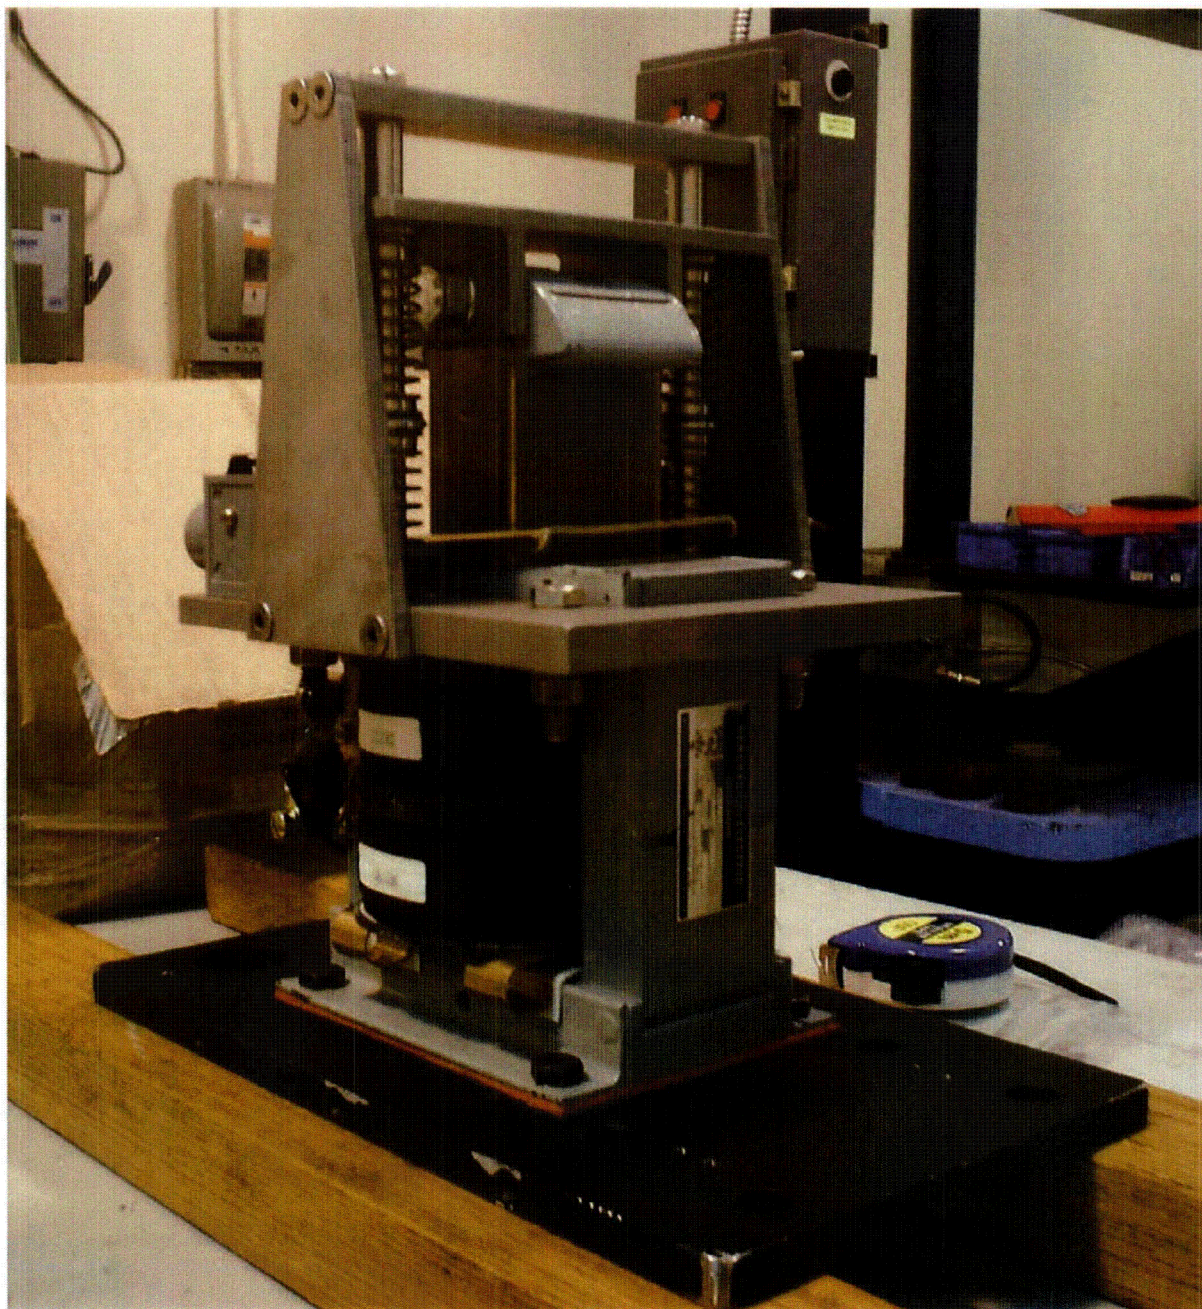
Figure 3. New Actuator Design for Testing

Figure 3 shows a picture of the newly modified actuator. Vibration testing of the new actuator was conducted during February and March of 2006 to test modifications and improve confidence in the new actuator for installation in the plant. The test included testing of alternative designs such as the design that was damaged during operation in the plant to provide a comparison of relative damage levels during the testing. This report evaluates the new design and provides an estimate of the vibration levels that are considered acceptable for operation in the plant.

The new actuator design (see Figure 3) incorporated a significant number of improvements, many of which were implemented as a result of lessons learned during the testing. The new actuator provides substantially more support for the guide posts. This was accomplished by mounting the posts to a thicker support plate at the bottom in place of the angle brackets on the original and including a frame that is tied to that plate and supports the tops of the guide posts. In addition, the springs are of a larger diameter and are split into two parts. The ends of the spring were mounted on the outside of both the bushings and a spacer that was added between the two spring parts on each post so the springs would remain separated from the posts. This prevents the springs from getting caught between the post and the bushing and limits the wear that will occur to the springs, the bushings, and the posts. Clearance between the top bushing and the post must be loose enough to prevent binding due to clearances between the plunger and the frame that allow the plunger to displace at the bottom but must be small enough to limit impact or fretting wear when the posts vibrate. The new actuator design also includes a silicone isolation pad that prevents much of the high frequency vibration from reaching the posts. In addition, the pivot plate that actuates the cutoff switch to limit current through the solenoids when the pilot valve is open was improved by tightening clearances to avoid rattling, adding bushings for the pivot pins, and modifying the material for the pivot pins and bushings to improve wear characteristics. Finally, the brackets used to attach the actuator components to its base were reinforced by gussets to help redistribute stresses over a larger region and procedures were implemented to ensure there is even loading on the heads of the bolts that secure the solenoid frame to the base plate of the actuator. The gussets were added halfway through the first series of testing due to cracking in the brackets and indicated, by no additional damage through the most severe testing period, that they were effective in eliminating the cracking problem. The modifications to the pivot plate were implemented due to knowledge gained during the first series of testing.

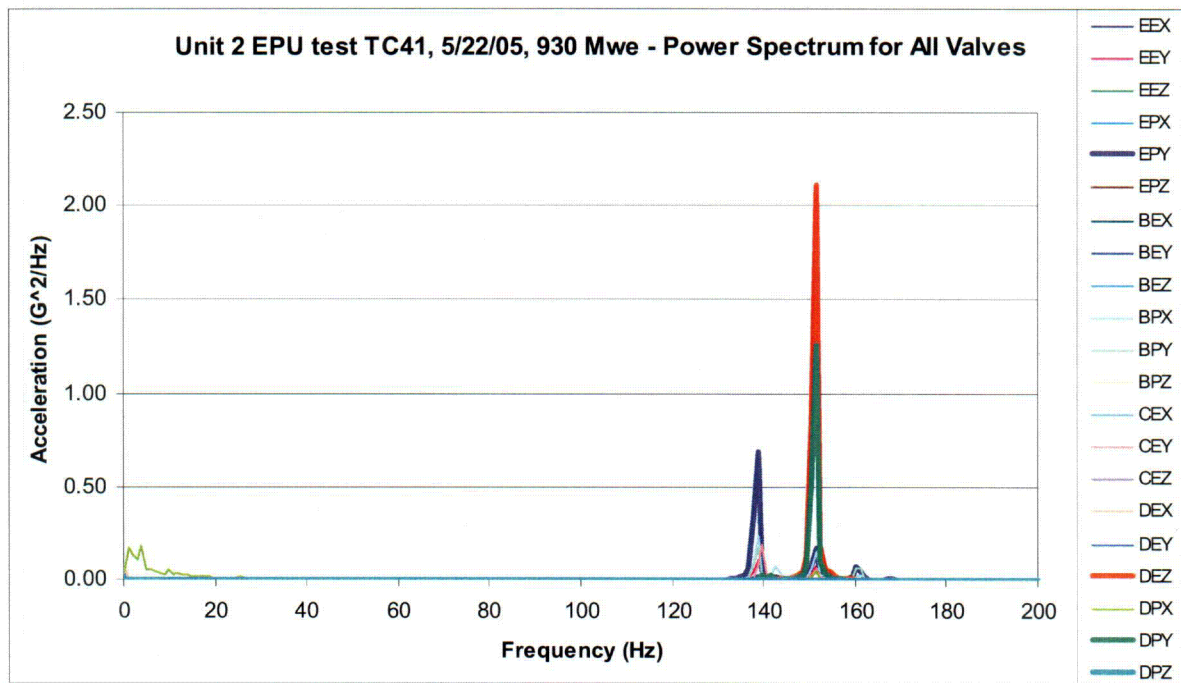
As is seen in Figures 4 through 6, the measured vibration is essentially composed of monochromatic accelerations at about 138 Hz, 151 Hz, and 161 Hz with the dominant response at 151 Hz at an amplitude of about 2 g RMS. The amplitude of the associated displacement is less than one mil.

Figure 4. EPU Vibration Spectra for all Unit 2 ERVs

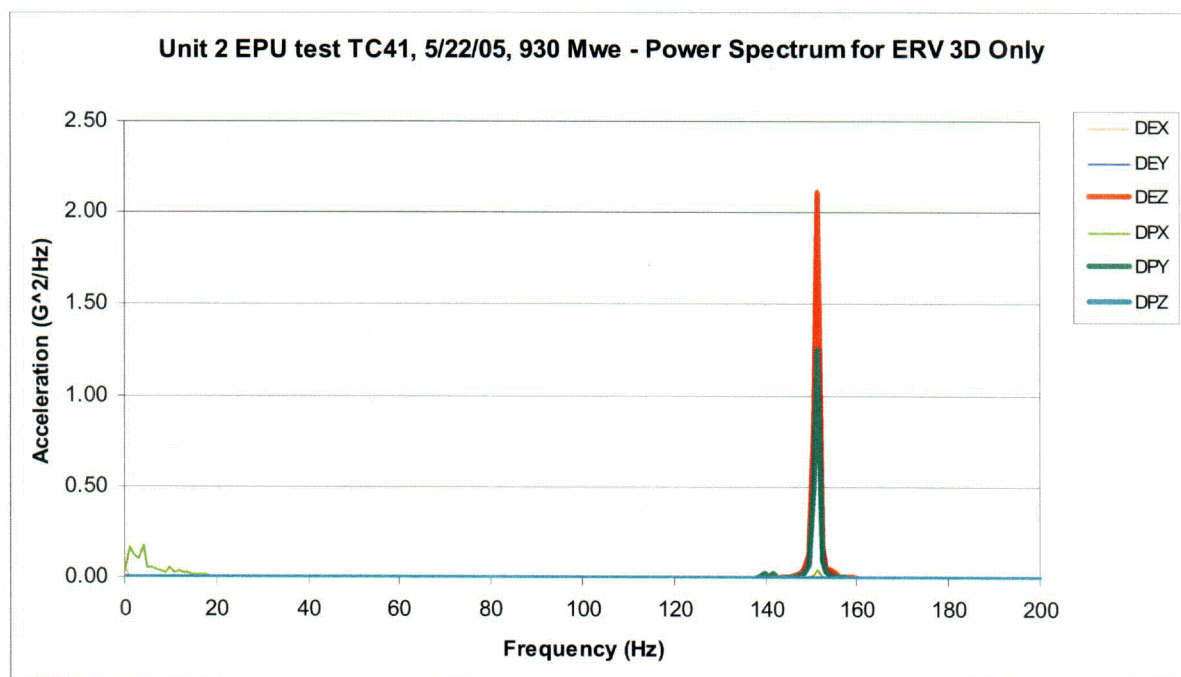
Figure 5. EPU Vibration Spectra for ERV 3D Only

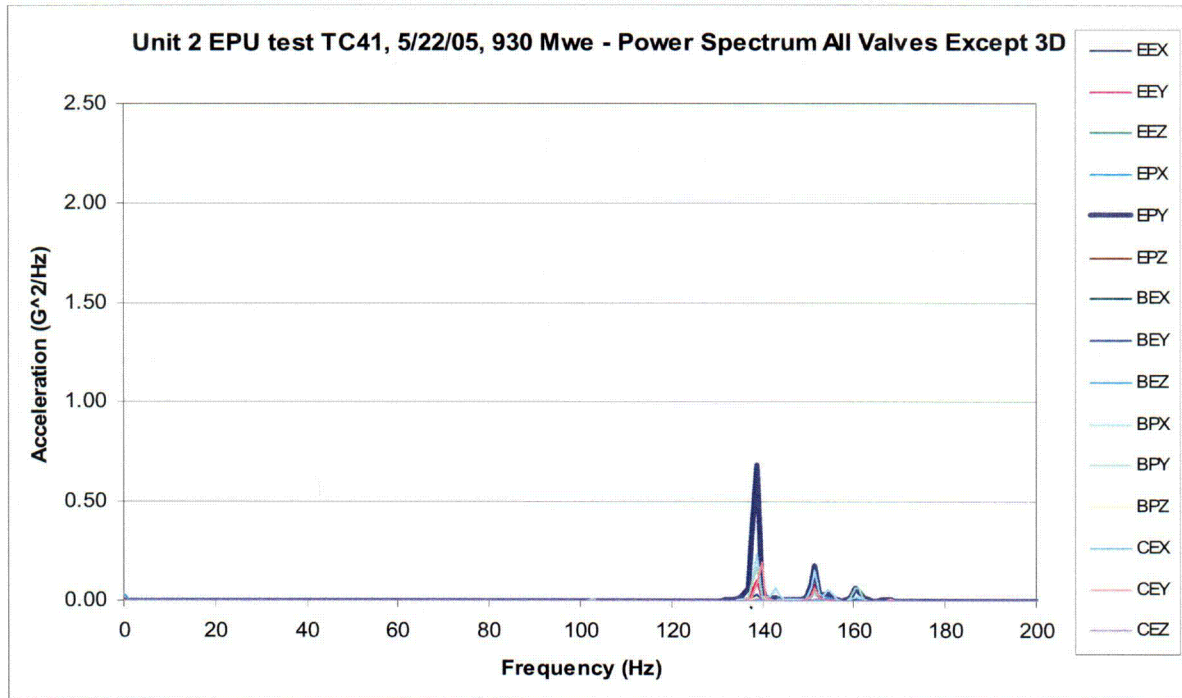
Figure 6. EPU Vibration Spectra for all Unit 2 ERVs Except 3D

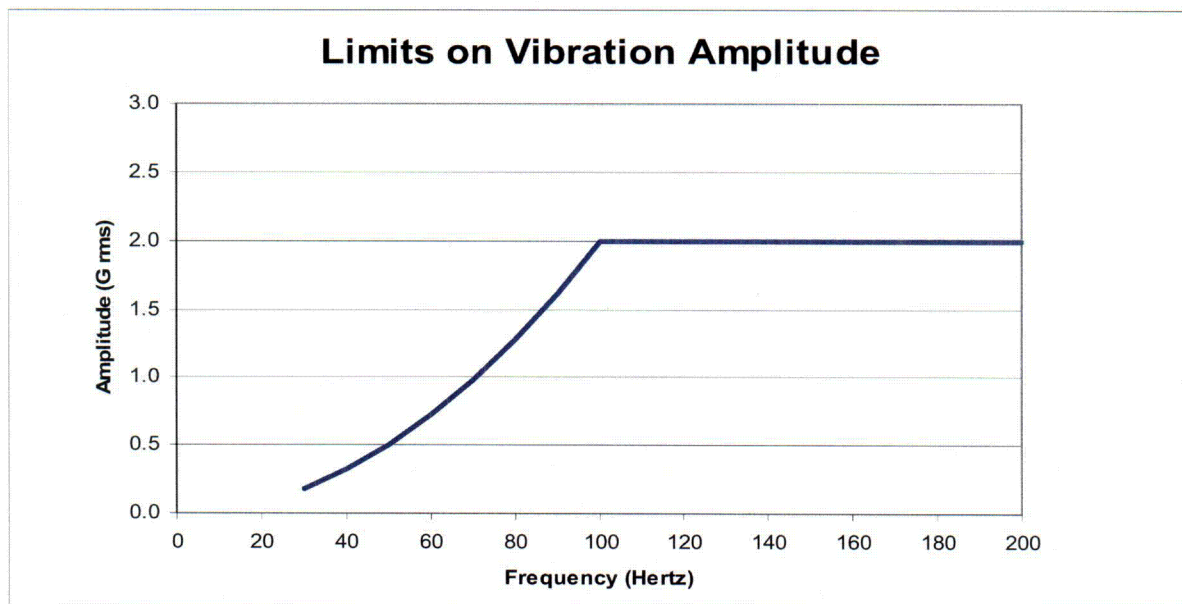
- In addition to the broadband excitation, a monochromatic frequency due to the acoustic mode can be tolerated if the amplitude of that frequency is less than 2.0 g RMS at 100 Hz to 200 Hz. Below 100 Hz, the displacement amplitude of the monochromatic vibration must remain below the 100 Hz 2 g RMS value. Figure 7 provides a plot of the vibration limit as a function of frequency for the monochromatic input at the base of the actuator resulting from excitation by the acoustic mode. This graph provides the maximum acceleration of a single sine wave at a specific frequency as a function of that frequency. The graph does not represent a spectrum with multiple frequency inputs. Numeric values of the acceptable limit are listed as a function of frequency in Table 1. The broadband background spectrum of 0.4 g RMS can be tolerated in addition to this monochromatic frequency excitation.

Figure 7. Acceptable Vibration Magnitude at the base of the New Actuator due to the Acoustic Mode as a Function of the Acoustic Mode Frequency
