SUBJECT: BRAIDWOOD NUCLEAR POWER PLANT, UNITS 1 AND 2, BASELINE
INSPECTION REPORT 05000456/2006008(DRS); 05000457/2006008(DRS);
PRELIMINARY WHITE FINDING

Report No: 05000456/2006008; 05000457/2006008(DRS)

Facility: Braidwood Nuclear Power Station, Units 1 and 2

IR 05000456/2006008; IR 05000457/2006008(DRS); 02/13/06 - 05/25/2006; Exelon Generation Company, Braidwood Nuclear Power Station, Units 1 and 2; Event Follow-up and Public Radiation Safety.

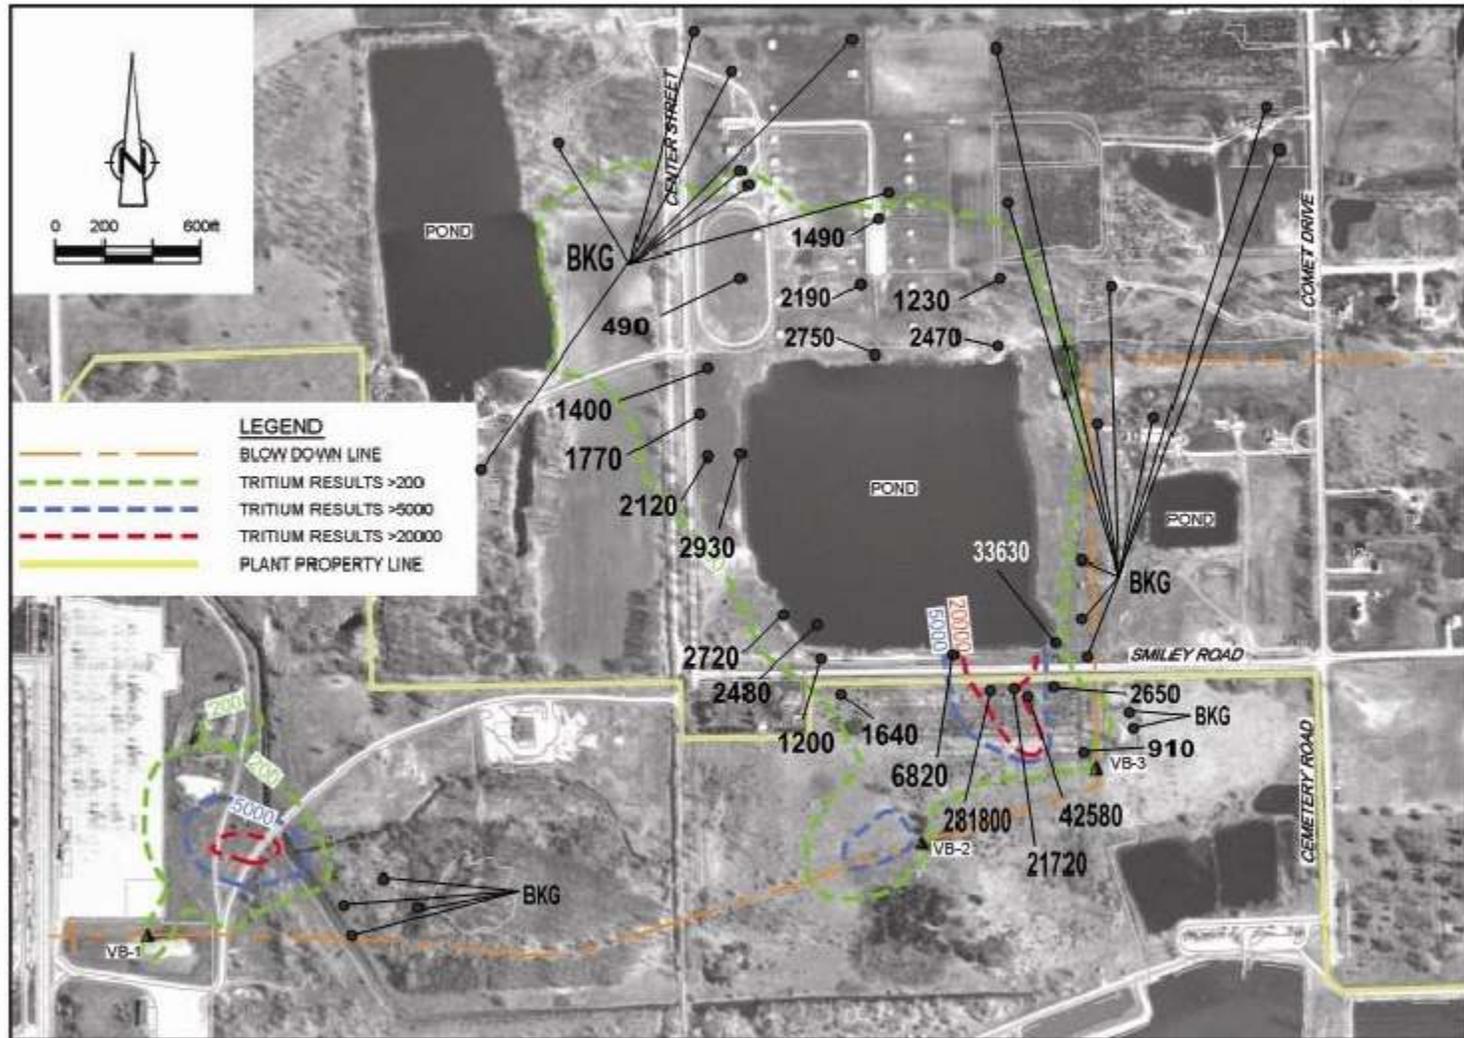
NRC Groundwater Measurement Results

The NRC's results confirmed that tritium was present in one offsite residential well at levels of about 1300 to 1500 picocuries per liter, which is a small fraction of the EPA drinking water standard of 20,000 picocuries per liter. In all other residential wells, no measurable levels of tritium or other licensed radioactive material above normal background have been detected. In a deeper onsite groundwater well, the NRC measured tritium as high as 282,000 picocuries per liter. Measurable levels of tritium have been found offsite in shallow monitoring wells and in a pond located near plant boundary. Appendix B contains a map of the area near the plant and the corresponding tritium results from various locations. The colored dose gradients represent licensee monitoring results while the specific values annotated indicate selected NRC monitoring results

BKG = Concentrations at or below normal environmental background levels
Numerical results in picocuries per liter
