Subject: **Docket No. 50-362**
Licensee Event Report No. 2006-003
San Onofre Nuclear Generating Station, Unit 3

Unit 3 LER No. 2006-003

1. FACILITY NAME San Onofre Nuclear Generating Station (SONGS) Unit 3	2. DOCKET NUMBER 05000362	3. PAGE 1 OF 4
---	-------------------------------------	--------------------------

4. TITLE
Reactor Coolant System Pressure Boundary Leak Caused by Incomplete Compression of a Mechanical Nozzle Seal Assembly Grafoil Seal.

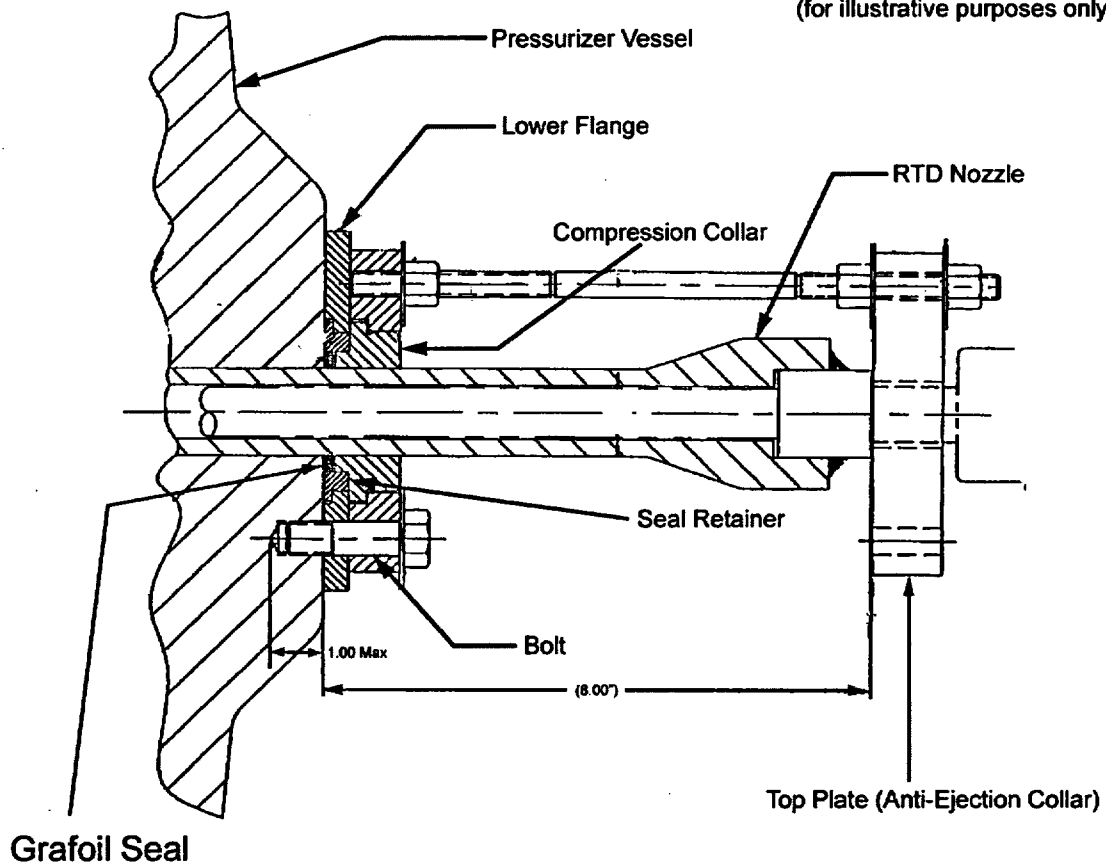
Side Pressurizer RTD Mechanical Nozzle Seal Assembly

SCE concluded the MNSA seal leak was caused by incomplete compression of the grafoil seal when it was installed (March 1998). The incomplete compression was most likely due to the bolts not reaching a depth that would have compressed the seal to the designed values. This could have resulted from (1) the threaded holes not being machined deep enough, and/or (2) insufficient thread lubrication causing the bolts to indicate the required torque values prior to fully compressing the seal. SCE confirmed the MNSA was installed in accordance with the vendor's procedure; however, the procedure did not require verification of seal compression by direct measurement when this MNSA was installed.

1. SCE removed the MNSA seal on the Unit 3 pressurizer RTD nozzle after performing inspections in an effort to determine the cause of the failed seal.
2. SCE examined the Unit 3 pressurizer RTD nozzle and repaired it with Inconel 690 material ("half nozzle" repair technique).
3. SCE removed the two remaining MNSA seals at SONGS Unit 3. Inspection of the seals indicated they had been installed with adequate compression of the grafoil seal. In addition, no indication of leakage was observed at the associated nozzles and eddy current examinations revealed no detectable indications of flaws. Nevertheless, SCE replaced the nozzles with Inconel 690 material ("half nozzle" repair technique).
