UNITED STATES
NUCLEAR REGULATORY COMMISSION

SUBJECT: VOGTLE ELECTRIC GENERATING STATION UNIT 2 - NRC SPECIAL
INSPECTION REPORT 05000425/2006010

SUBJECT: SPECIAL INSPECTION CHARTER TO EVALUATE REPETITIVE RESIDUAL HEAT REMOVAL SYSTEM WELD FAILURES AT VOGTLE ELECTRIC GENERATING PLANT

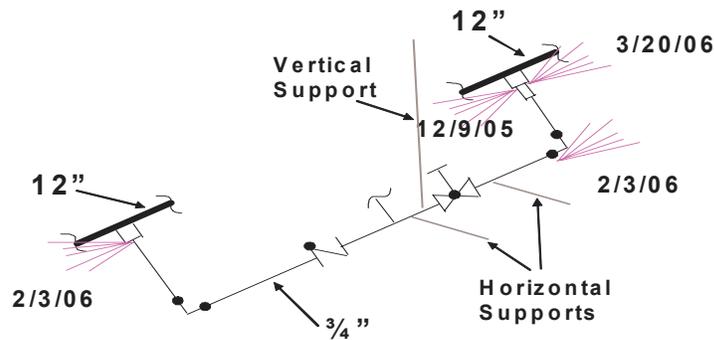
RHR Bypass Line Leak Locations

On February 3, 2006, two additional leaks were discovered in the same bypass line. The leaks were identified at welds 238 W 106 (butt welded elbow) and 238 W 101B (socket welded half coupling). The leak which was repaired in December 2005 was at the socket welded half coupling at the opposite end of the bypass line from this socket weld failure. Welds associated with the February 2006 leaks had been in service since plant construction.

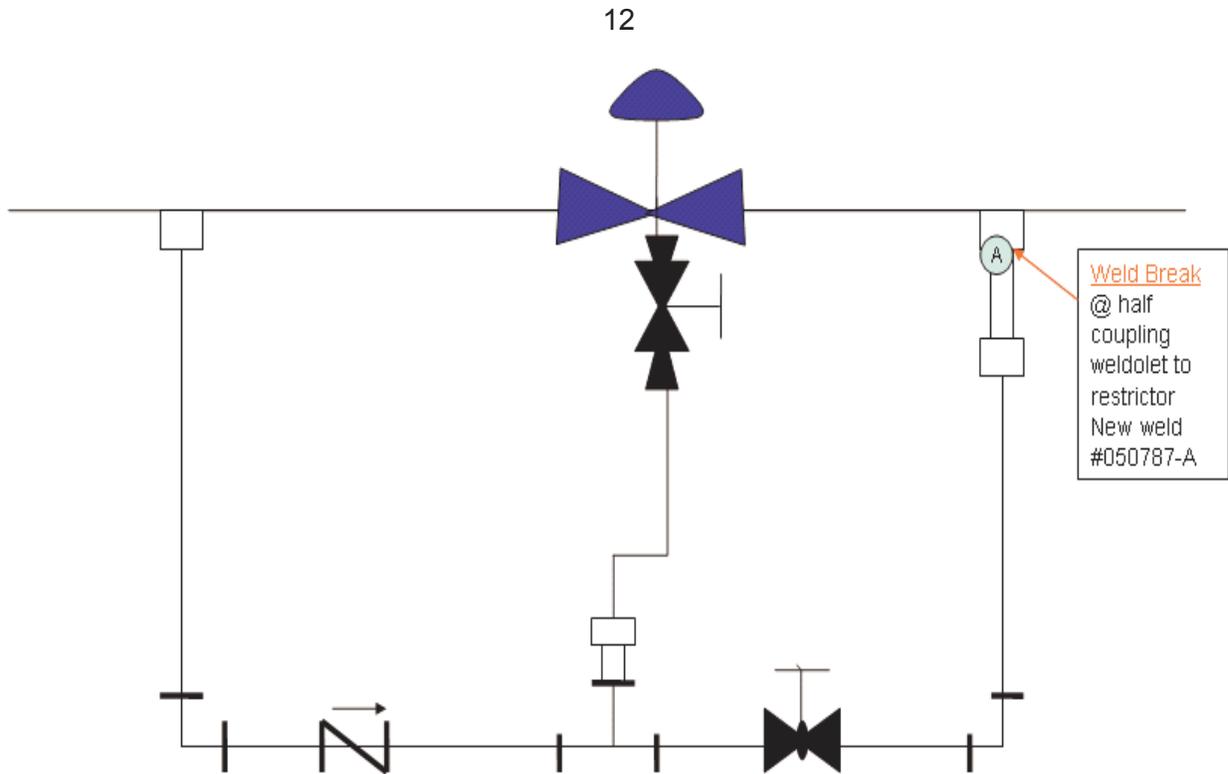
The RHR Loop Suction Valve (2HV8701B) bonnet vent line was first installed during the 2R8 (April 2001) refueling outage to equalize the valve bonnet pressure with the upstream pressure to prevent pressure locking of the valves. This was accomplished by installing $\frac{3}{8}$ inch stainless steel tubing that attached to the original packing leakoff port of the valve and connected to the upstream (RCS) side of the valve. During subsequent operations, a leak developed at the valve connection to the leakoff line and the modification was removed.

During 2R9 the bonnet vent line was modified and reinstalled. The $\frac{3}{8}$ inch tubing was replaced with $\frac{1}{2}$ inch schedule 160 piping, the check valves were eliminated and additional flow restrictors were added.

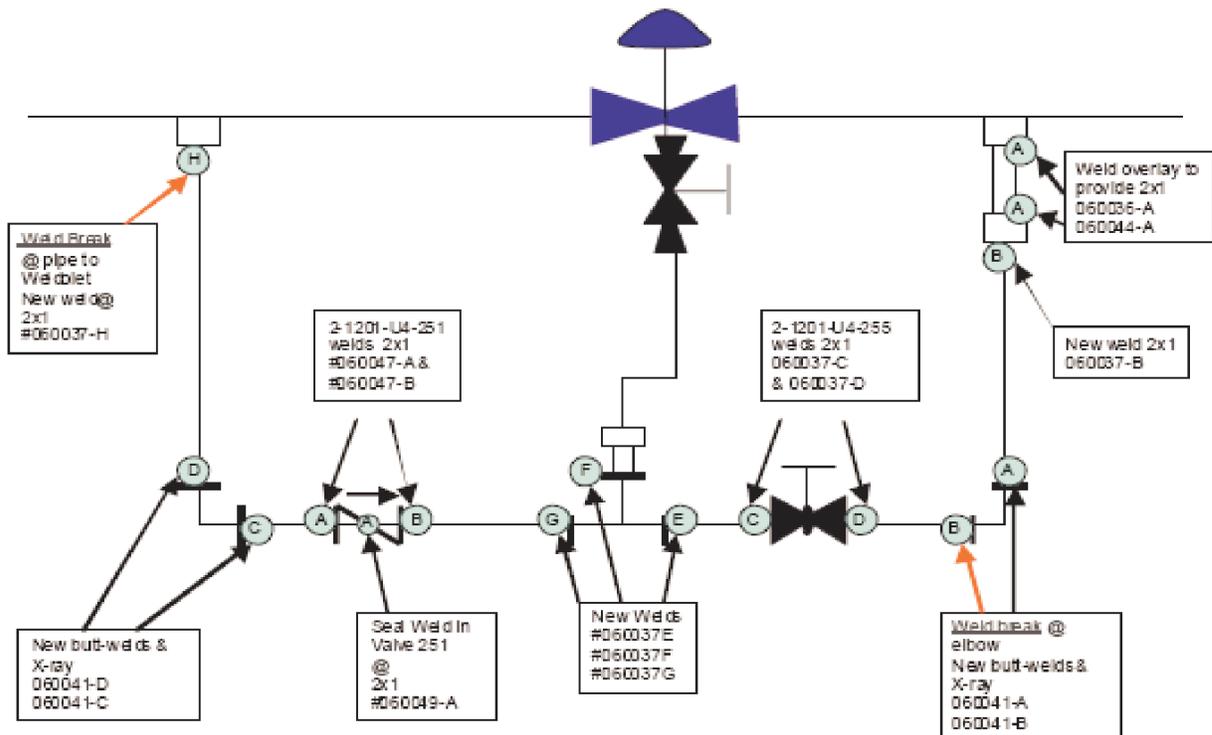
December 2005 bypass line weld failure and repair.

The inspectors reviewed the licensee's evaluation of the defect in the socket weld between the half coupling and the flow restrictor on the bypass line for valve 2HV8701B. The defect was found to be a circumferential linear flaw, approximately $\frac{1}{4}$ to $\frac{1}{2}$ inch long located approximately $\frac{1}{8}$ inch from the toe of the weld nearest the half coupling. The root cause of the defect was attributed to a lack of fusion when this weld was installed in October 2002.

The photos of the flaw show it to be located at an apparent start-stop point of a small bore $\frac{3}{4}$ inch socket weld. The start-stop point in a weld is a common location for a lack of fusion defect. Lack of fusion discontinuities are typically oriented in the direction of welding and can be caused by undesirable manipulation of the welding arc or by inadequate cleaning of contaminants on the weldment surfaces when the weld was performed. Socket welds are examined by surface examination methods, so when the

The December 2005 failure developed in a $\frac{3}{4}$ inch socket weld connection between a $\frac{1}{4}$ inch restrictor and an ANSI half coupling (Figure 12). This weld was fabricated during 2R9 when the flow restrictor was installed.

The inspectors reviewed Condition Report (CR) 2005111460, which discussed the several repair options that were developed. The appropriate plant conditions were established and the weld was ground out and replaced. The inspectors reviewed the documentation for the weld and the non-destructive examination exams and found that they met the requirements of ASME code, Section XI. Furthermore, the licensee identified no further leakage when the weld was visually inspected while the unit was at normal operating pressure and temperature.

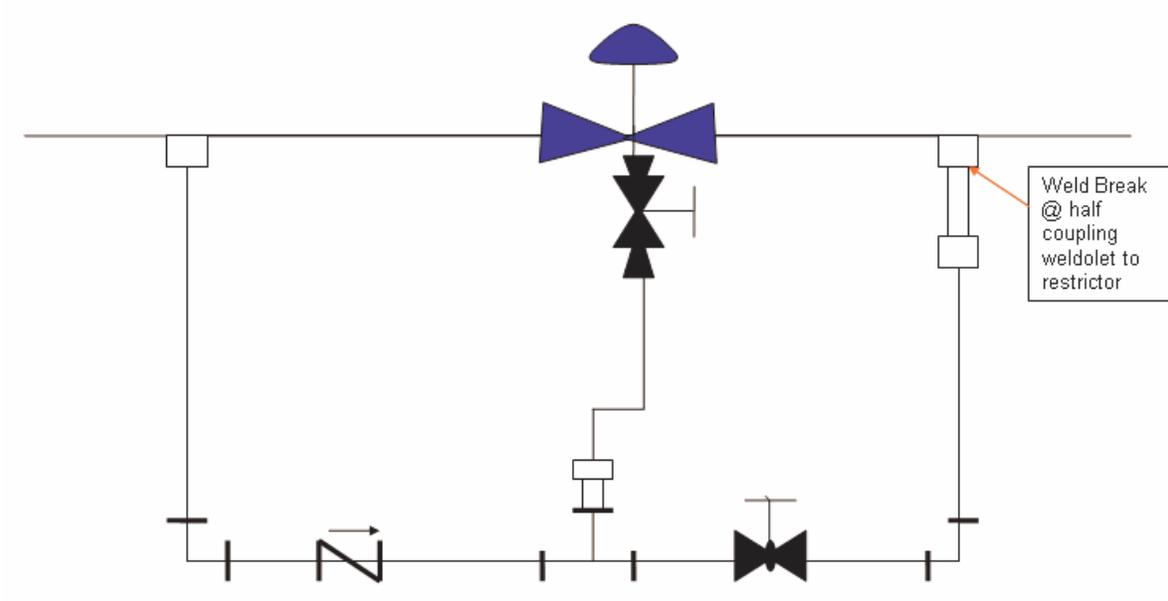
February 2006 weld failures and repairs.

Westinghouse Letter Report STD-MCE-06-18, "Evaluation of a Failed $\frac{3}{4}$ inch Sch. 160 Pipe to Elbow Weld in the Vogtle Unit 2 RHR Bypass Line", was issued to provide the results of the post mortem examination of the failed pipe. The inspectors determined that this report supported the conclusion that weld 238-W-101B failed through a fatigue mechanism which is supported by the presence of striations and indications that the crack progressed from the inside surface to the outside in nearly a straight line. The crack initiated at the 3 o'clock outboard position of the elbow due to improper welding of the root pass, i.e., the welder failed to successfully tie in to a stopping point when continuing with the root weld, which created a notch that became a stress concentration. While the overall deep penetration of the root pass and half moon profile contributed to initiating a crack to nearly a full inner circumference of the weld joint, a particular notch at one location created a condition for a deep crack to initiate and to then become unstable. Cracking did not only progress radially but circumferentially as well, presumably due to the non-axial loading of the pipe. This fatigue assessment is also supported through the absence of other modes of failure or influence: cracking was not typical of stress corrosion cracking; corrosion did not appear to be a factor in the initiation or growth of the crack; microstructures of the pipe, elbow, and weld were sound and did not contain any anomalies that would influence cracking or crack growth; other than the unfavorable penetration of the root pass the weld was sound in that it did not exhibit porosity, inclusions, or hot cracks; the fracture surface did not exhibit any brittle features; and the crack was ductile throughout its fatigue propagation regime indicating that stress overload was not a factor.

Compared to weld 238-W-101B, all of the butt welds from the bypass line exhibited similar bead profiles and small corner cracks emanating from the intersection of the weld bead and the pipe and elbow. These cracks were not believed to be active. The presence of the specific notch in weld 238-W-101B is believed to be the determining factor in its ultimate failure.

The entire bypass line was replaced with the exception of the two half-couplings, flow restrictor and full-coupling. The February 2006 failures occurred in welds 238-W-106 (butt welded elbow) and 238-W-101B (socket welded half coupling). The previous leak that was fixed in December 2005 was at a coupling at the opposite end of the bypass line from the leaks that occurred in February 2006.

The design objective of DCP 2060240801, which replaced the bypass line, was to provide a reliable repair to address the two leaks in the bypass line around RHR isolation valve 2HV8701B. The DCP provided the design to re-fabricate the bypass line and remove pipe support V2-1201-238-H601. The new piping assembly fit into the same location as the original assembly, continued to perform its original function of allowing pressure equalization from the downstream to upstream side of 2HV8701B, and was supported by the two remaining original supports. The DCP also provided revised weld details for socket welds on line 2-1201-238- $\frac{3}{4}$, for improved fatigue strength. The new piping assembly was shop fabricated and utilized enhanced weld profiles to minimize local stress. All the new butt welds were radiographically tested.

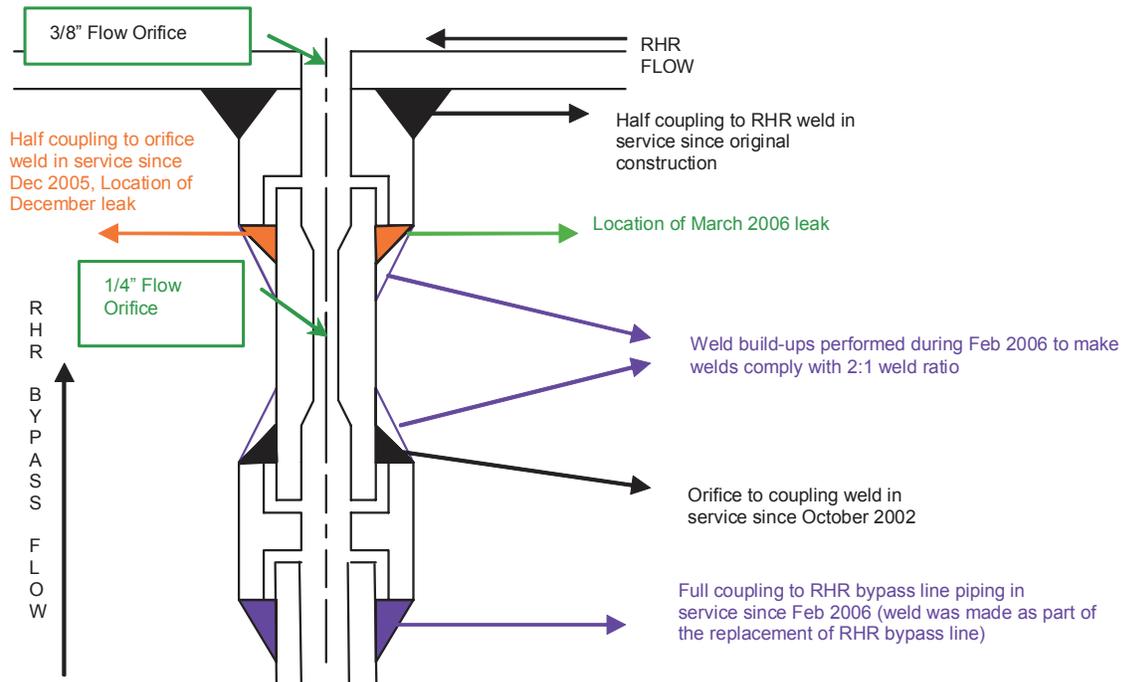
Weld Repair History for 2HV8701B flow-restrictor

The inspectors reviewed Westinghouse MCE Report STD-MCE-06-25 that noted that the RHR bypass line socket to flow restrictor weld most likely failed due to fatigue. Although fatigue striations were not readily visible (possibly due to the surface damage during removal), no other failure mechanism appeared relevant. The fatigue assessment is also supported through the absence of evidence of other modes of failure or influence. The flaw was not typical of stress corrosion cracking nor did general corrosion appear to be a factor in the initiation or growth of the crack.

Dye penetrant testing revealed a circumferential crack which ran approximately from 3 o'clock to approximately 4 o'clock. The crack was approximately 5/8 inch in length and approximately 3/16 inch from the toe of additional weld reinforcement that was applied in February to improve the weld profile to a 2:1 profile. Radiographic testing (RT) of the failed weld was not able to adequately reveal the extent of cracking in the socket weld as it may have run subsurface circumferentially.

March 2006 Weld Failure

The March 2006 failure was in a $\frac{3}{4}$ inch socket weld connection between a $\frac{1}{4}$ inch restrictor and an ANSI half coupling. This weld was the same weld that failed in December 2005. The metallurgical analysis of the failed socket weld indicated that the weld may have already been cracked when the February 2006 failure occurred.

During the March 2006 forced outage the RHR Bypass Line and the RHR 2HV8701B leak off lines were removed. The entire bypass line was removed and the empty half-couplings were plugged.
