Vogtle Unit 2

RHR Bypass Line Leaks

Root Cause Investigation

May 2006

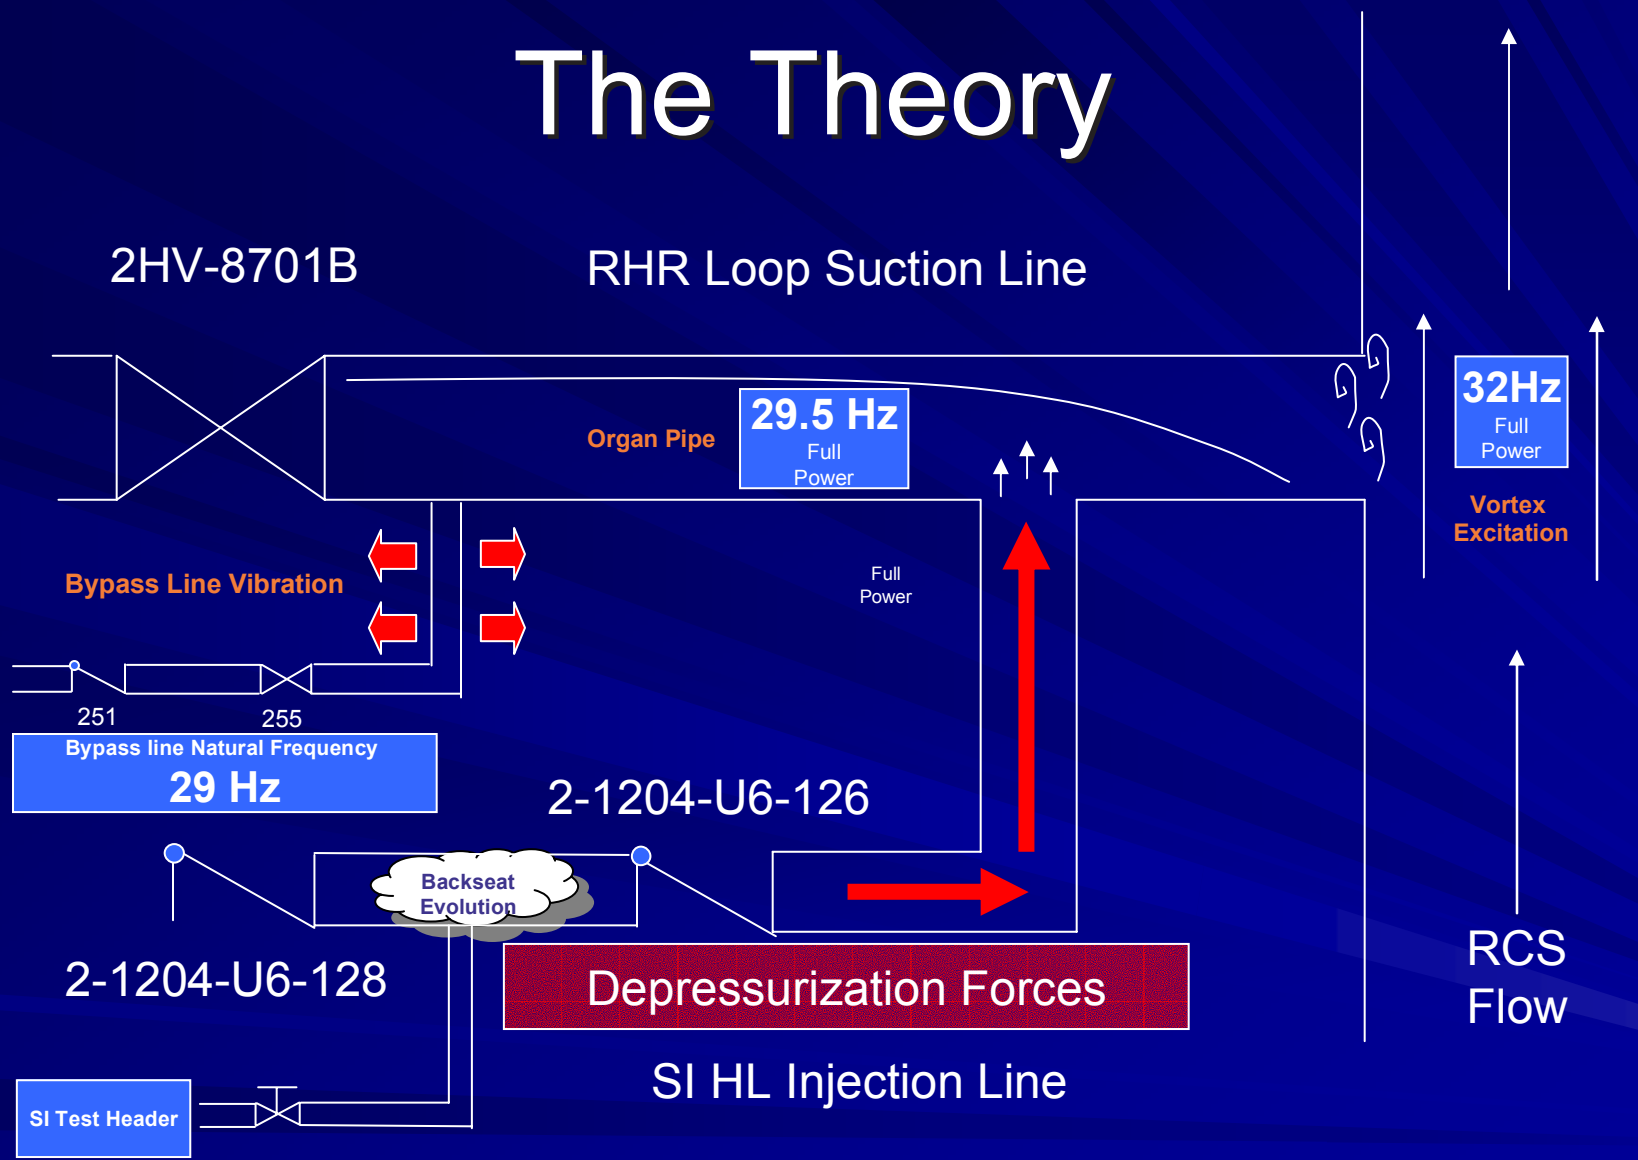
# The Theory

When frequencies align, resonance occurs.
