for Leave to File New Contentions, submitted on April 6, 2006 ("April 6 Request"). Briefly summarized, on September 10, 2003, Entergy filed an application ("EPU Application") to increase the maximum authorized power level from 1593 megawatts thermal ("MWt") to 1912 MWt (extended power uprate or "EPU"). NEC filed a petition to intervene and request for a hearing with respect to the EPU Application.<sup>2</sup> On November 22, 2004, the Board admitted two of NEC's proposed contentions. LBP-04-28, 60 NRC 548 (2004). Hearings on NEC's two admitted contentions are scheduled for September and October 2006.<sup>3</sup>

### **A. The April 20 Request is Untimely**

A formal root cause analysis performed by Exelon Nuclear of the causes of the Quad Cities Unit 2 steam dryer crack has been recently released. Exelon Nuclear Root Cause Report Q2R18 “Concerns Related to Steam Dryer” dated May 16, 2006 (“Root Cause Report”), Exhibit 5 hereto (available in the ADAMS system under accession number ML061420307). Its issuance lays to rest NEC’s argument disputing “that there exists defensible technical basis [sic] for going forward with ascension power testing on the Quad Cities model until thorough r

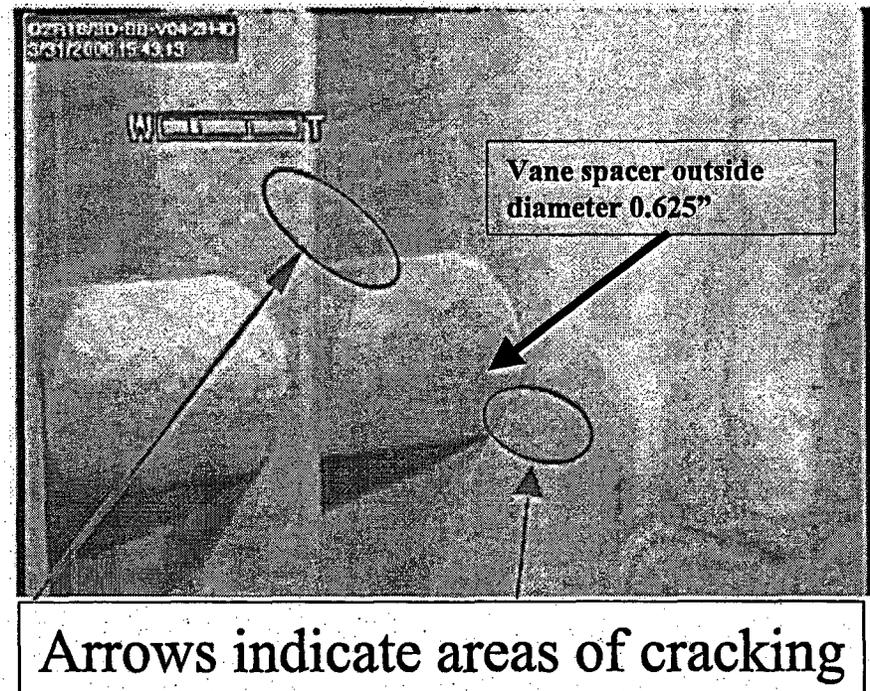
## Dryer Vane Bank Assembly

- INRs 06-06, 06-08, and 06-10 document minor indications in the vane bank assemblies for dryer banks F, D, and B, respectively

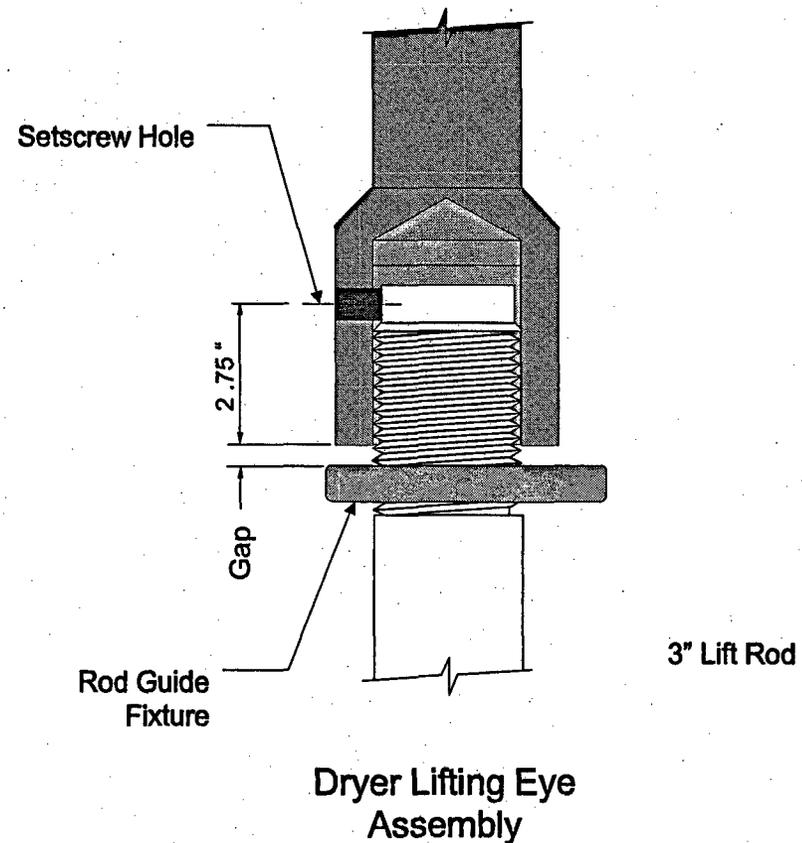
## Dryer Lifting Eye Assembly

- INR 06-01 documented lifting eye rotation and lifting rod thread damage

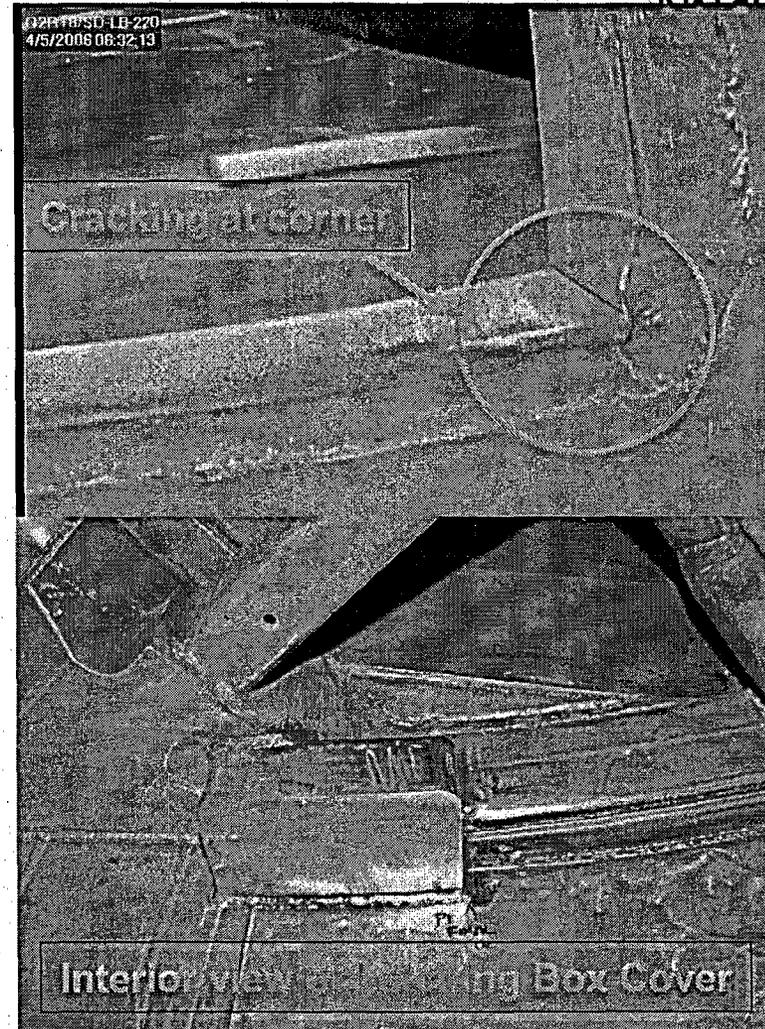
## Latch Box

- INR 06-29 identified crack in latch box

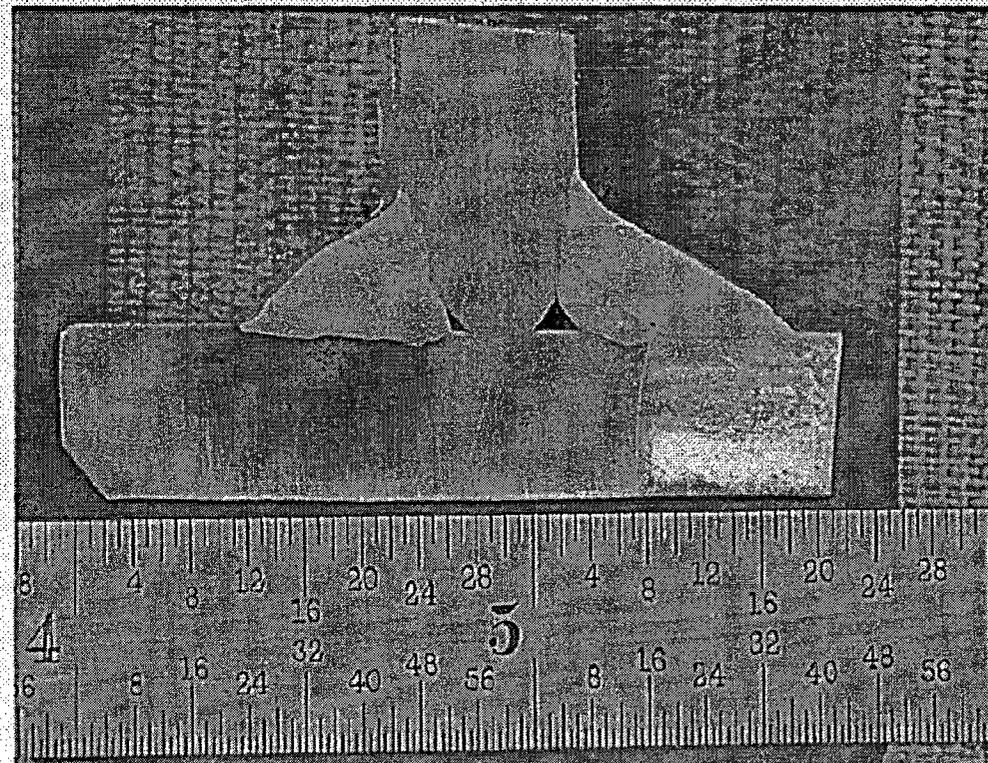
- Weld details require ID and OD penetration of 0.16" with 0.1" fillet reinforcement
- As built configuration has significant fillet reinforcement and weld size not cause of failure

Figure 2: Weld cross section of Sample 1-1 (in cut-out)  
(~2 inches from fracture)

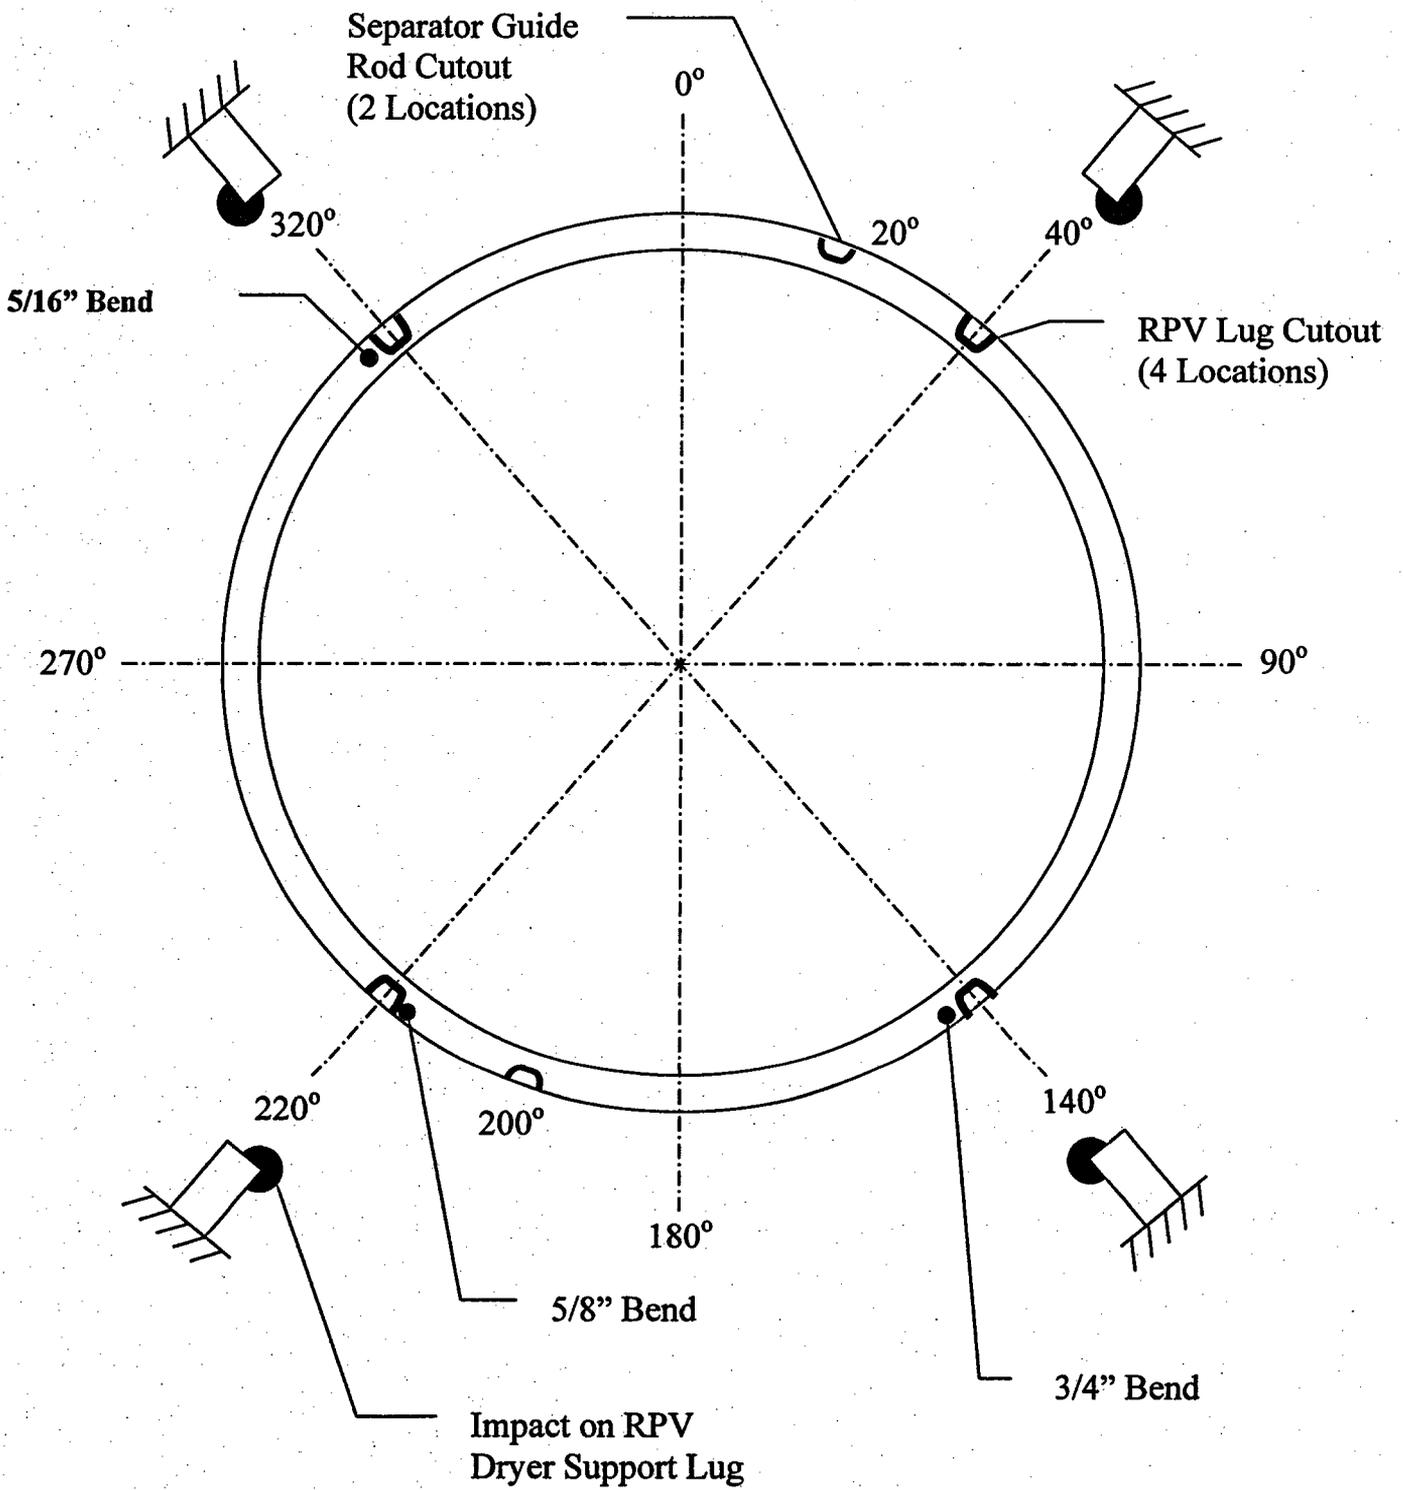
**Figure 2 Steam Dryer Plan – Impact Locations**

The Root Cause Report confirms the preliminary assessment that the crack was not formed by flow induced vibrations during plant operations but was due to deformation caused by the dryer skirt base ring being caught on the reactor pressure vessel dryer support lugs while the dryer was being lifted in May 2005. Root Cause Report at 3. The report states: “Analyses completed by General Electric (GE) and reviewed by Exelon determined that without the additional stresses and material degradation resulting from the May 2005 lifting event, the operational loads were not sufficient to initiate cracking in the U-2 dryer skirt plate.” Id. at 4. Furthermore, “the Unit 1 steam dryer, which did not experience either the fabrication ovality or

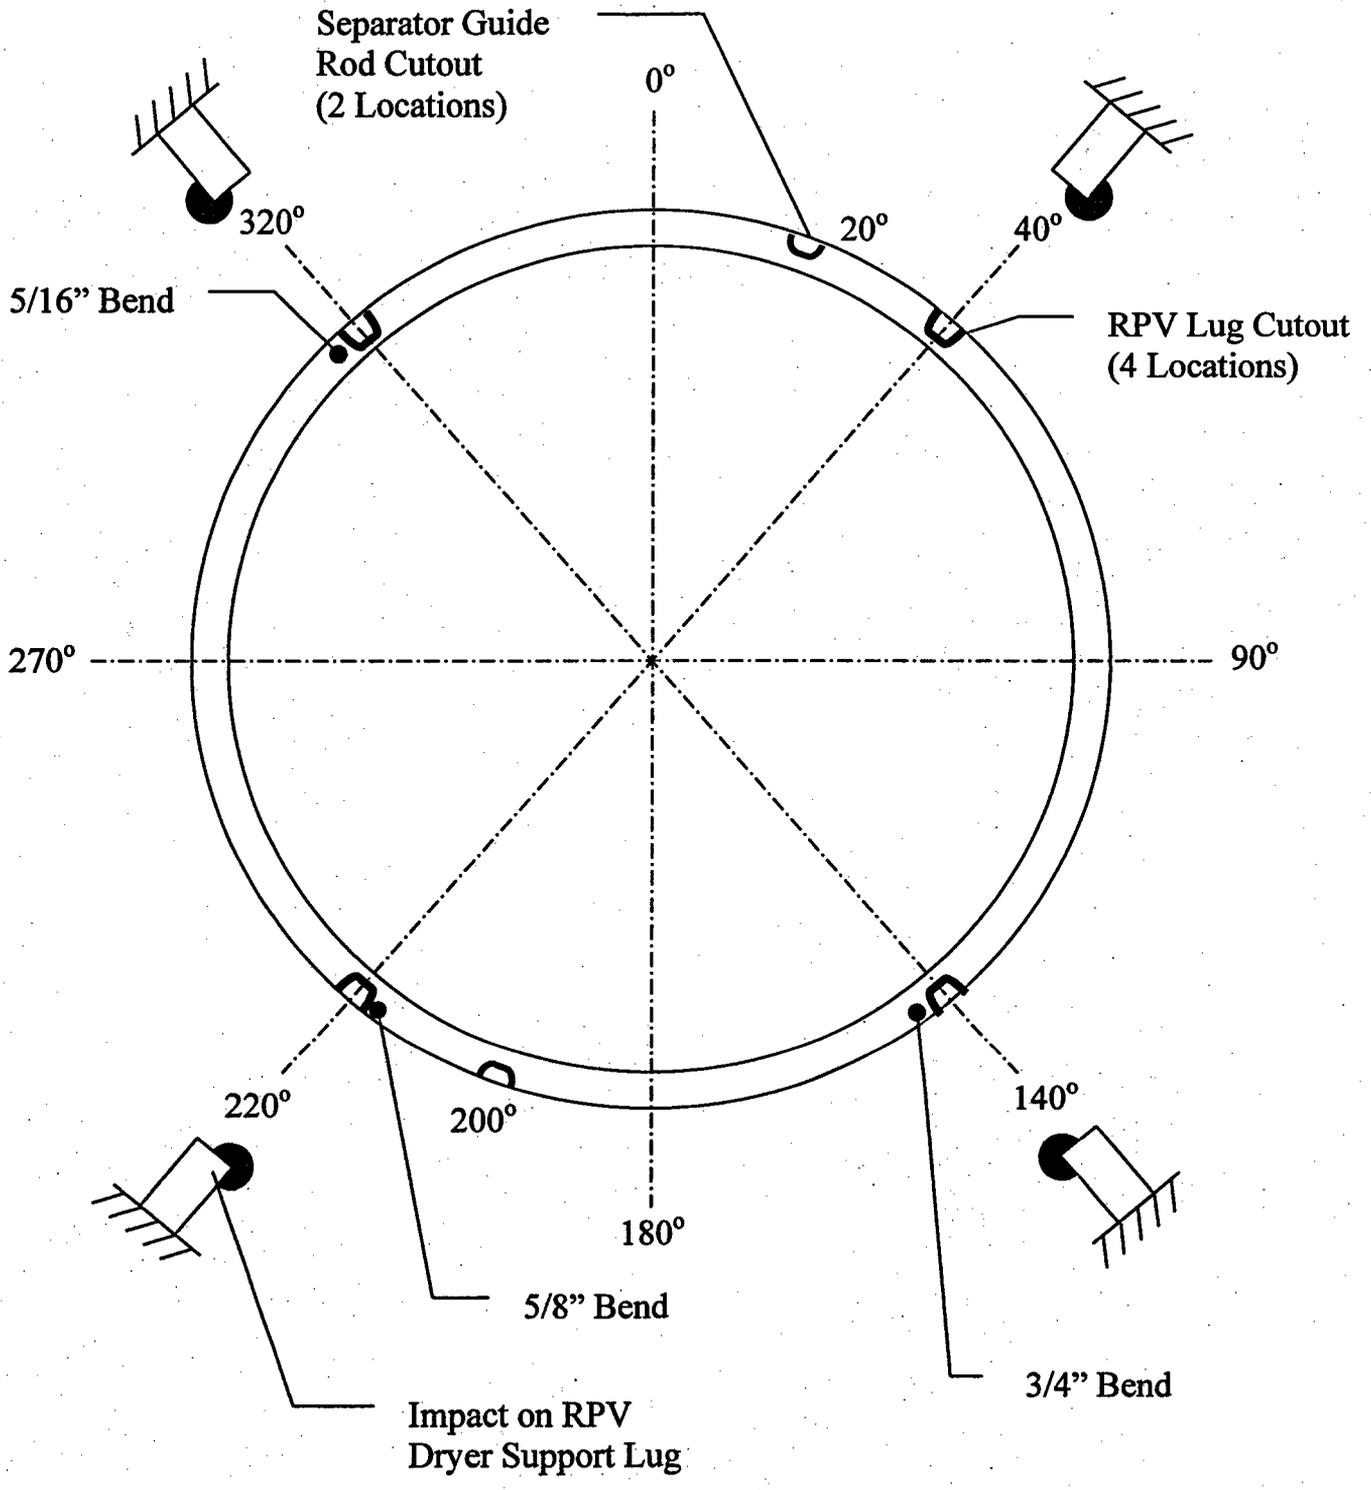
**Figure 1**  
Steam Dryer Plan – Impact Locations

8. Dryer rotates and swings into the 140 and 40° lug.
9. Dryer impacts the 140° lug below the right lower edge of the lug.
10. This impact results in a sharp crease in the dryer support lug and the formation of an edge on the base plate gusset. The corner of the 140° lug is pushed in and partially shears off.
11. During the tilt/rotation, the dryer impacts the right bottom corner of the 40° lug, shearing off the corner.
12. The dryer lift is completed without further incident.

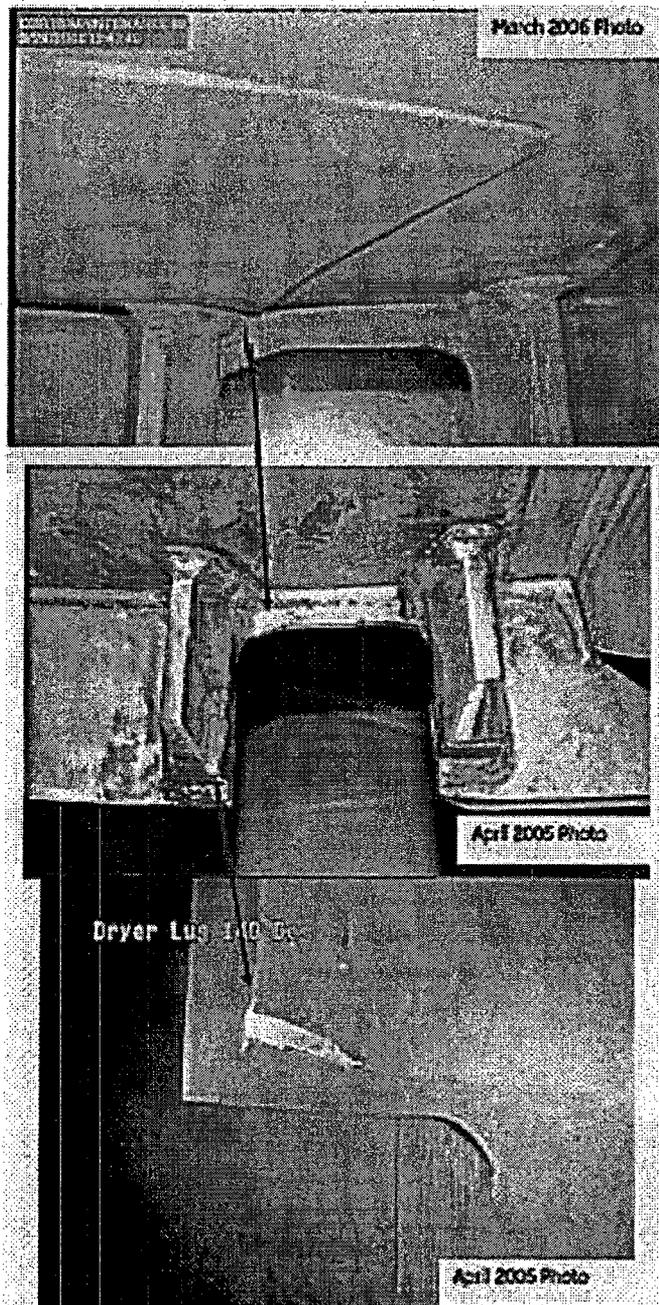
**Figure 2**

**General Relationship Between Dryer Cracking (Top), Dryer Guide Slot Cutout at 140 Degrees (Center), and Dryer Support Lug at 140 Degrees (Bottom)**

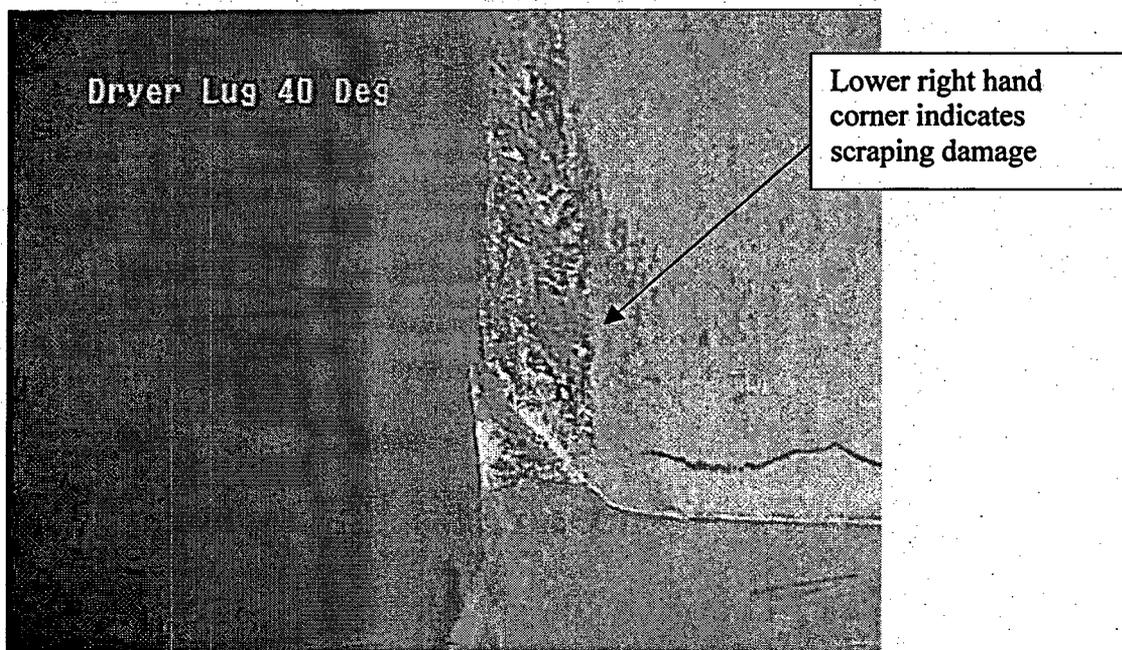
**Figure 3**

Damage to 40 Degree Lug, Lower Right Hand Corner Damaged During Impact

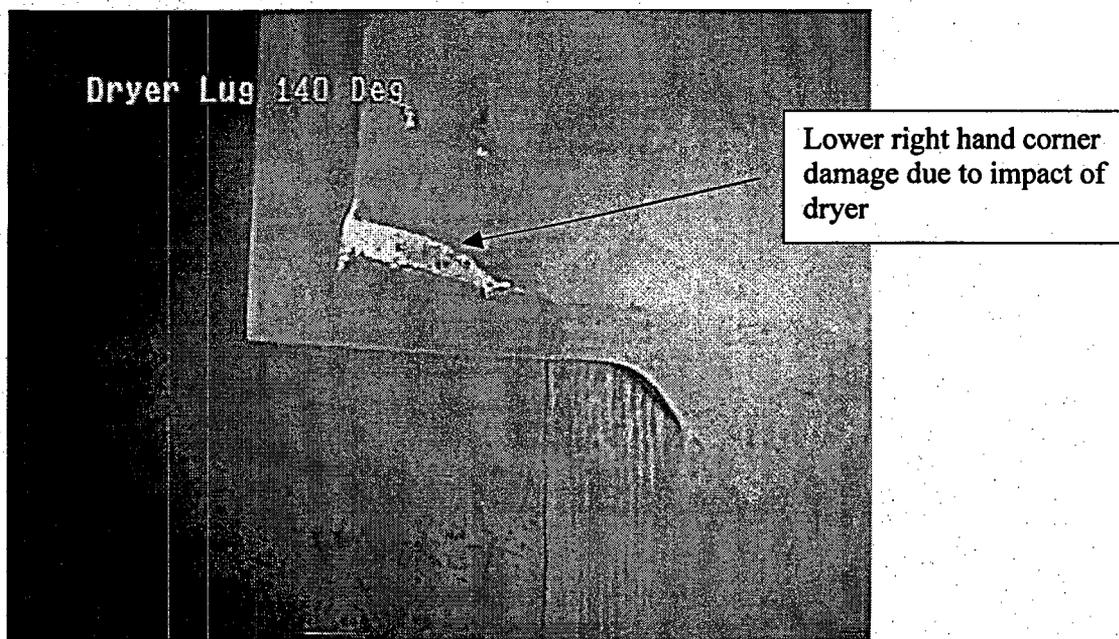
**Figure 4**

Damage To 140 Degree Lug, Lower Right Hand Corner Damaged Due to Major Impact

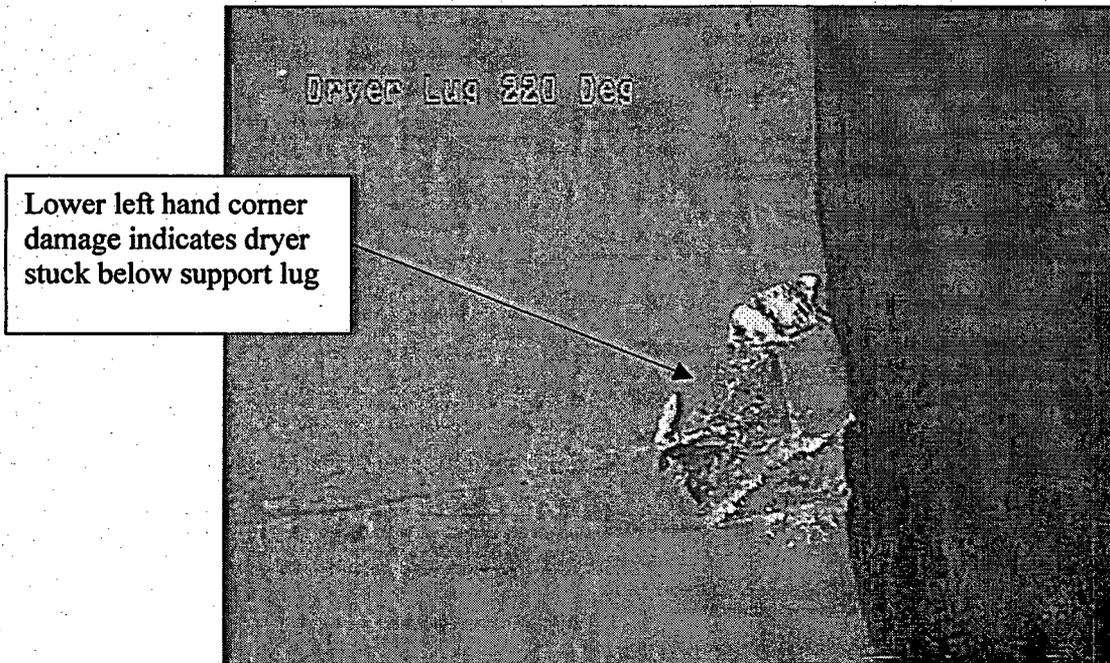
**Figure 5**

Damage To 220 Degree Lug, Lower left hand Corner

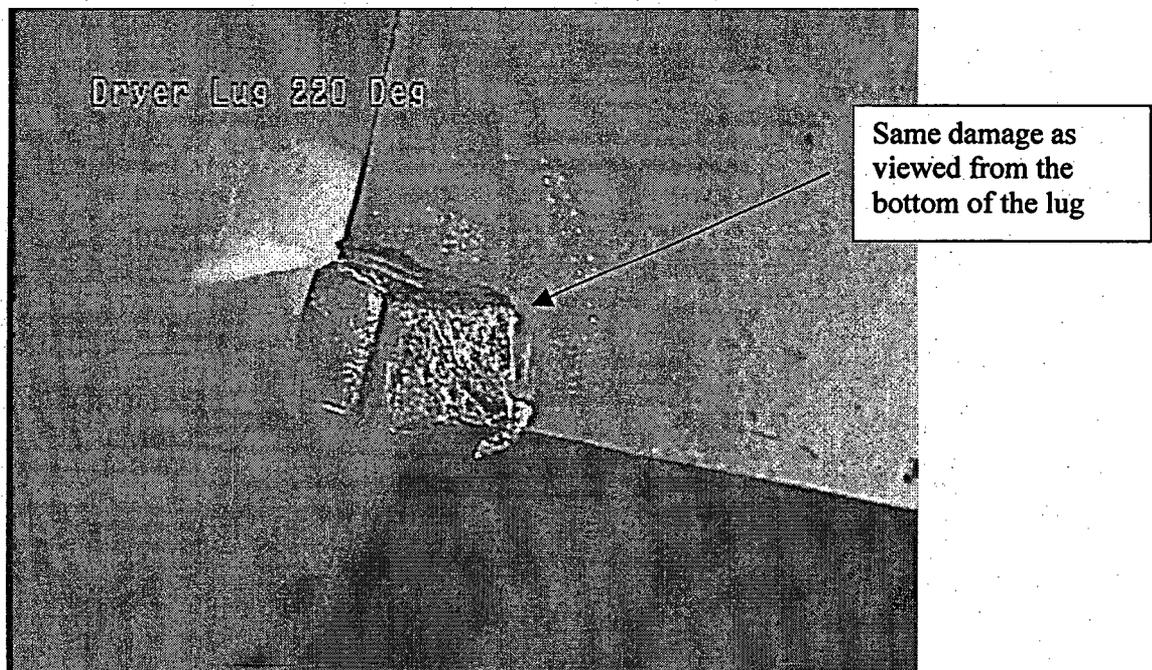
**Figure 6**

Damage To 220 Degree Lug, Lower left hand Corner (View from Bottom)

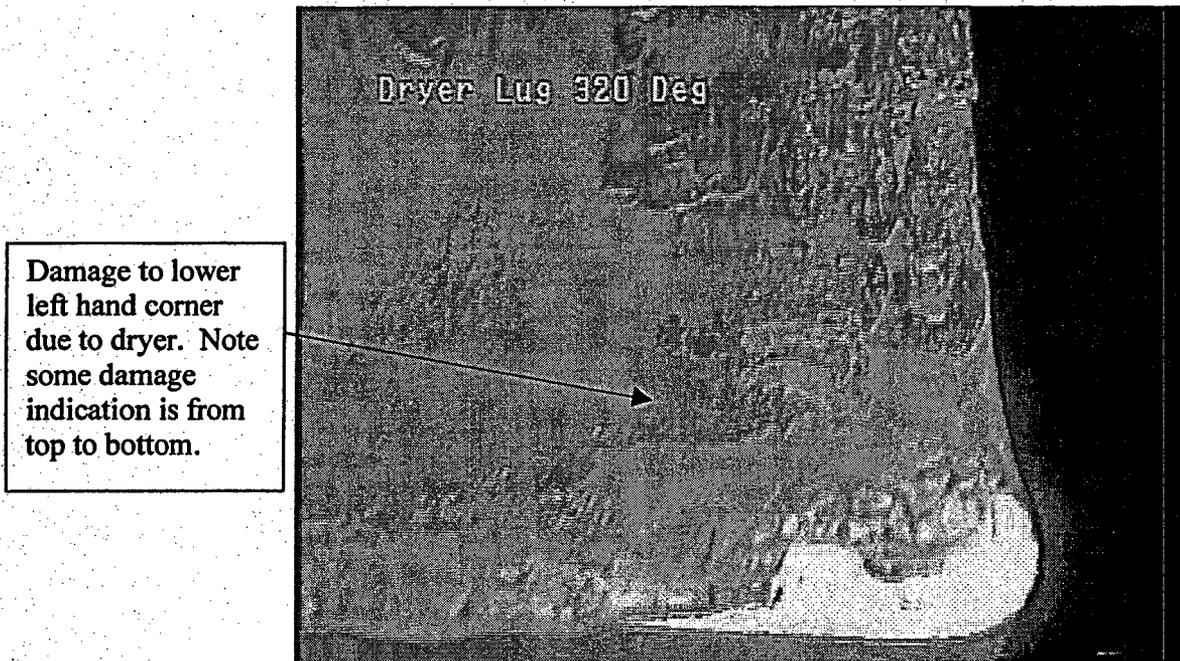
**Figure 7**

**Damage to 320 Degree Lug, Lower Left Hand Corner**

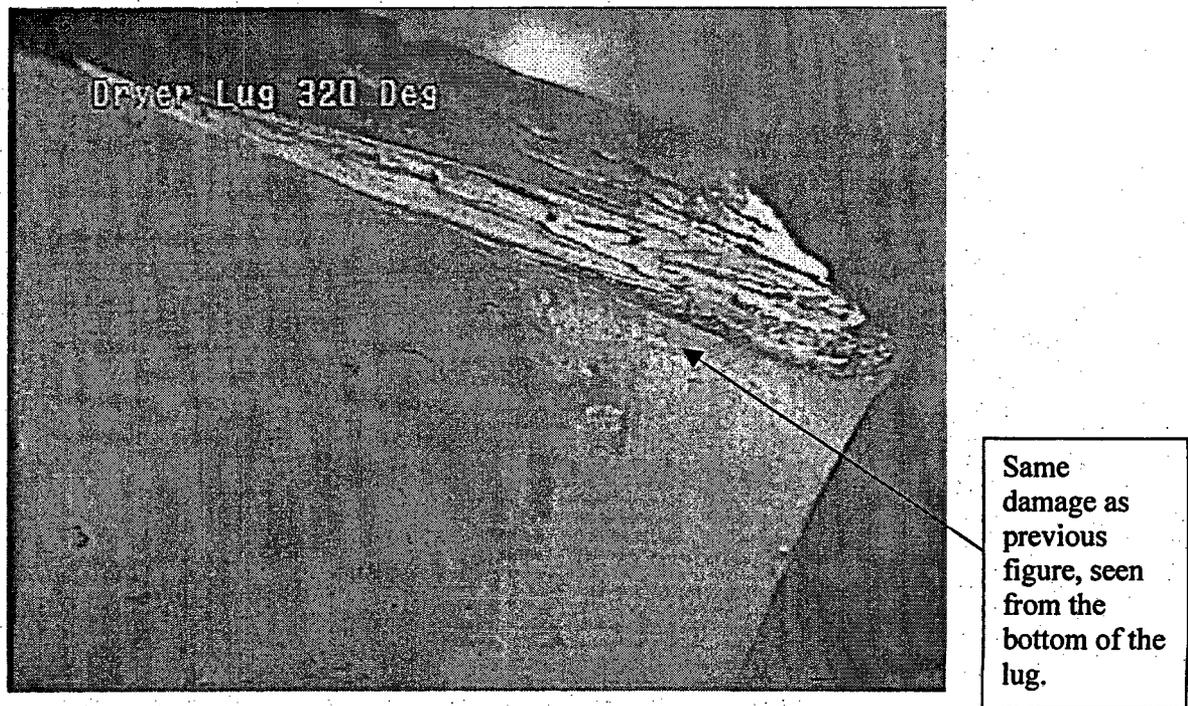
**Figure 8**

**Damage to 320 Degree Lug, Lower Left Hand Corner (View From Bottom)**
