Mason & Hanger-
Silas Mason Co., Inc.

IOWA ARMY AMMUNITION PLANT
MIDDLETOWN, IOWA 52638-9701

Subject: Difficulty in Exposing Co-60 Source from
Stored Position in Exposure Device

Reference: NRC License No. 14-24479-01

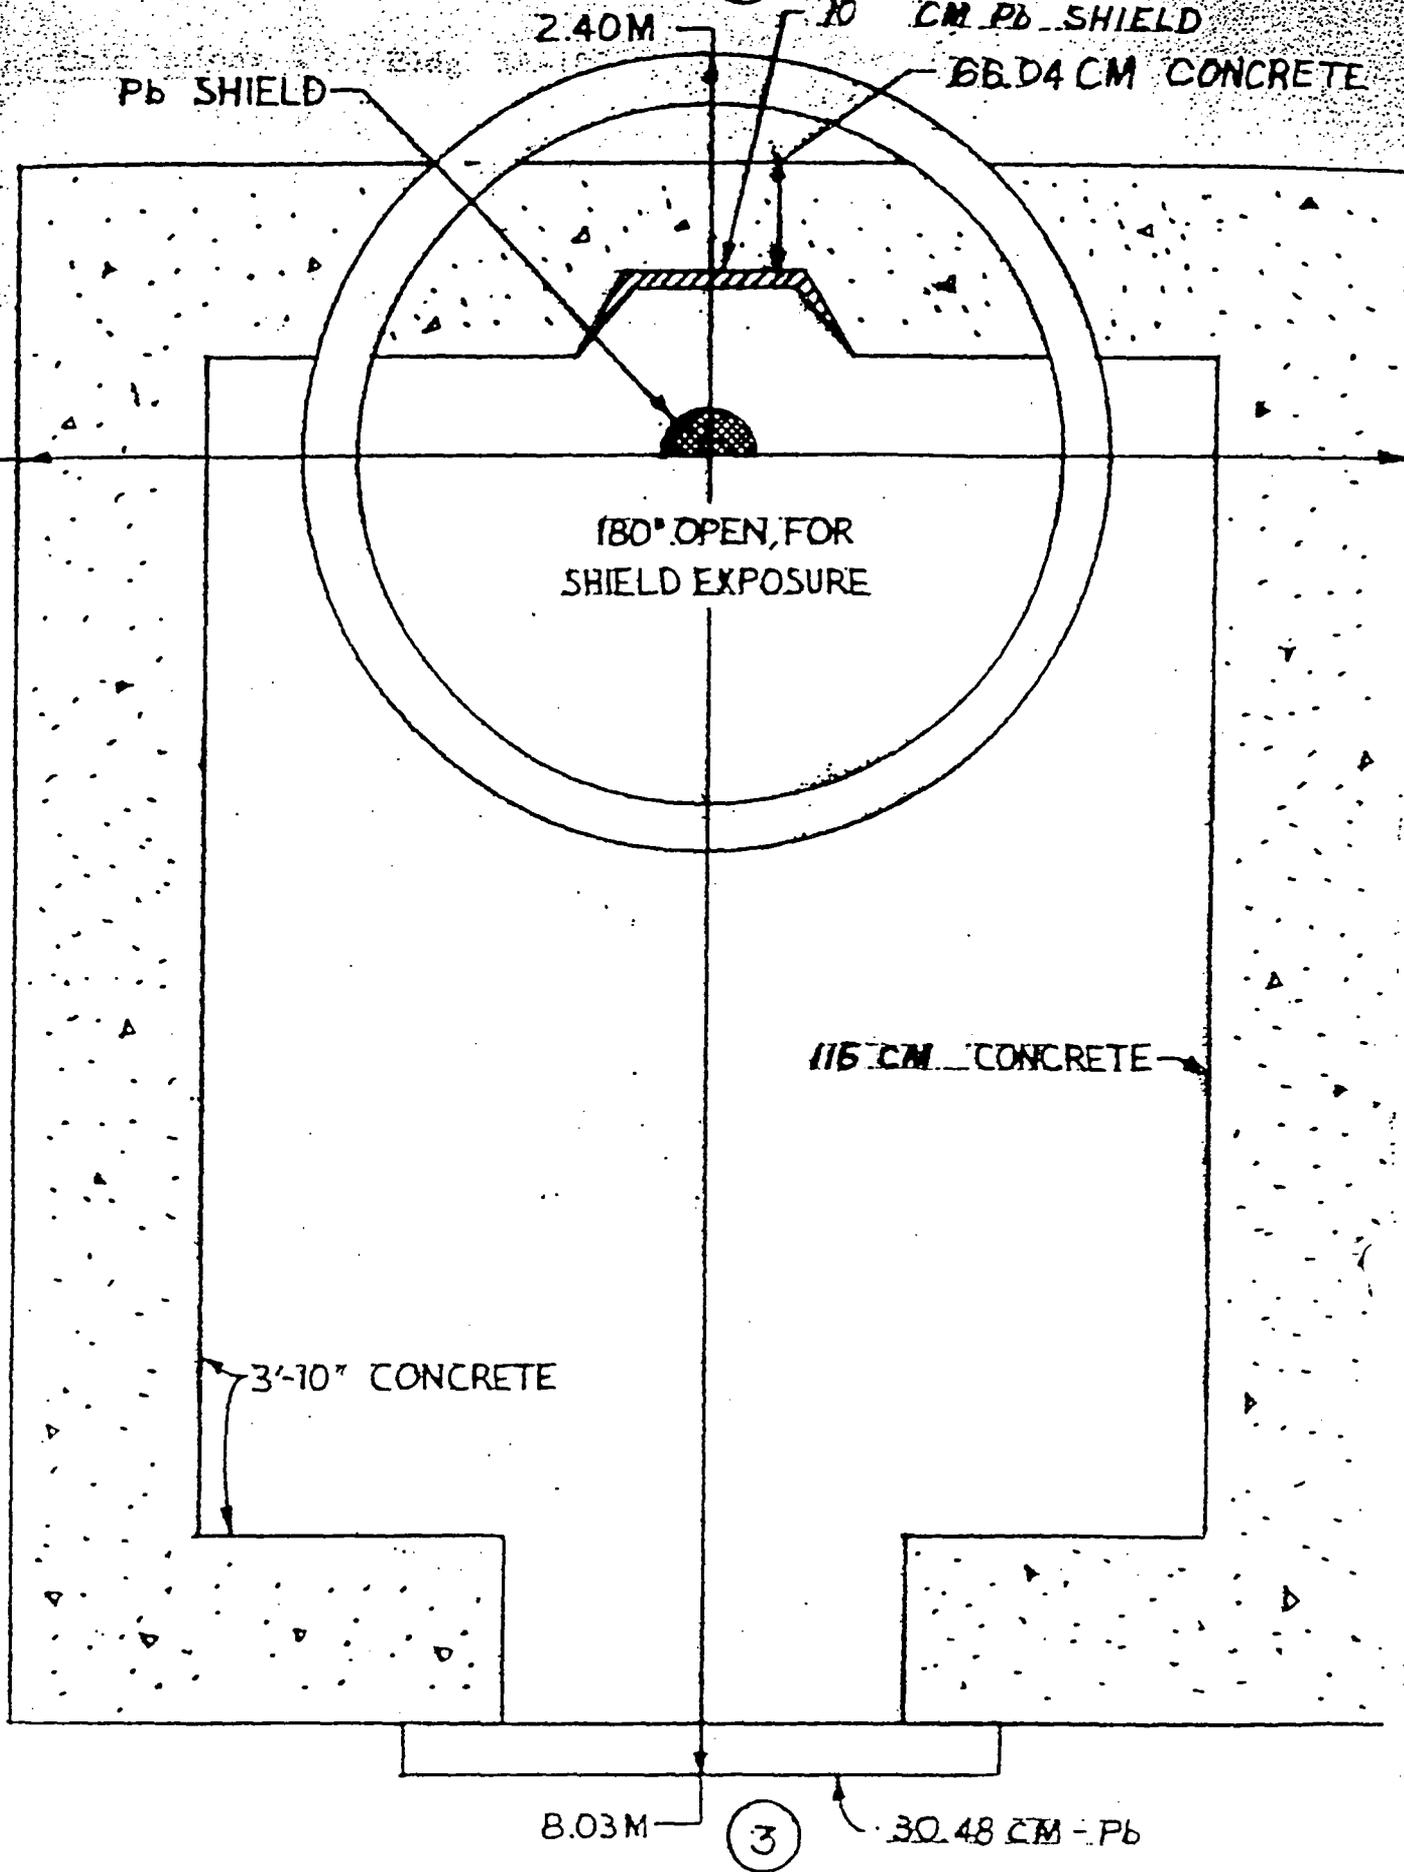
1000 CURIE COBALT 60 SHIELDING - BLDG 3A-100

It is believed that the source capsule was lodged in the tapered portion of the source travel tube (See Attachment No. 2, Dwg. 2-10-M-1055, Sheet 2 of 5). Factors which potentially contributed to the stuck source include: inaccurate air cylinder placement, polymerization of lubricant on the taper allowing the source to stick, and the length of time since the source was last exposed.

To prevent recurrence, the air cylinder has been positioned so the source capsule in the fully retracted position is a minimum of one-eighth of an inch from the tapered portion of the tubing joint. Also, during periods of inactivity the source will be periodically exposed.
