**Re: 2005 Annual Report for University of California Davis/ McClellan Nuclear  
Radiation Center, Docket No. 50-067, License No. R-130**

2005

ANNUAL REPORT

Docket Number 50-067  
License Number R-130

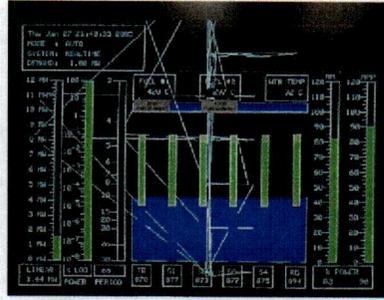
1. On 27 January, the CSC Hi-Resolution monitor began tracing white lines throughout the screen. The reactor operator notified the senior reactor operator, and observed the display and function of the monitor. All active regions of the monitor displaying dynamic parameters and indications updated properly. The senior reactor operator gave permission to continuing operations, since the lines did not interfere with either the display or function of the monitor. The facility director was apprised of the situation, and concurred with the senior reactor operator. Following the reactor

shutdown, the reactor operator rebooted the CSC. The problem did not reoccur. See attached photo:
