UNITED STATES  
NUCLEAR REGULATORY COMMISSION

SUBJECT: JOSEPH M. FARLEY NUCLEAR PLANT - NRC SPECIAL INSPECTION  
REPORT 05000348/2006009 AND 05000364/2006009

The report documents special inspection activities conducted by a resident inspector and a senior reactor inspector to investigate the failure of three Unit 1 Main Steam Isolation Valves (MSIVs) to close.

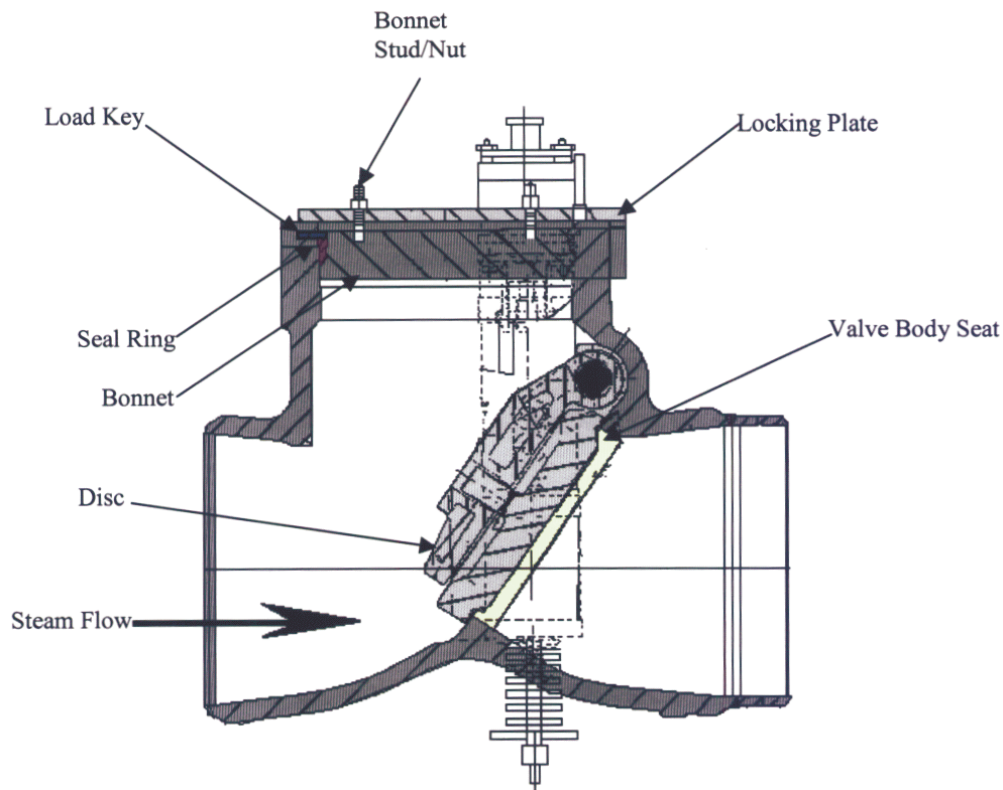
Each unit of the Farley plant has three lines of main steam flow in which each line has two MSIVs installed in series downstream from the safety relief valves outside containment. The upstream and downstream MSIVs, manufactured by Atwood & Morrill (now WEIR), are identical in construction and their bodies are separated by approximately six inches of piping. The MSIVs are 32-in., 600-lb disk, full-flow, swing-check, nonreturn-type valves with pneumatic actuators. During normal plant operation, the valves are kept open against a spring force by air pressure in the actuator. In the normal open position, the disc is held well out of the steam flow by the air operator. In case of high pressure in the containment, or high steam line flow in coincidence with low-low  $T_{avg}$  or low steam line pressure, the air pressure in the cylinder is relieved and the valve is closed within seven seconds by action of the spring to prevent the forward flow of steam through the valve. In the event of a steam line break, the MSIVs prevent continuous uncontrolled steam release from more than one steam generator, regardless of whether the break is inside or outside the containment, even when it is assumed that there is a failure of one of the isolation valves. The valve design also incorporates a means to perform an approximate 5% movement partial closure test. This test can be performed with or without steam flow present.
