UNITED STATES
NUCLEAR REGULATORY COMMISSION

SUBJECT: JOSEPH M. FARLEY NUCLEAR PLANT - NRC SPECIAL INSPECTION
REPORT 05000348/2006009 AND 05000364/2006009

The report documents special inspection activities conducted by a resident inspector and a senior reactor inspector to investigate the failure of three Unit 1 Main Steam Isolation Valves (MSIVs) to close.

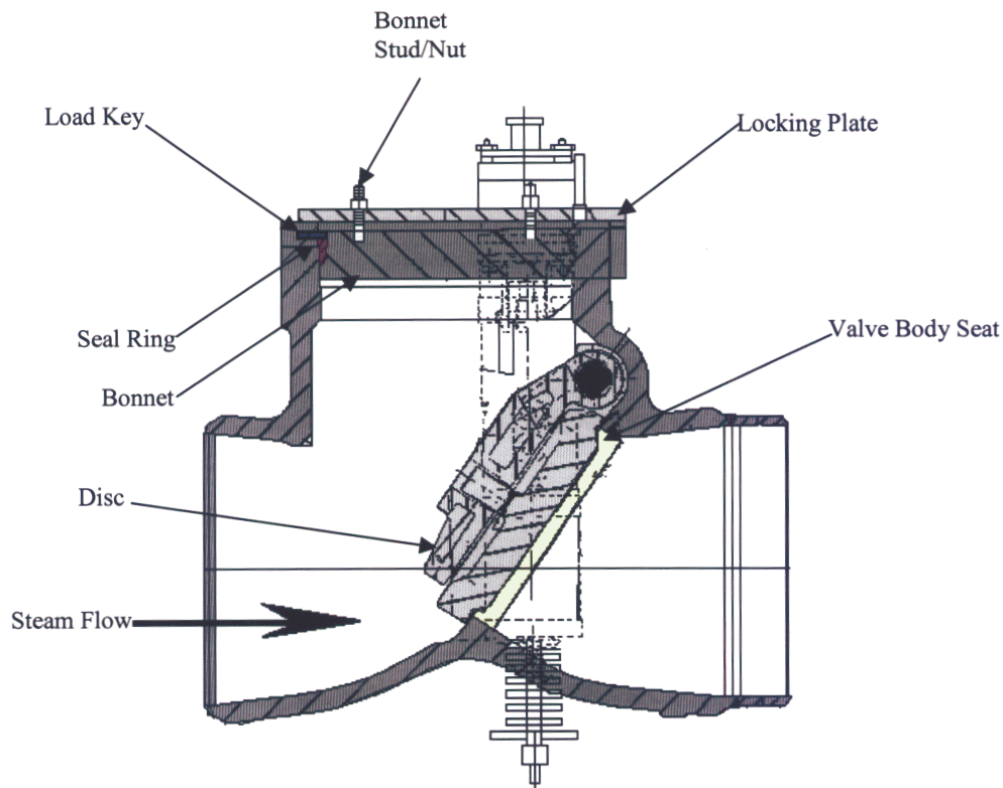
Farley MSIV Design Overview

Each unit of the Farley plant has three lines of main steam flow in which each line has two MSIVs installed in series downstream from the safety relief valves outside containment. The upstream and downstream MSIVs, manufactured by Atwood & Morrill (now WEIR), are identical in construction and their bodies are separated by approximately six inches of piping. The MSIVs are 32-in., 600-lb disk, full-flow, swing-check, nonreturn-type valves with pneumatic actuators. During normal plant operation, the valves are kept open against a spring force by air pressure in the actuator. In the normal open position, the disc is held well out of the steam flow by the air operator. In case of high pressure in the containment, or high steam line flow in coincidence with low-low T_{avg} or low steam line pressure, the air pressure in the cylinder is relieved and the valve is closed within seven seconds by action of the spring to prevent the forward flow of steam through the valve. In the event of a steam line break, the MSIVs prevent continuous uncontrolled steam release from more than one steam generator, regardless of whether the break is inside or outside the containment, even when it is assumed that there is a failure of one of the isolation valves. The valve design also incorporates a means to perform an approximate 5% movement partial closure test. This test can be performed with or without steam flow present.
