44  
RH-5A15

Notification	10132527	Notification type	CR
Description	SW-P-D STARTED, NO DISCHARGE PRESSURE	Condition Report	12/26/2001
Reported by	DJBROME	11:10:56	11:10:56
Start date	12/26/2001	NotificnDate	12/26/2001
Start time	11:10:56	End date	01/02/2002
Priority	CM	End time	09:10:56
Physical Location	CNS-2-SW-P-D	SWP D	
SORT	SW-P-D		
Equipment Order	4216374		
Assembly			
MaintPlanGroup	CNS	Planning Dept	
Malf. Start Date			
Malf. Start time	00:00:00	Tel.	
		Malf. End date	
		Malf. End time	00:00:00

**ORDER #4216374**

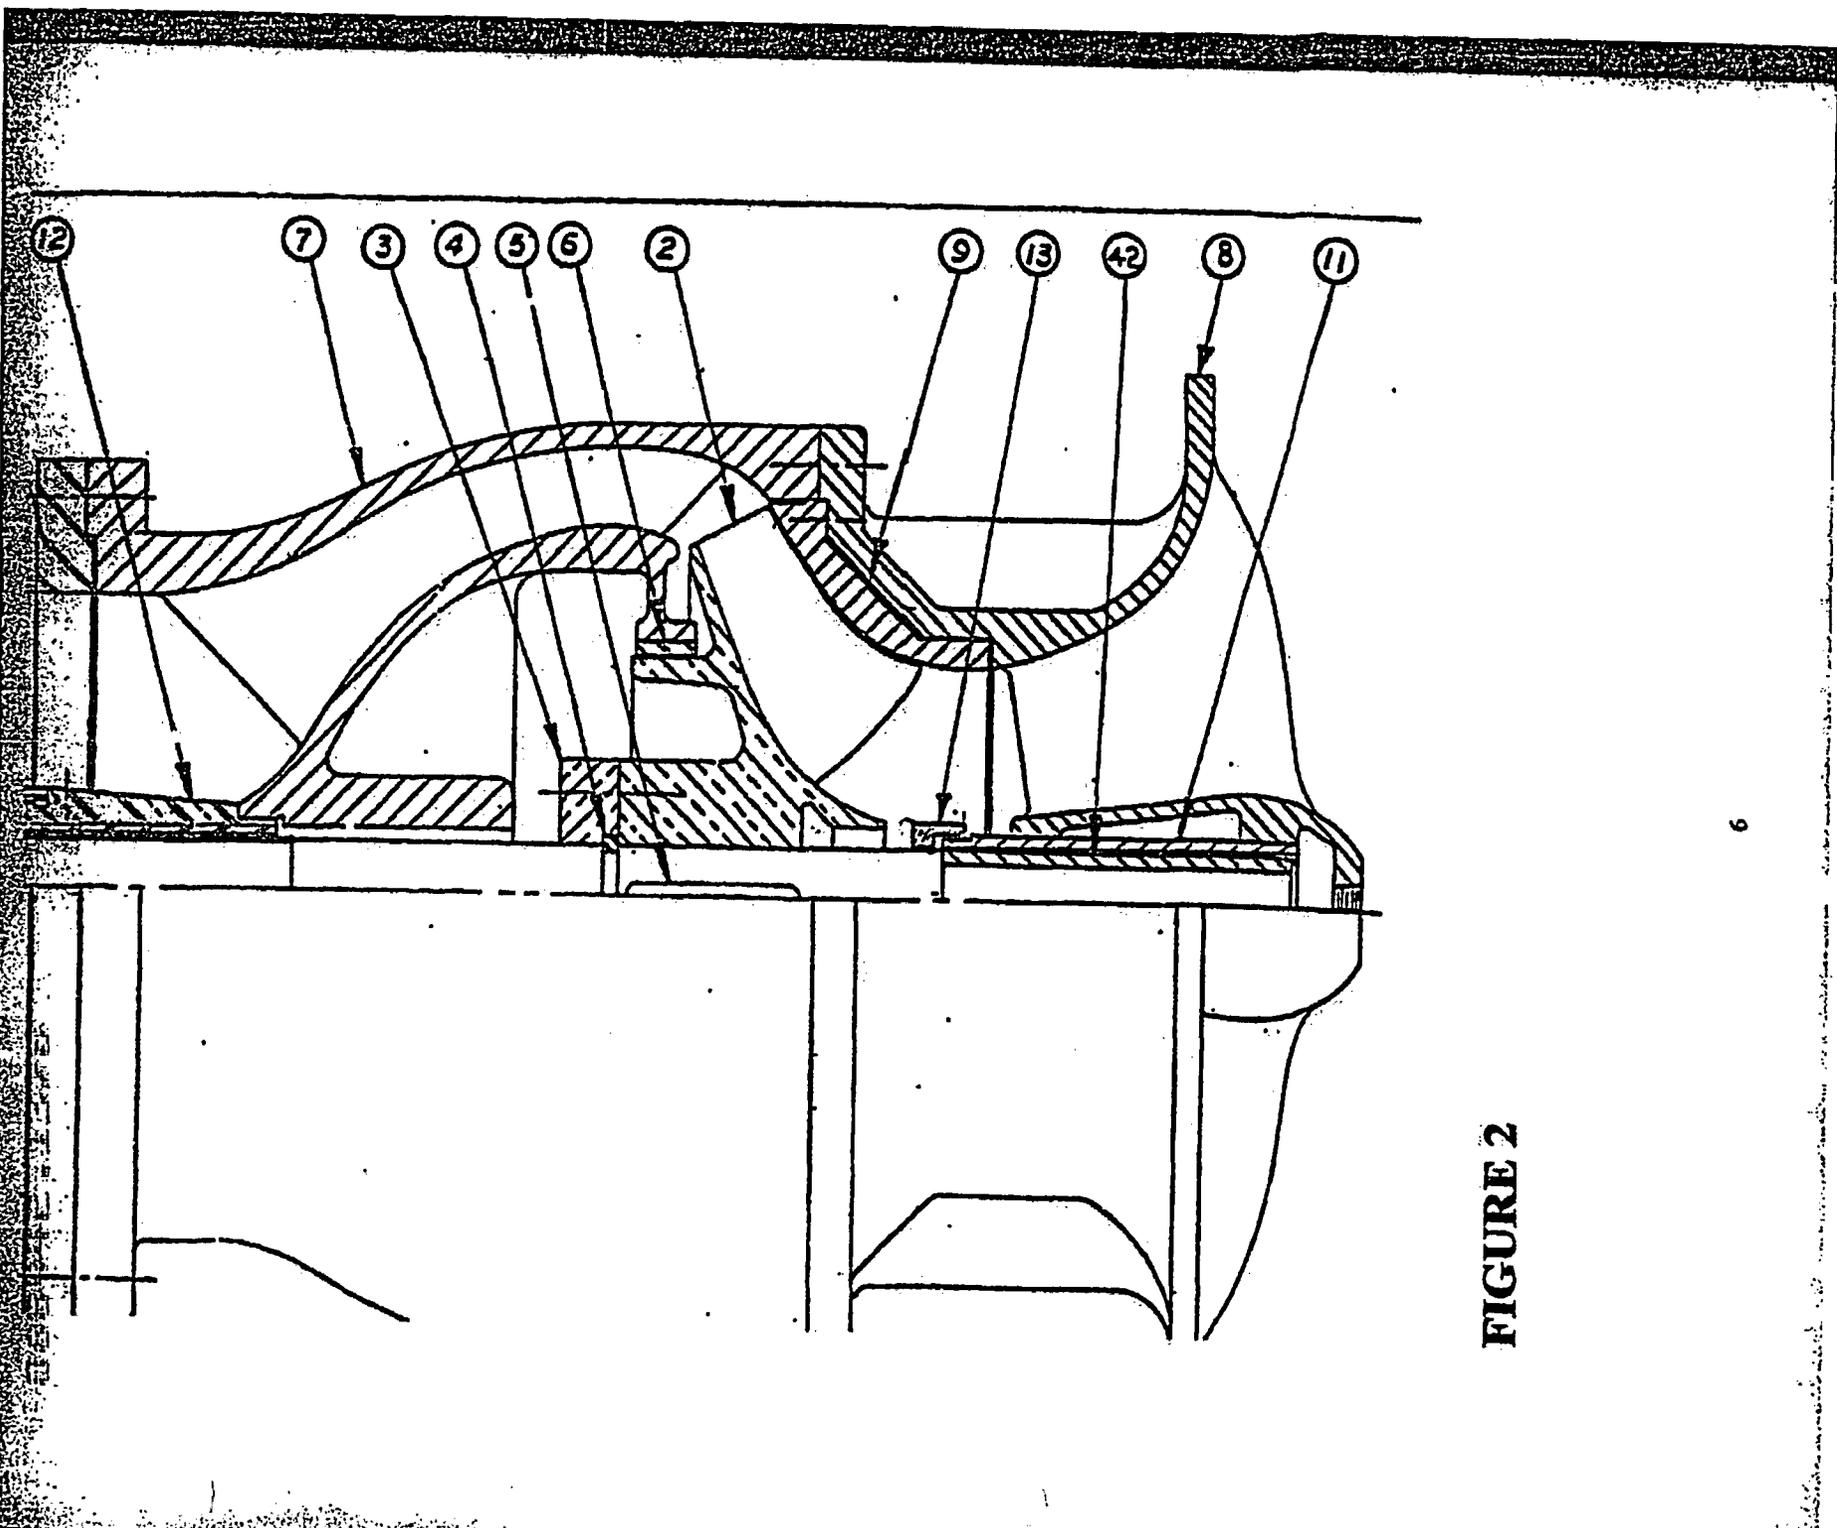
**FIGURE 2**

The SW pumps are also exposed to another phenomena that will cause the lift to change on these style of pumps. This is caused by different coefficients of thermal expansion of the impeller shaft and the pump outer column based on changes in the river water temperature. As the river warms up, the pump lift increases due to the shaft expanding at a lower rate than the column and as the river cools down the opposite occurs and pump lift decreases.

The gland water supply to the lineshaft bearings also plays a role. The temperature of the gland water in the inner column around the pump shaft causes additional thermal expansion and contraction effects because this water may be a different temperature than the pumped water. If the gland water is at a significantly different temperature than the pumped fluid, the thermal expansion and contraction effects can be large.

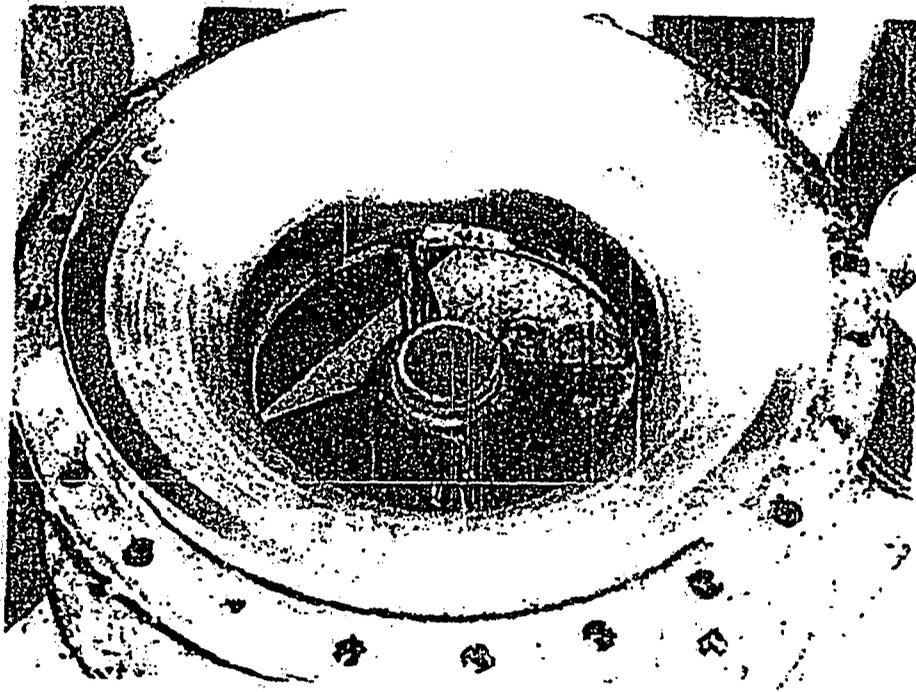
**The impeller and liner were disassembled, removed and examined. The liner and impeller were badly abraded, as shown in photographs 4 and 5. The liner had an especially deep phonograph type wear pattern caused by impingement of the impeller into the liner. This was caused by insufficient lift adjustment. Some of the marks on the**

liner appeared fresh. Roll over material abraded from the edges of the impeller blades was also razor sharp, which is an indication of having been recently made. Abrasions that have been present for some time in the liner or impeller tend to be "softened" and blunted by erosion of the suspended solids in the water.

Photograph 4. Phonograph abrasion pattern in liner.

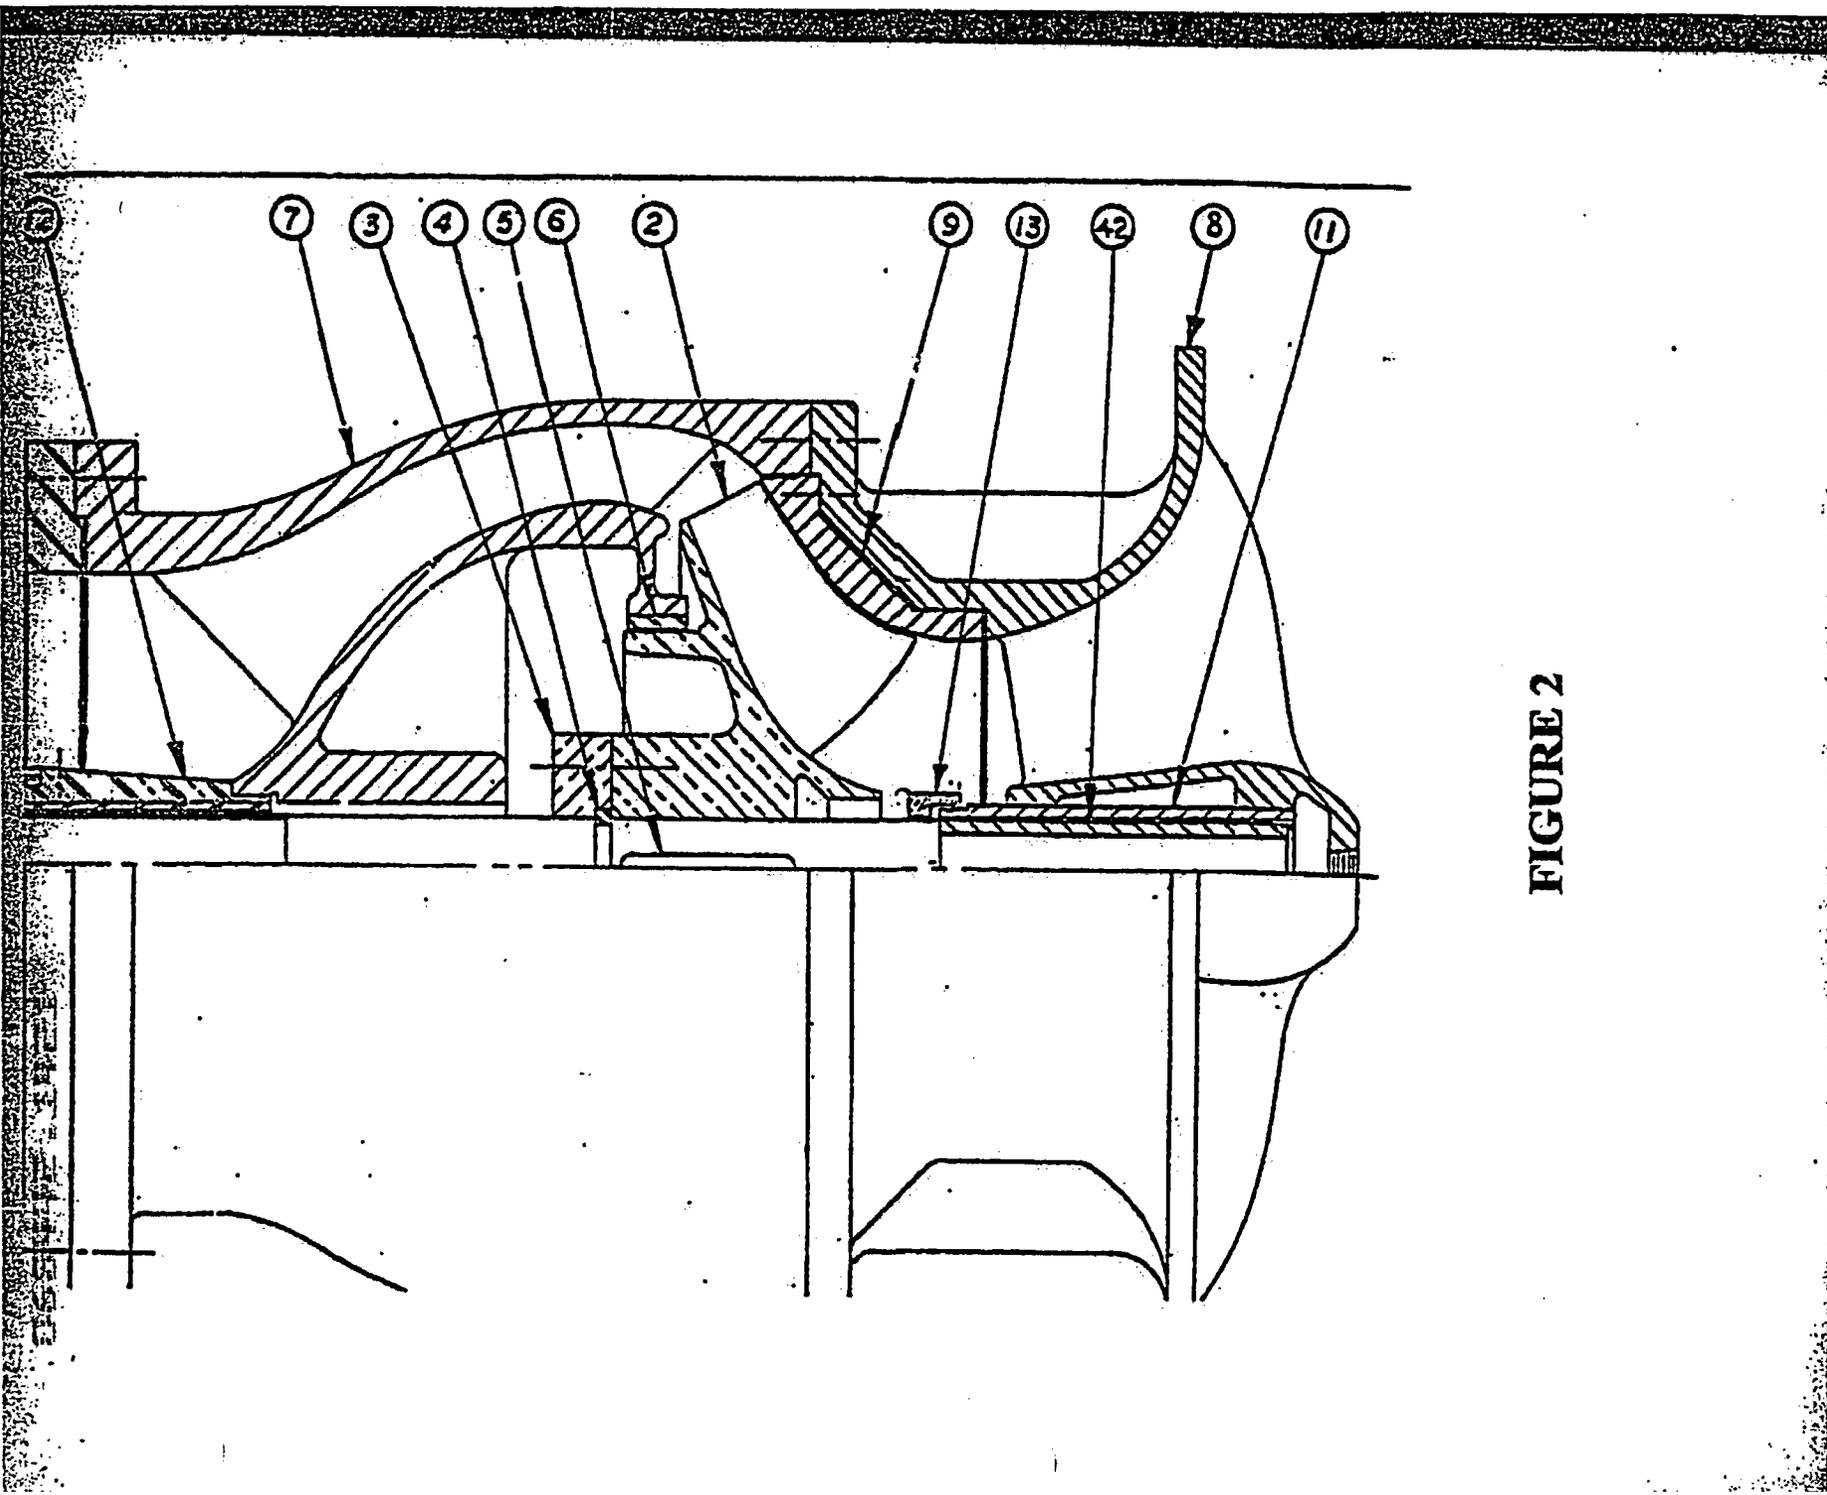
FIGURE 2

These pumps are also exposed to another phenomena that will cause the lift to change on these style of pumps. This is caused by differential expansion of the impeller shaft and the pump outer column based on changes in the river water temperature and riverwell water temperature. As the river warms up this creates the lift to increase due to the shaft expanding a lower rate than the column and as the river cools down vice versa. The riverwater supply to the lineshaft bearings also plays a role but to a lesser degree. Based on design river water temperatures of 32 deg F to 90 deg F, the lift can vary up to 0.060" due to thermal expansion

If the pumps were set at a lift of 0.021" and the shaft stretch is at least 0.030" from downthrust along when the pump is started, it can easily be seen that the impeller will contact the liner. This is not even taking into account the effects the river temperature changes have on the impeller and liner clearance area. Both of these materials (impeller and liner) are stainless steel and rubbing of these two materials together under high speeds (1180 rpm) will produce galling of the surfaces. This could lead to pump binding and/or shaft breakage.
