SUBJECT: COLUMBIA AREA SAMPLING PLAN

SAMPLING LOCATIONS
WESTINGHOUSE-COLUMBIA

WESTINGHOUSE
COLUMBIA PLANT

SUBJECT: URANIUM CONTAMINATION IN SOIL BELOW RECOVERY AREA FLOOR

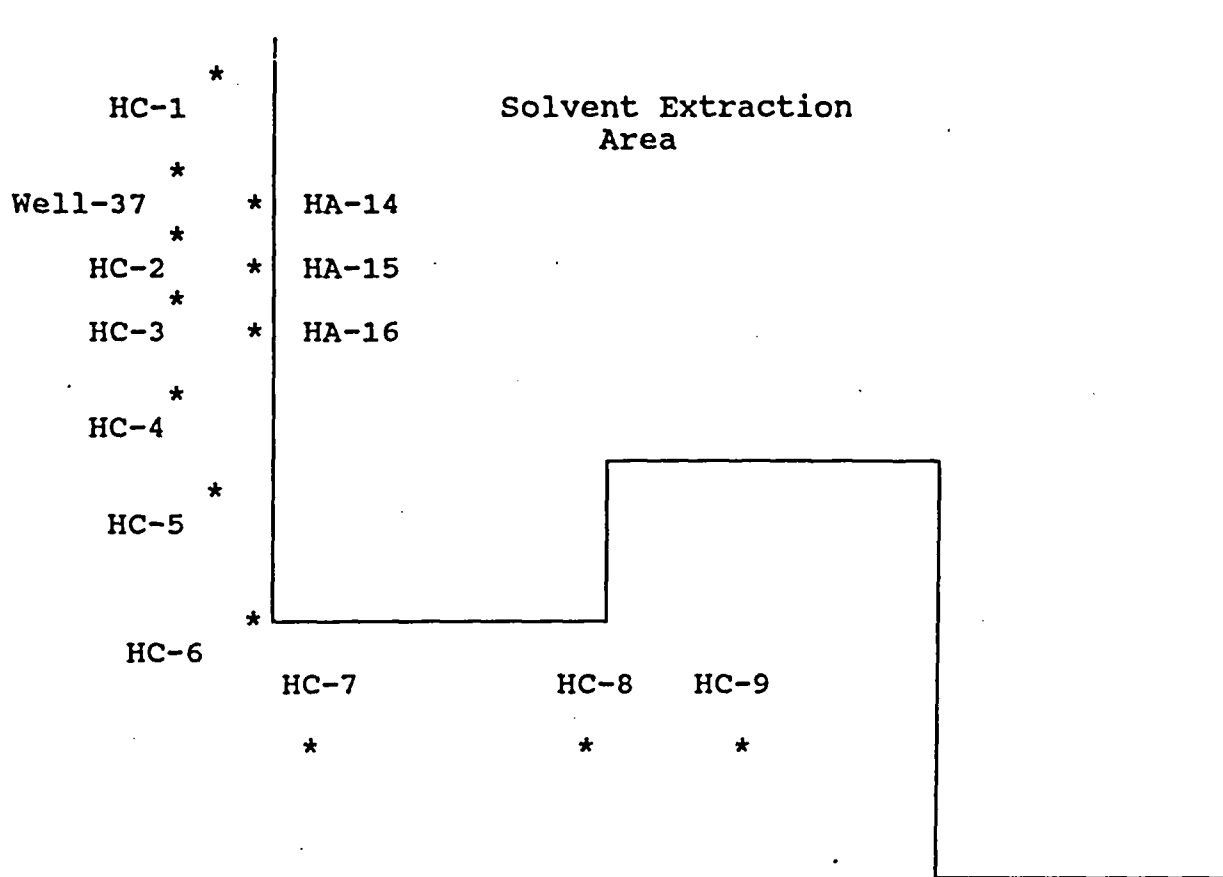
HC-"Hydrocone" sampling locations

Soil samples taken from these locations at depths of 3 ft, 6 ft, and 9 ft.

Water samples taken from these locations at depths of 10ft and 20 ft.

HA-Hand Auger sampling locations

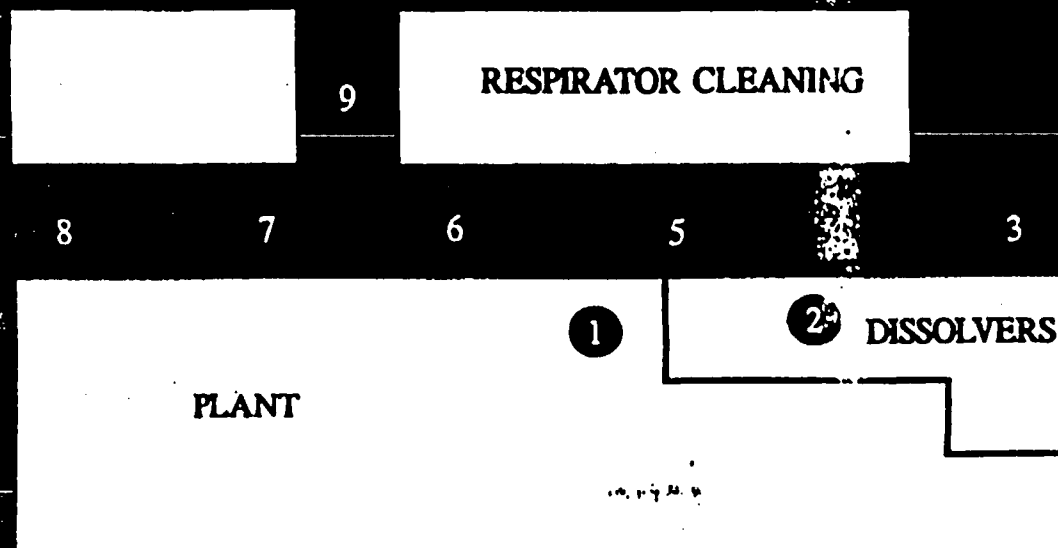
SAMPLE LOCATIONS WITHIN FACILITY

SOIL SAMPLING RESULTS

| SAMPLE NUMBER | SAMPLE ACTIVITY(PCI/GM) " VARIOUS DEPTHS(FT) | | | | | |
|---|---|---|---|---|---|---|
| 1 | 645 | 2068 | 2711 | 2584 | 2412 | — |
| 2 | 752 | 549 | 184 | — | — | — |
| 3 | 385 | 69 | 811 | 328 | 3 | — |
| 4 | 1962 | 1601 | 2045 | — | — | — |
