SUBJECT: COLUMBIA AREA SAMPLING PLAN

Enclosed please find a sampling plan for soil and water samples taken from an area near the Westinghouse-Columbia plant. Also enclosed is a copy of the presentation made to the NRC by Westinghouse which provided information regarding uranium contamination discovered beneath the floor of the processing area.

PRELIMINARY NOTIFICATION OF EVENT OR UNUSUAL OCCURRENCE PNO-11-92-01

SUBJECT: URANIUM CONTAMINATION IN SOIL BELOW RECOVERY AREA FLOOR

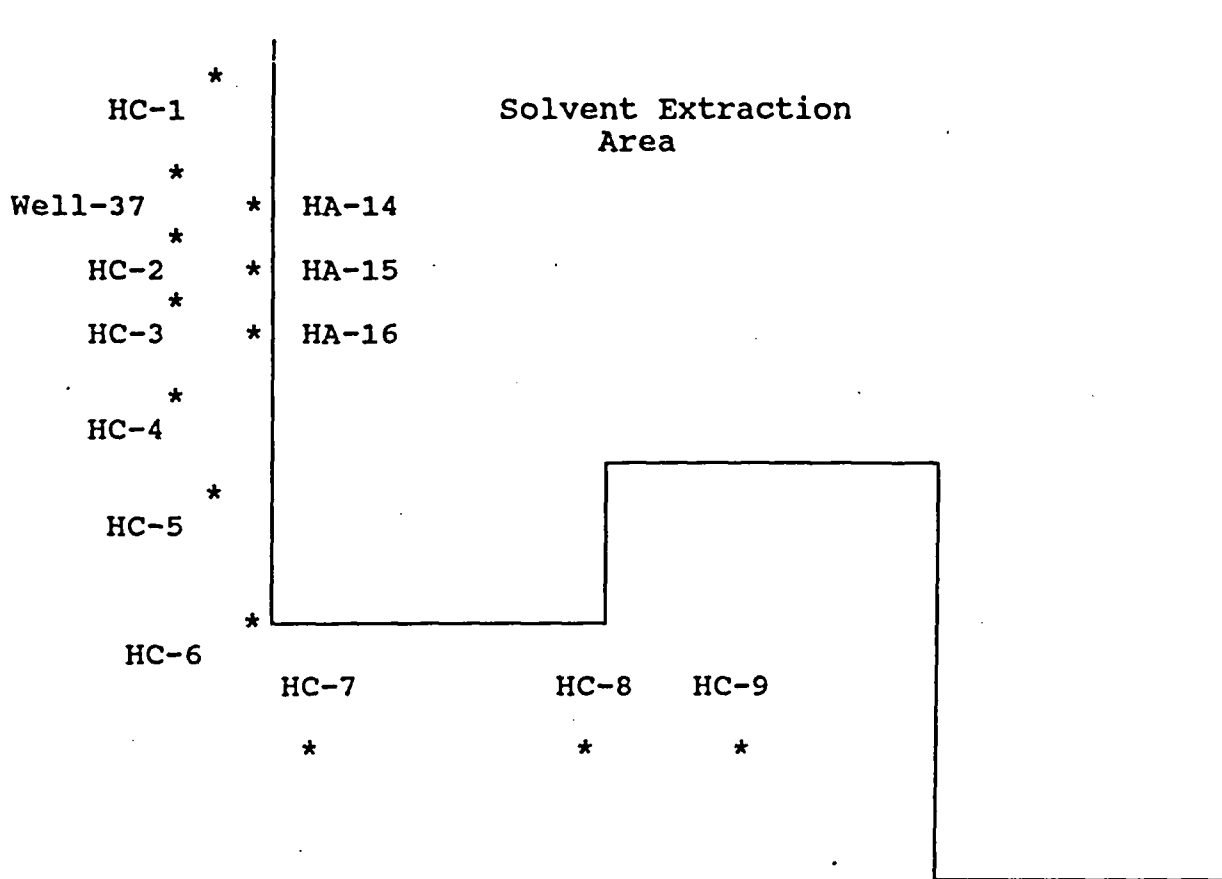
SAMPLING LOCATIONS
WESTINGHOUSE-COLUMBIA

HC-"Hydrocone" sampling locations

Soil samples taken from these locations at depths of 3 ft, 6 ft, and 9 ft.

Water samples taken from these locations at depths of 10ft and 20 ft.

HA-Hand Auger sampling locations

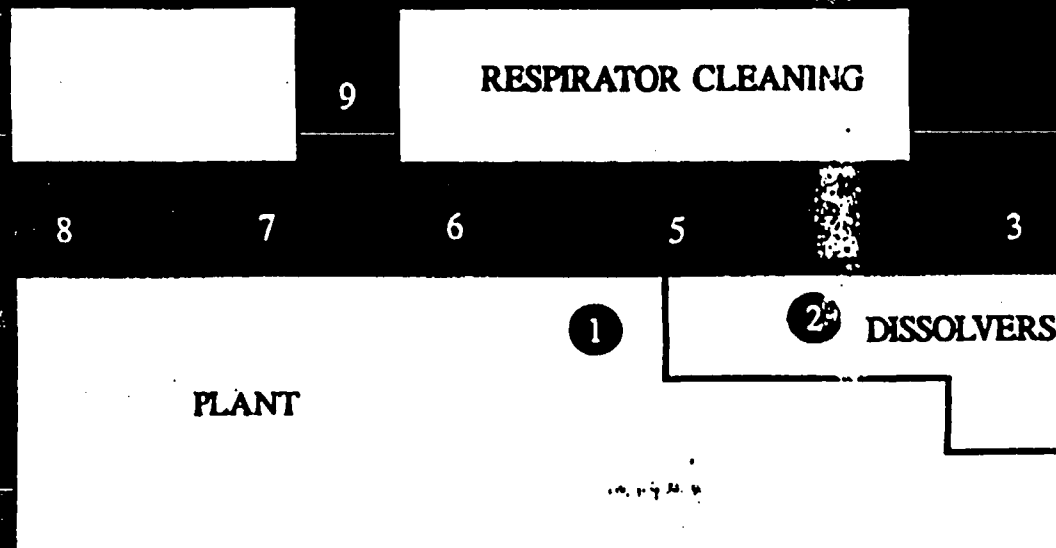
SAMPLE LOCATIONS WITHIN FACILITY

SOIL SAMPLING RESULTS

SAMPLE NUMBER	SAMPLE ACTIVITY(PCI/GM) @ VARIOUS DEPTHS(IN)						
	6"	12"	18"	24"	30"	36"	42"
1	203	195	311	328	193	213	326
2	434	631	831	776	737	956	828
3	2	1	—	—	—	—	—
4	314	141	—	—	—	—	—
5	9	2	3	—	—	—	—
6	2	2	—	—	—	—	—
7	12	3	—	—	—	—	—
8	30	41	—	—	—	—	—
9	4	3	5	3	—	—	—

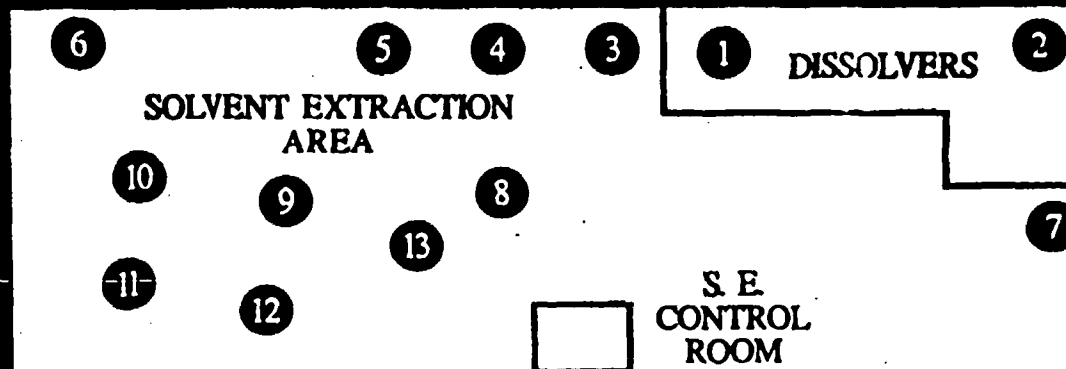
SAMPLE LOCATIONS WITHIN FACILITY

SOIL SAMPLING RESULTS

SAMPLE NUMBER	SAMPLE ACTIVITY(PCI/GM) @ VARIOUS DEPTHS(FT)					
	2'	4'	6'	8'	10'	12'
1	645	2068	2711	2584	2412	—
2	752	549	184	—	—	—
3	385	69	811	328	3	—
4	1962	1601	2045	—	—	—
5	44	11	—	—	—	—
6	3	5	—	—	—	—
7	208	8	—	—	—	—
8	9	10	5	4	6	2
9	3	5	—	—	—	—
10	24	5	—	—	—	—
11	24	27	11	34	3	—
12	16	5	3	3	2	—
13	252	183	—	—	—	—
