**FPL REPLY TO:**  
**STEAM GENERATOR TUBE INSPECTION DISCUSSION POINTS**  
**PREPARED BY THE OFFICE OF NUCLEAR REACTOR REGULATION**  
**FLORIDA POWER AND LIGHT COMPANY**  
**SAINT LUCIE NUCLEAR PLANT UNIT 2**  
**DOCKET NO. 50-389**

**Status of inspections as of 0800 on 5/5/06 for SL2-16.**

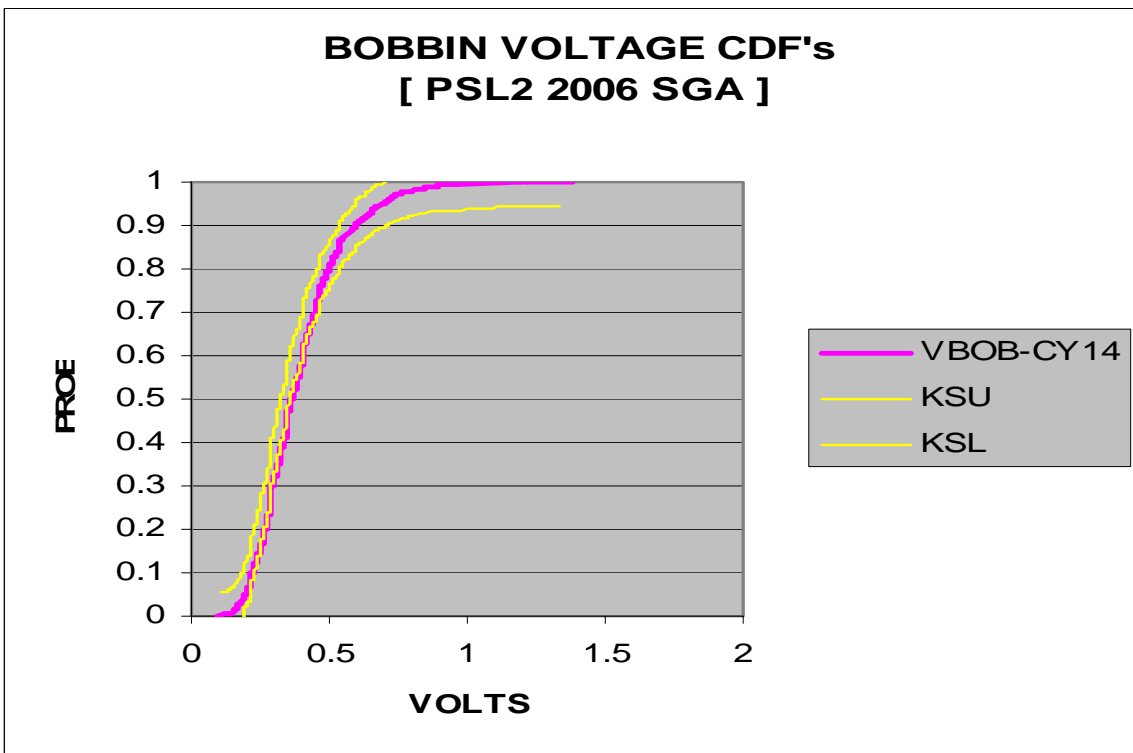
Figure 1 – CY 14 and CY-15 Bobbin Indication Voltages

Reply – The only unexpected results is that the number of indications observed in the SGs is lower than expected. The voltage, depth and length distributions are consistent with observations from prior inspections and within expectations (Refer to Figures 1-5).

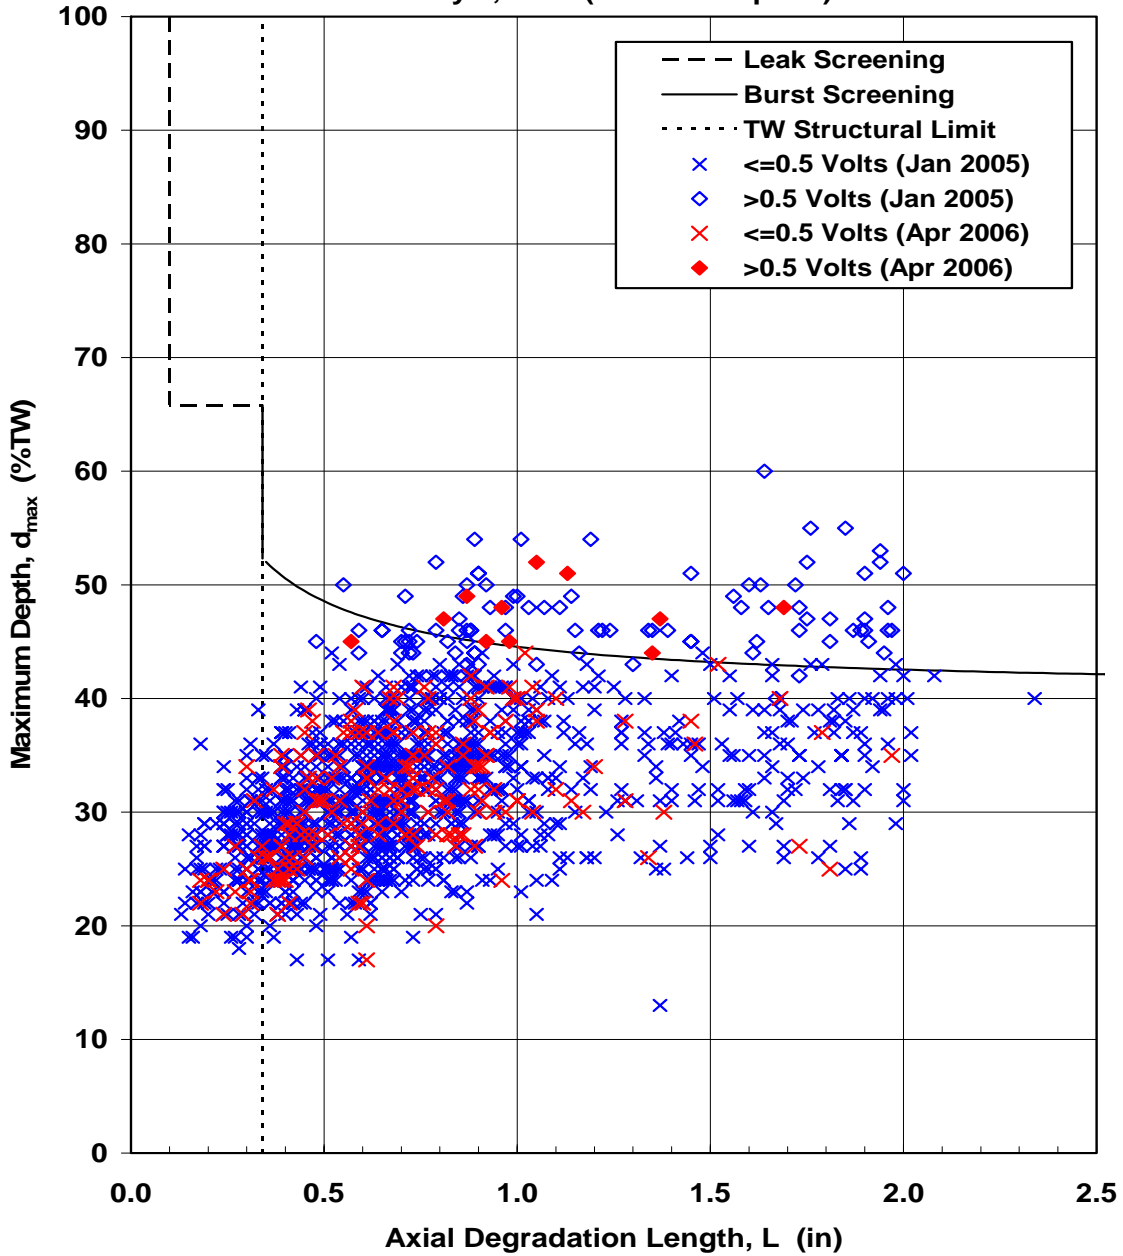
**Figure 5**

**PSL-2 SG B Axial ODSCC at Eggcrates & Diagonal Bars  
April 2006 vs January 2005 Inspection Data  
As of May 4, 2006 (22.8% Complete)**
