Subject: Duke Power Company LLC d/b/a Duke Energy Carolinas, LLC  
(Duke)  
Catawba Nuclear Station, Units 1 and 2  
Docket Nos. 50-413 and 50-414  
Licensee Event Report 413/06-001

Attached is Licensee Event Report 413/06-001 titled "Loss of Offsite Power Event Resulted in Reactor Trip of Both Catawba Units from 100% Power."

4. TITLE  
Loss of Offsite Power Event Resulted in Reactor Trip of Both Catawba Units from 100% Power

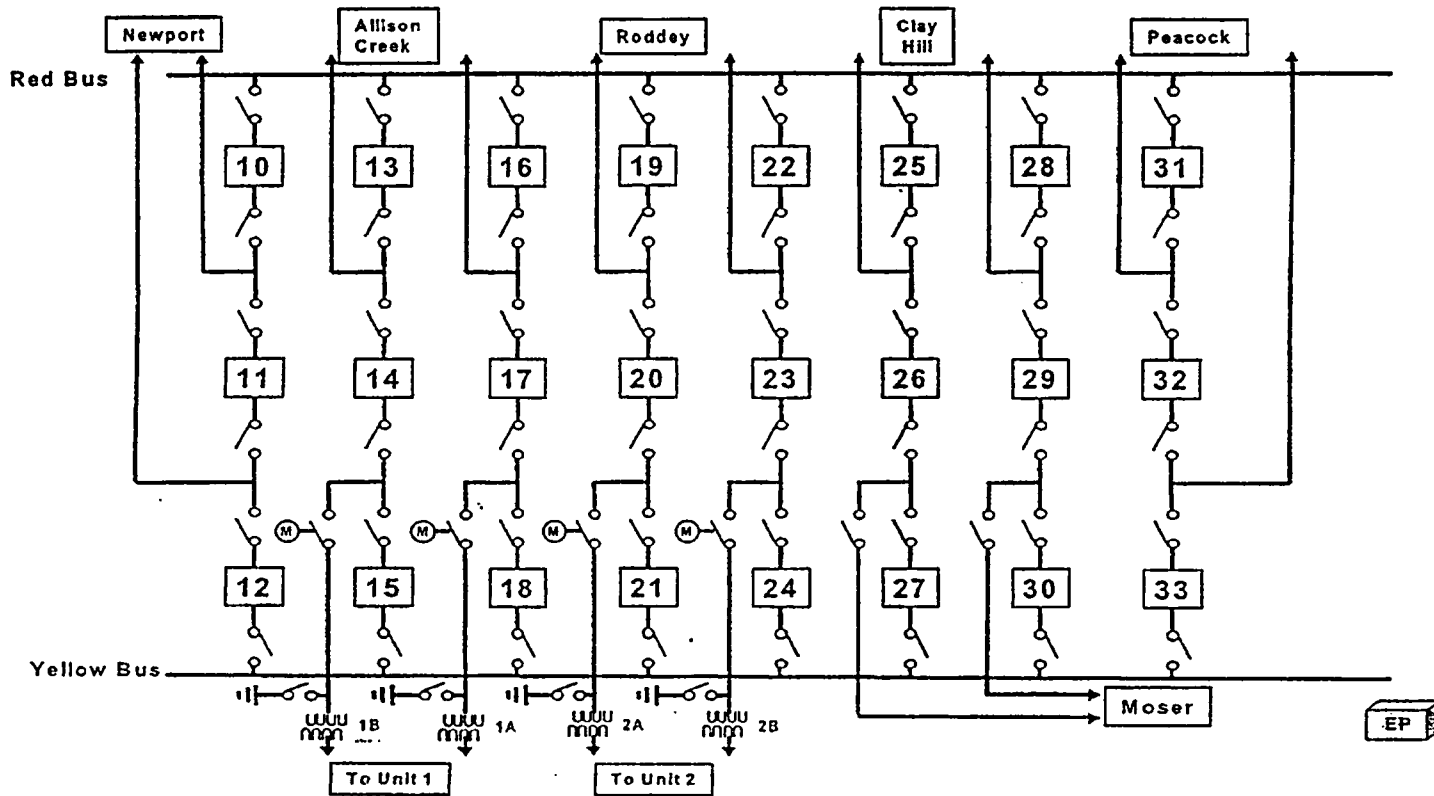
The Catawba 230kV switchyard [EIIS: FK] is designed in a breaker-and-a-half scheme which allows any one of the switchyard power circuit breakers (PCB) [EIIS: 52] to be isolated from the grid without deenergizing any transmission line or affecting the integrity of the switchyard. Six double-circuit transmission lines from the primary transmission system terminate in the switchyard. Additionally, each Catawba unit is tied to the 230kV switchyard by two separate and independent overhead lines. The entire switchyard, including the power circuit breakers, cabling system, ac and dc auxiliary power systems, protective relaying system, and control system is also divided into two power trains. Additionally, the incoming transmission lines are also assigned to power trains in such a way as to separate the associated cabling, protective relaying, and controls for each circuit of the double-circuit transmission lines into two distinct sources of offsite power. The Catawba 230kV switchyard design assures the independence of the redundant offsite power feeders to each nuclear unit. Refer to Figure 1 for a visual depiction of the Catawba 230kV switchyard and offsite power arrangement.

This event was initiated as a result of the PCB-18 current transformer "X" phase ground fault. The exact cause of the ground fault is still under investigation. In addition, while the event was in progress, the PCB-23 "Y" phase current transformer also failed, which contributed to the LOOP. The exact cause of this failure is also still under investigation. When the investigations are complete, Catawba will evaluate whether a supplement to this LER is necessary; if a supplement is warranted, it will be submitted to the NRC.

During the investigation of this event, it was discovered that the red bus differential relays were inadequately set, which resulted in the red bus tripping inappropriately. This, in conjunction with the PCB-18 current transformer "X" phase ground fault and the failure of the PCB-23 "Y" phase current transformer, caused all four bus lines from the two units to isolate. This resulted in the loss of all offsite power to the units. The root cause analysis for this event determined that in 1981, tap setting changes for the yellow and red bus differential protective relays to account for load growth were not implemented at Catawba. Power Delivery documentation was subsequently erroneously updated to indicate that the changes had been made.

1. The Emergency Response Organization directed the overall response to the LOOP event following the declaration of the NOUE.
2. Once all four essential busses were aligned to offsite power, the NOUE was terminated.
3. The red and yellow switchyard bus differential protective relays were adequately set and tested.
4. The PCB-18 "X" phase and PCB-23 "Y" phase current transformers were replaced.
