SUBJECT: PALO VERDE NUCLEAR GENERATING STATION, UNIT 3 - SUMMARY OF
CONFERENCE CALL REGARDING 2006 STEAM GENERATOR TUBE
INSPECTION RESULTS (TAC NO. MD1240)

SUMMARY OF CONFERENCE CALL

REGARDING 2006 STEAM GENERATOR TUBE INSPECTION RESULTS

PALO VERDE NUCLEAR GENERATING STATION, UNIT 3

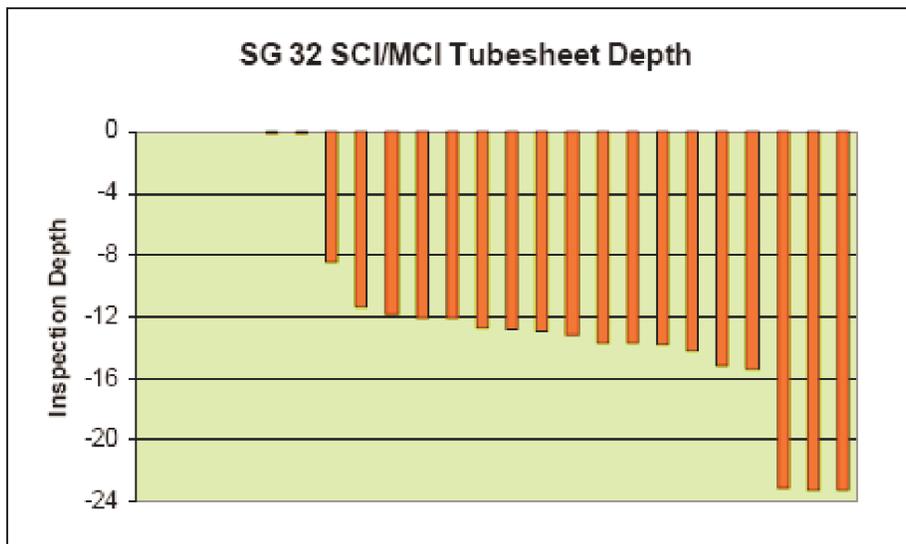
As indicated in the 3/29/06 call, additional analysis performed by Westinghouse to accommodate “first slip” resulted in a change to the minimum inspection depth to 12.6 inches below the Bottom of the Expansion Transition (BET). APS indicated an intention to change the minimum inspection depth to 13 inches. For U3R12, the inspection was conducted at a 14 inch depth to provide additional margin. As such, the acquisition and data management personnel verify that at least 14 inches of inspection length below the

BET is acquired. As a figure of merit, the average inspection depth (from TTS) is 15.31 inches in SG 31 and 15.41 inches in SG 32.

As reported previously, in general, tubesheet SCC is not a progressing damage mechanism. That is, most of the defects detected are outside previously inspected elevations. Additionally, in the case of SG 31, no circumferential SCC was found outside the tubesheet transition region. For SG 32, the distribution of circumferential SCC indicates that most of the detected flaws are beyond the inspection depth performed in U3R11 (i.e., 12 inches). See below.
