SUBJECT: PALO VERDE NUCLEAR GENERATING STATION, UNIT 3 - SUMMARY OF
CONFERENCE CALL REGARDING 2006 STEAM GENERATOR TUBE
INSPECTION RESULTS (TAC NO. MD1240)

SUMMARY OF CONFERENCE CALL

REGARDING 2006 STEAM GENERATOR TUBE INSPECTION RESULTS

PALO VERDE NUCLEAR GENERATING STATION, UNIT 3

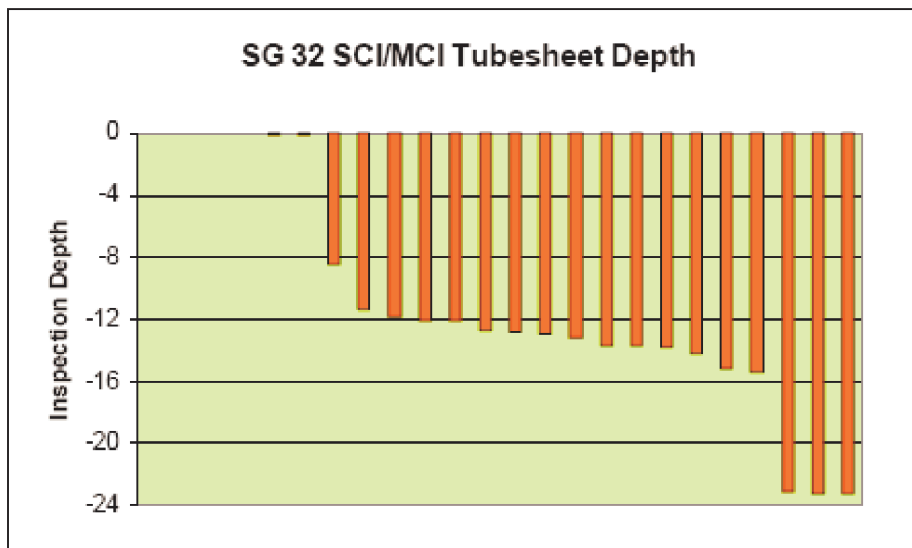
As reported previously, in general, tubesheet SCC is not a progressing damage mechanism. That is, most of the defects detected are outside previously inspected elevations. Additionally, in the case of SG 31, no circumferential SCC was found outside the tubesheet transition region. For SG 32, the distribution of circumferential SCC indicates that most of the detected flaws are beyond the inspection depth performed in U3R11 (i.e., 12 inches). See below.
