**UNITED STATES
NUCLEAR REGULATORY COMMISSION
REGION IV
611 RYAN PLAZA DRIVE, SUITE 400
ARLINGTON, TEXAS 76011-4005**

August 7, 2006

**SUBJECT: CALLAWAY PLANT - NRC INTEGRATED INSPECTION
REPORT 05000483/2006003**

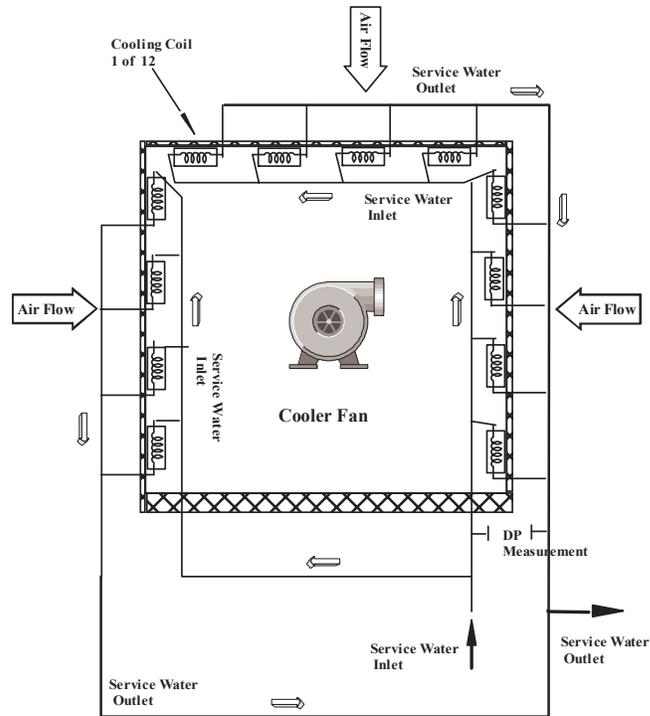
Figure 1
Containment Heat Exchanger

Description: The inspectors identified that AmerenUE had not adequately demonstrated, through performance, flow and differential pressure testing, that the containment heat exchangers would perform acceptably following installation. The Callaway Plant has two containment heat exchangers in each containment cooling train. Each train is required to remove 141×10^6 British thermal units per hour (BTU/hr) under accident conditions. AmerenUE performed containment heat exchanger replacements during Refuel Outages 11 and 12. Each new containment heat exchanger consisted of 12 parallel coils, 8 coils arranged across one service water supply header, and 4 coils across a second header (Figure 1). The postmodification testing requirements, established by Testing Requirements Determination Record 00-1018, Revision A, included:

The performance test used the Temperature Effectiveness Method to verify that the new containment heat exchangers were capable of removing the required postaccident heat load. The flow verification test used the Differential Pressure Method to verify the service water tube side was free of flow obstructions. The in-service test verified minimum service water flow was available for each containment heat exchanger. The inspectors identified that the performance test acceptance criteria was not met for two containment heat exchangers. Procedures ETP-GN-0001A and B established a minimum of 80 percent heat transfer effectiveness. The inspectors identified that the test conditions for the other two containment heat exchanger performance tests were not appropriate. In both cases the air leaving the containment heat exchangers was warmer than the air entering the containment heat exchangers. The absence of a heat load across the containment heat exchangers invalidated the test results. AmerenUE

Electric Power Research Institute Guideline NP-7552 established the testing methodology and requirements for the Temperature Effectiveness Method. Guideline NP-7552 required that the flow conditions during the test be within ± 5 percent of the accident flow conditions. The inspectors identified that AmerenUE performed all four performance tests with the heat exchanger fans passing 140,000 SCFM (standard cubic feet per minute) on the fin side. The fans are expected to operate at 67,000 SCFM during accident conditions. The inspectors also identified that service water flow on the tube side during each test was significantly less than the expected ESW accident flow rates. The inspectors concluded that the postmodification tests failed to demonstrate any of the four heat exchangers were capable of removing the required heat loads. AmerenUE entered the failure to perform the test under appropriate conditions in the corrective action program as CAR 200509450.

The inspectors identified that AmerenUE failed to establish acceptance criteria for the flow verification test. The flow verification test used the Differential Pressure Method to verify no tube side flow obstructions existed for the new heat exchangers. Plant engineers measured the pressure drop across the header that supplied 8 of the 12 coils. Figure 1 indicates the location where AmerenUE measured differential pressure. The measurement was performed at the same static head on all four new containment heat exchangers. The pressure drop test results, corrected for flow variances, ranged from 20 pounds per square inch differential (psid) to 31.4 psid. The expected value from the manufacturer was 14.5 psid. AmerenUE did not perform an evaluation to address why the test results varied between the newly installed coils or from the manufacturer's expected value. The inspectors identified that AmerenUE did not include differential pressure acceptance criteria into the postmodification test. AmerenUE entered the failures to perform an evaluation of the flow verification test results and provide test acceptance criteria into the corrective action program as CAR 200600012.
