NUREG/CR-5580
SAND90-1507
Vol. 2

Evaluation of Generic Issue 57: Effects of Fire Protection System Actuation on Safety-Related Equipment

Appendices A, B, and C

Sandia National Laboratories
Operated by
Sandia Corporation

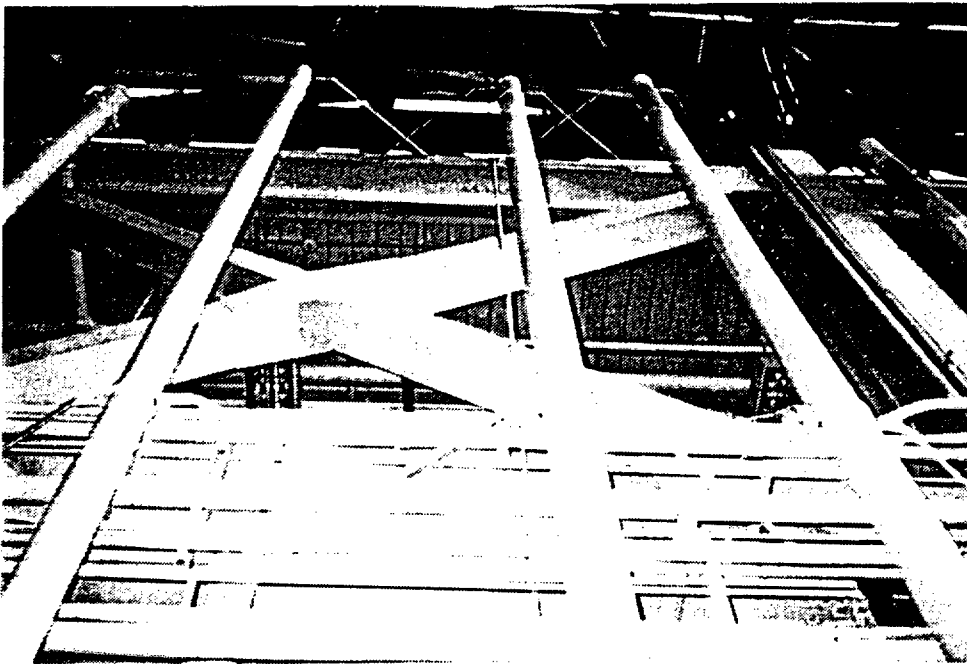
Figure 3.5. Lateral Restraints on Feed Line Risers at Alameda Naval Air Station

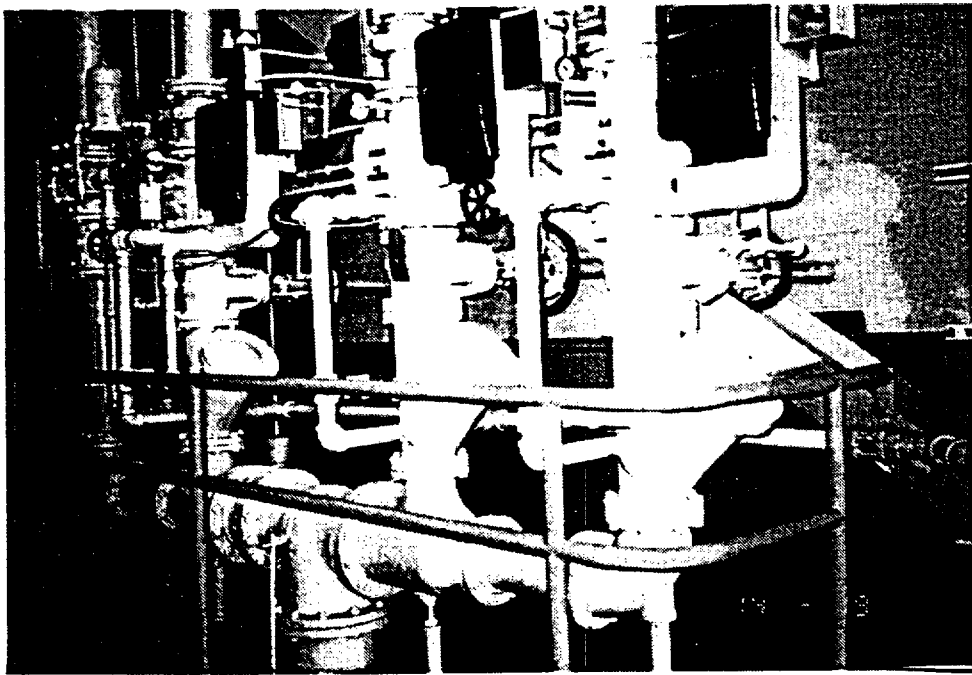
Figure 3.6. Deluge Valve Station at Alameda Naval Air Station

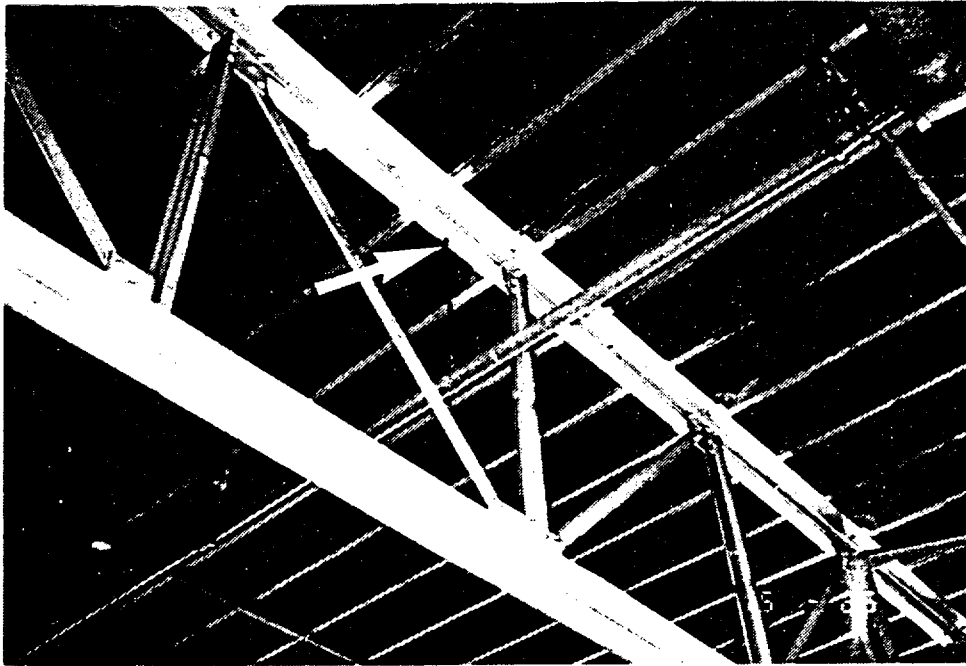
Figure 3.9. C-Clamp Support Used at Oakland Naval Supply Center

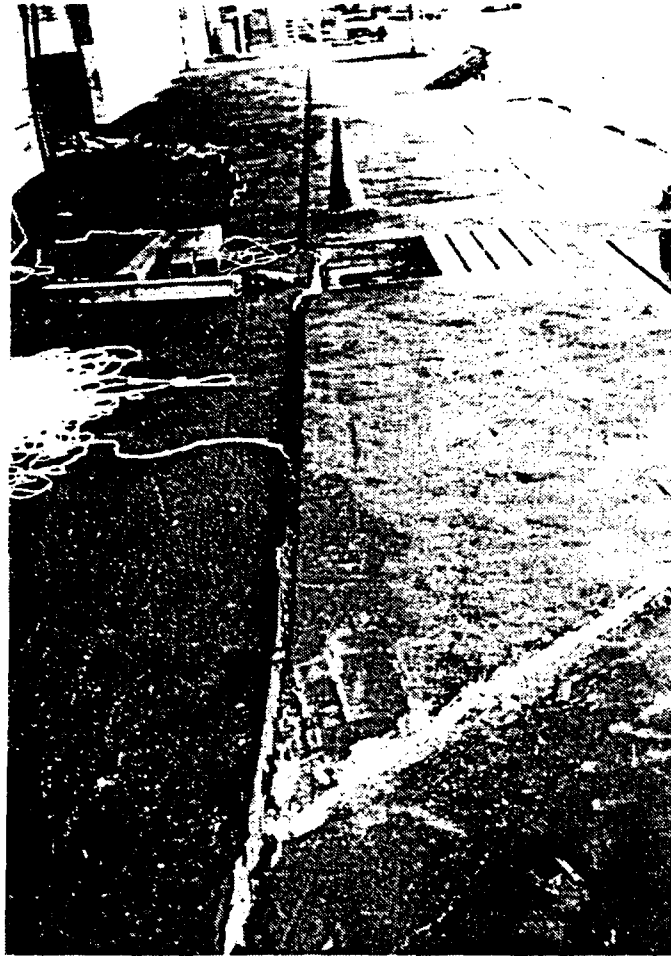
The building is founded on piles driven into the harbor and sits over water. The building rests partially on shore on two adjacent sides. The piles settled during the earthquake and caused the building to pull away from the shore by two to three inches in one direction and approximately one inch in the other direction (Figure 3.12).

Figure 3.12. Settlement at Port of Oakland Warehouse Caused Building to Pull Away From Shore

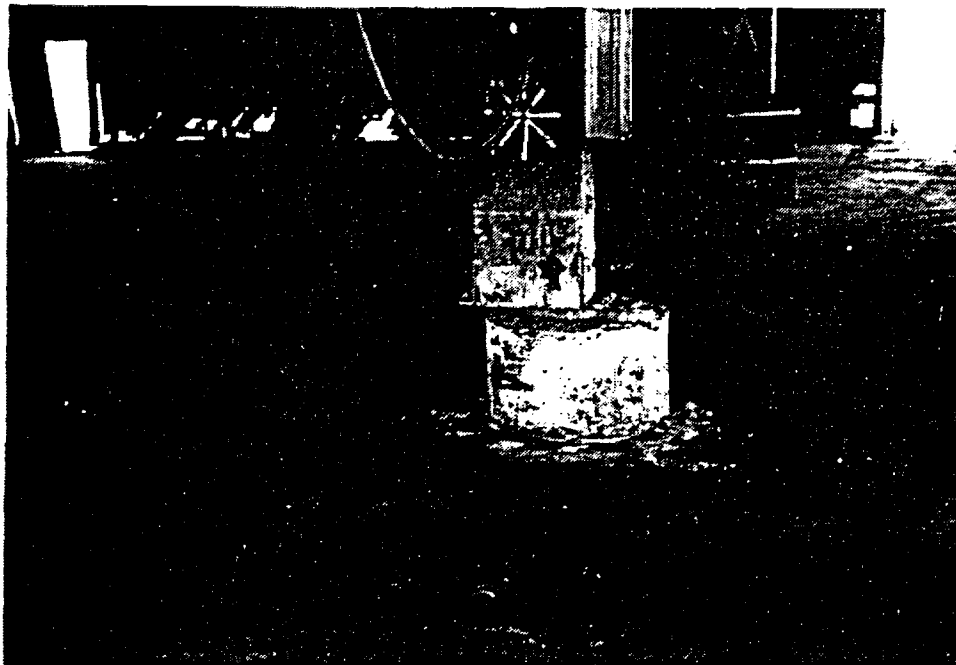
Figure 3.14. Displaced Column at Port of Oakland Wood-Frame Warehouse.
Building is scheduled for demolition.

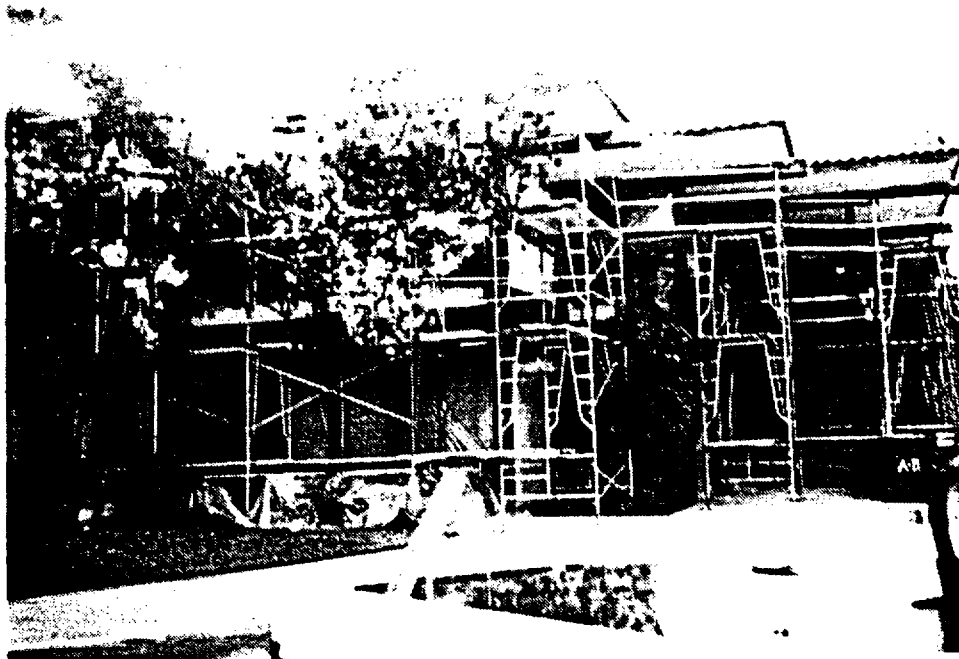
Figure 3.15. Lockheed's Palo Alto Building Experienced Structural Damage in Addition to 6-Inch Diameter Threaded Elbow Failure

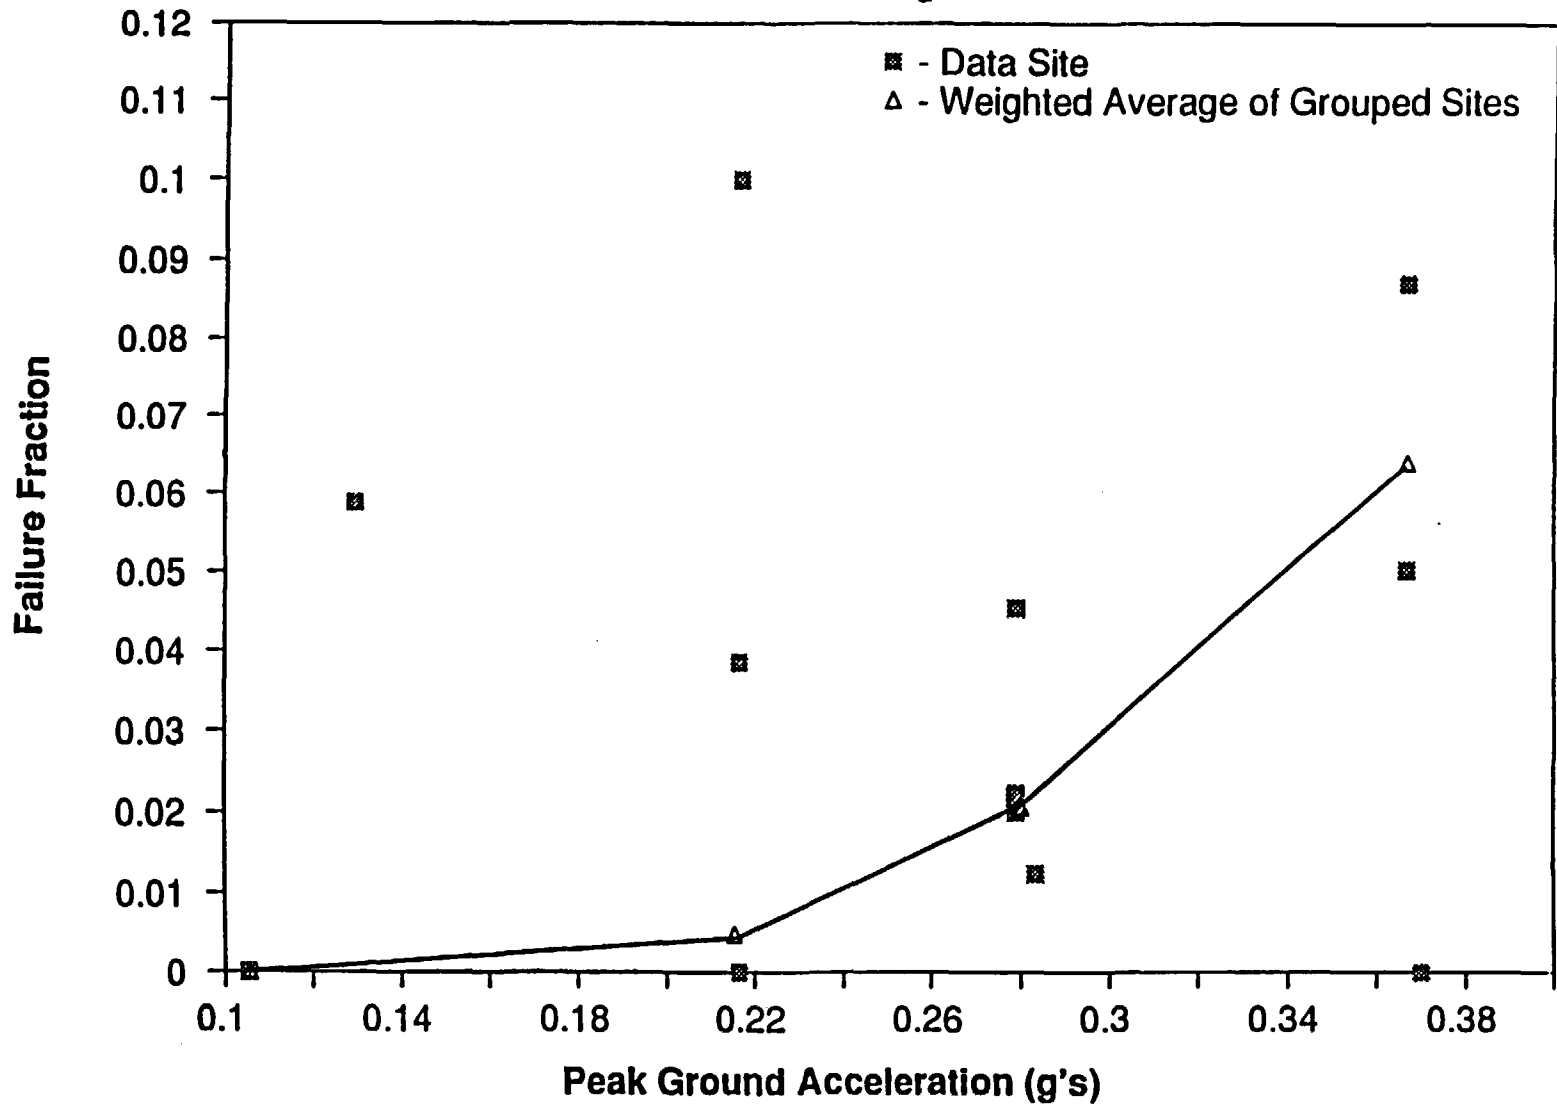
Figure 4.7. Loma Prieta Fire Protection Piping Correlation of Damage to PGA
