August 28, 2006

MEMORANDUM TO: Jared S. Wermiel, Deputy Director
Division of Safety Systems

FROM: Michael L. Scott, Chief */RA/*
Safety Issues Resolution Branch
Division of Safety Systems

SUBJECT: STAFF OBSERVATIONS OF STRAINER INSTALLATION DURING
MAY 12, 2006, TRIP TO INDIAN POINT 2

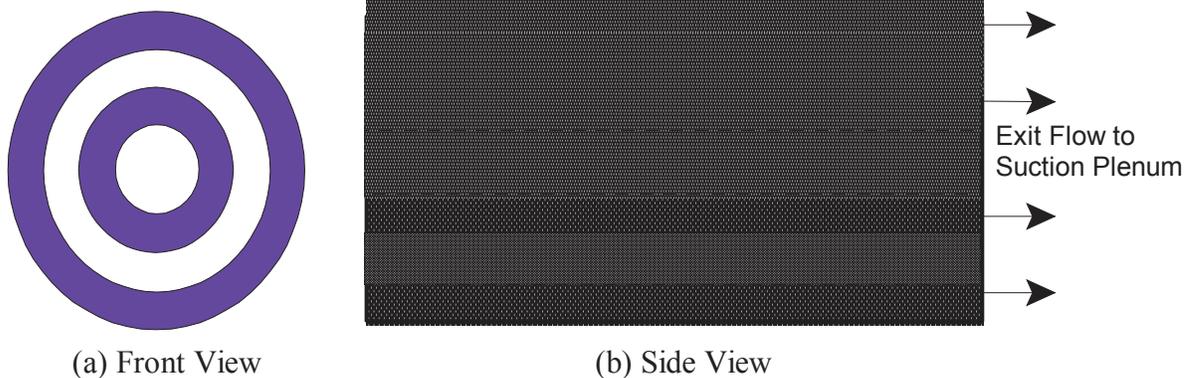
Figure 1: Double Top-Hat Strainer Module (not to scale)

On the front view, the shaded annular areas represent solid metal plate surface, and the white annular areas represent the interstitial volumes of the strainer. On the side view, the darker rectangular areas represent perforated plate surface, and the lighter rectangular areas represent internal interstitial volumes. Perforated strainer area exists on the outer cylindrical surface of the top hat module, as well as on the three inner cylindrical surfaces. Each double top-hat strainer module can accommodate two downstream filters, one inside each annular internal volume (i.e., inside the volumes represented by the dark shaded areas in the above diagram). Vendor personnel indicated that the IPP2 strainer perforations will be 3/32 inch in diameter.
