RE: St. Lucie Unit 2
Docket No. 50-389
NRC Order EA-03-009 – Reactor Vessel Head and
Vessel Head Penetration Nozzle Inspection Results SL2-16

**FIRST REVISED NRC ORDER EA-03-009:
REACTOR PRESSURE VESSEL HEAD AND VESSEL HEAD
PENETRATION NOZZLE POST REFUELING OUTAGE INSPECTION RESULTS
FOR ST. LUCIE UNIT 2 – Spring 2006**

St. Lucie Unit 2 Spring 2006 (SL2-16) Post Outage Reactor Vessel Upper Head Inspection Results:

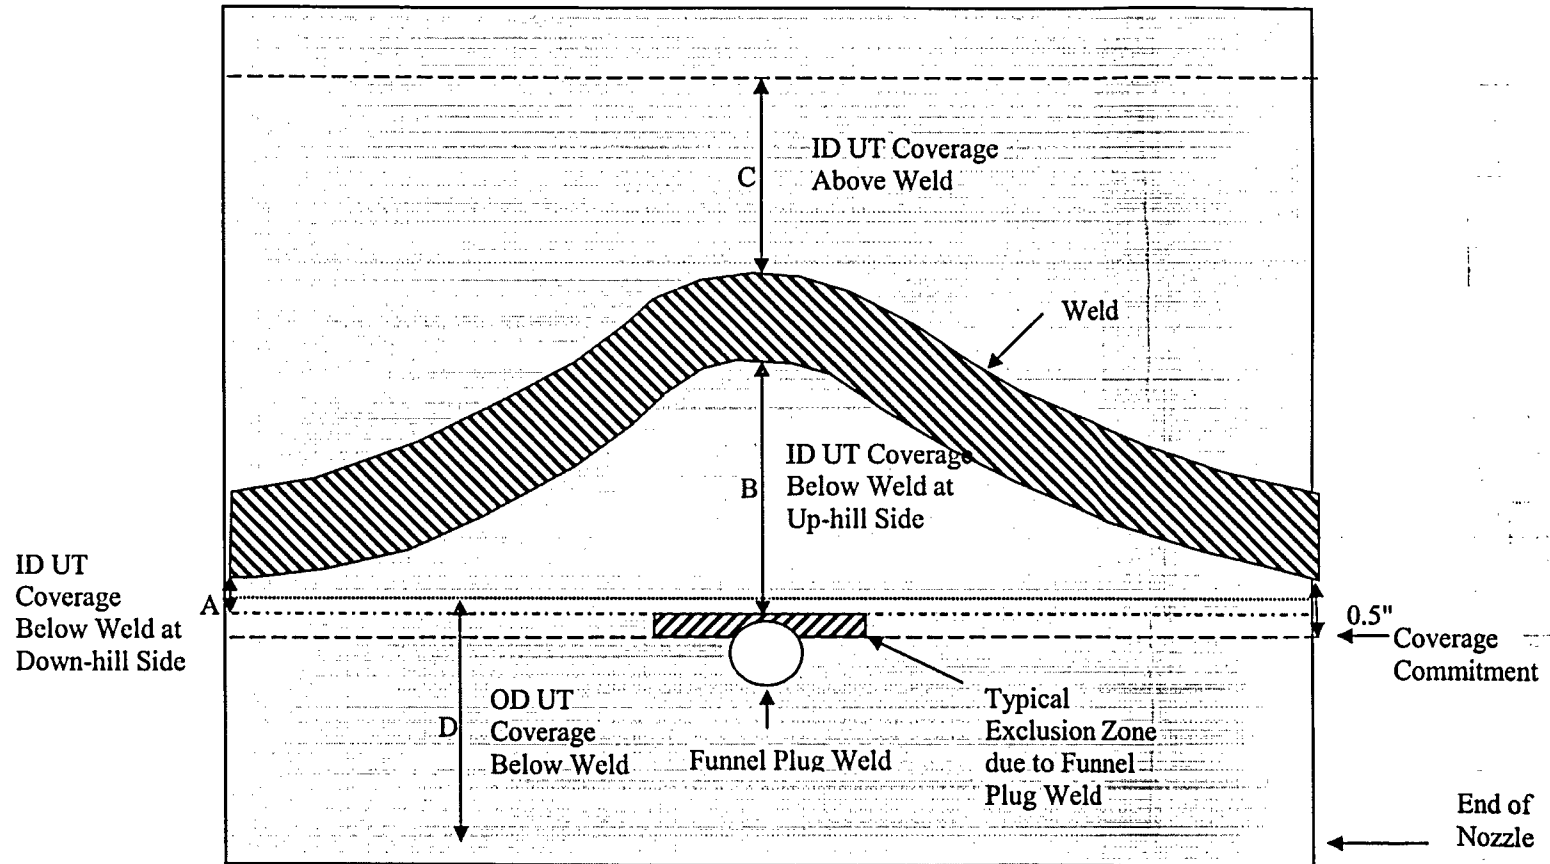
Figure 1: St. Lucie 2 CEDM Examination Coverage Parameters

Supplemental OD NDE was required on 17 CEDM nozzles to obtain the required examination area of 0.50 inches below the weld. The OD NDE method included UT and manual dye penetrant (PT). A limitation was experienced on 15 CEDM nozzles, where the OD UT was utilized to extend the coverage below the weld toe. These limitations were caused by lift off at the funnel plug weld on the high hillside of the nozzle. The small lift off limitations were ≥ 3.80 inches below the weld toe. The supplemental OD NDE (UT and PT) did not reveal any relevant indications. The details of the ID coverage, supplemental OD coverage, and limitations associated with the funnel plug weld are described in Tables 1 and 2 and Figure 1.
