RS-06-088

U. S. Nuclear Regulatory Commission
ATTN: Document Control Desk
Washington, DC 20555-0001**Braidwood Station, Units 1 and 2**
Facility Operating License Nos. NPF-72 and NPF-77
NRC Docket Nos. STN 50-456 and STN 50-457**Byron Station, Units 1 and 2**
Facility Operating License Nos. NPF-37 and NPF-66
NRC Docket Nos. STN 50-454 and STN 50-455**Subject: Requested Information Concerning Pressurizer Heater Sleeve Flaw at Braidwood Station**

Subject: **Metallurgical Evaluations of a Leak in the #52 Heater Assembly on the
Braidwood Unit 1 Pressurizer**

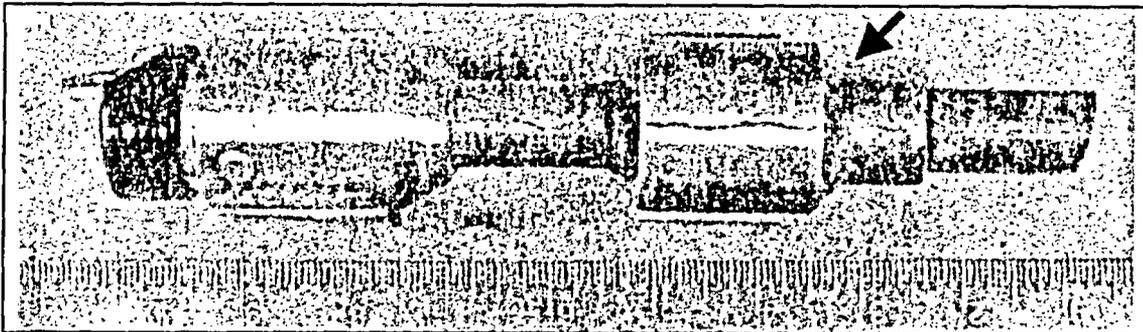
Figure 2 – Sample 1 from the #52 heater. The arrow points to the socket weld that connected the pressure tube to the coupling.

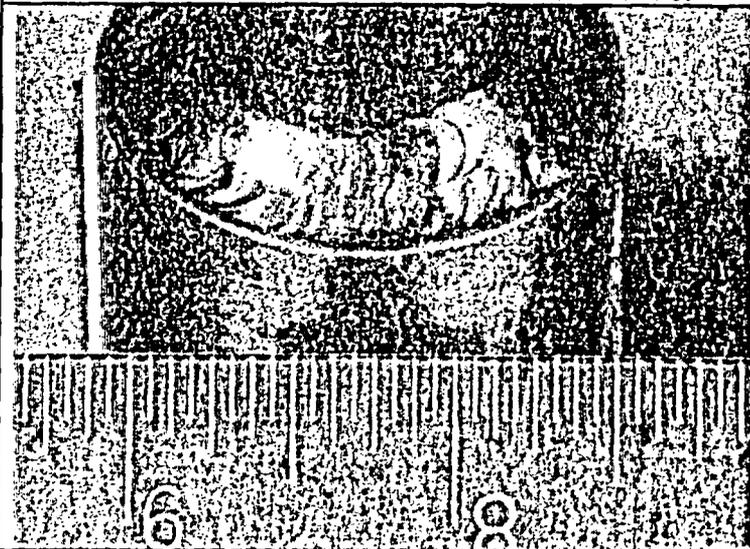
The external surfaces of the heater sheath, coupling, coupling welds and pressure tube were in generally good condition. The welds exhibited local regions of grinding/polishing (Figures 4-7). The final weld quality and weld profiles were relatively good, although there was a minor geometry change at a weld pass stop point near the 135° position. The fillet legs exceeded the 0.19" design minimum at all locations. No cracking was observed.

Figure 4 – A macro-photo of the upper coupling weld as looking toward the 0 degree side. The weld was fabricated using multiple passes. There was evidence of local grinding on the surface of the weld.

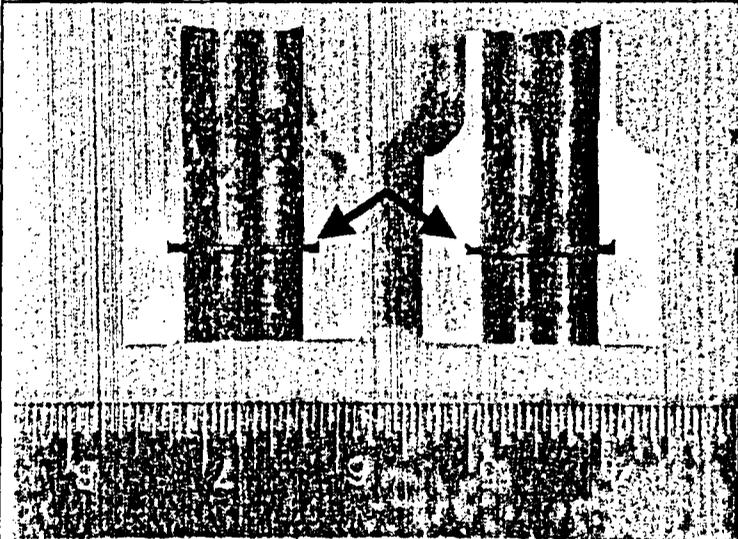
Figure 12 - A photo showing the inner surface of the sample 1 coupling and pressure tube after axial sectioning. The arrows point to the gap near the bottom of the socket connection.

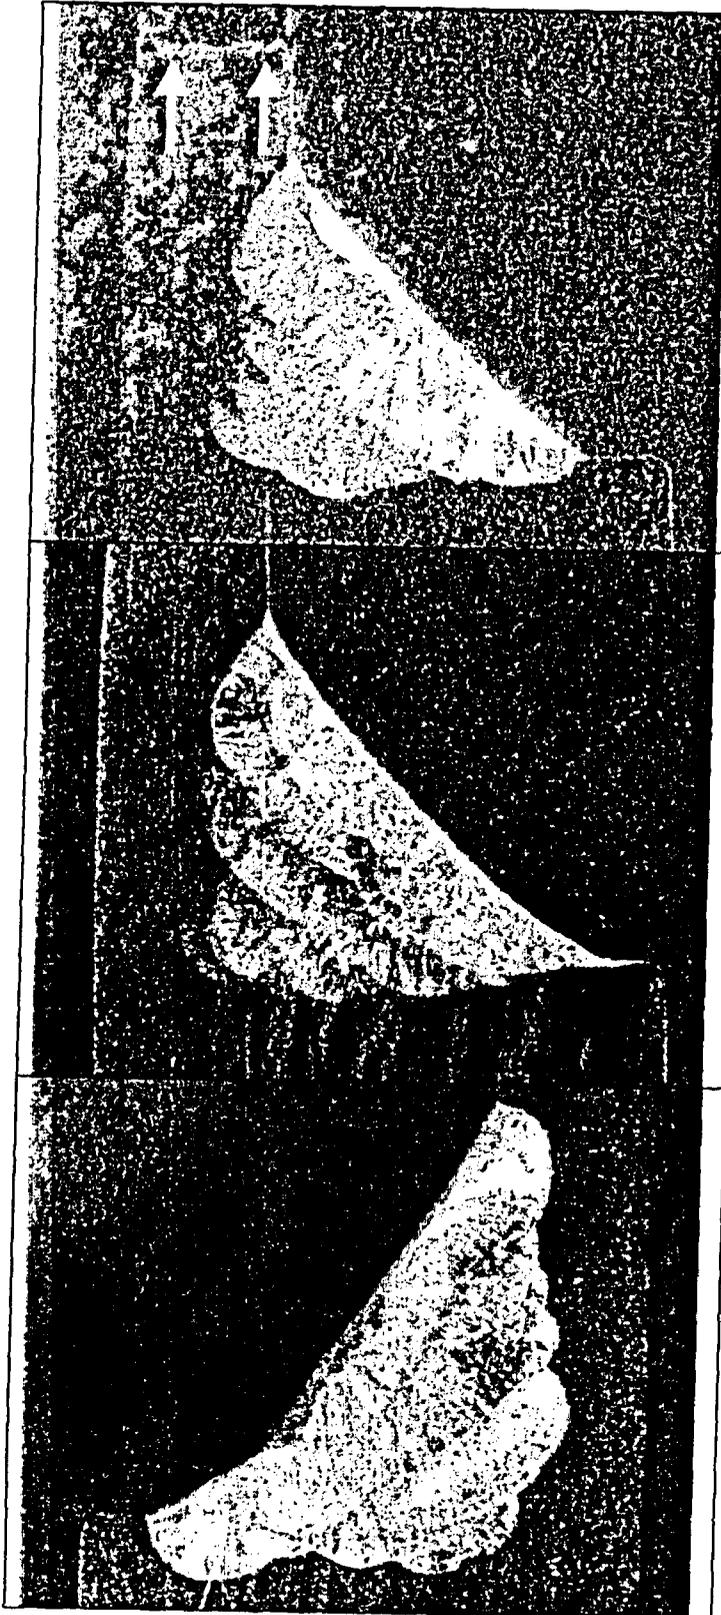
Macro-etching revealed the coupling to pressure tube socket weld was fabricated using 5 or more passes (Figures 16-18). The tube side fillet legs measured 0.2" to 0.32" long and the coupling side legs measured 0.22" to 0.26" long. In general the shortest leg lengths were located near 110° (leak) position. All the leg lengths met the 0.19" minimum design length. All the weld sections exhibited good penetration at the root and relatively deep penetration into both base metal components. The pressure tube wall thickness measured 0.108" near the thru wall leak and up to 0.113" in the other evaluated sections.

Figure 16 - A macro-etched photo of an axial section thru the upper weld at the 110 degree orientation. Note the thru wall crack in the tube wall near the upper left side of the photo (arrows). Based on the etching pattern, the weld was fabricated with 5 passes. The tube side fillet leg measured 0.2" long and the coupling side leg measured approximately 0.22" long.

Figure 17 - A macro-etched view of an axial section thru the upper coupling weld at the 270 degree position. Note the multiple weld passes. At this location, the fillet leg lengths measured approximately 0.25" long.

Figure 18 - A macro-etched section thru the 40 degree position. The tube side leg in this section measured 0.32" long.

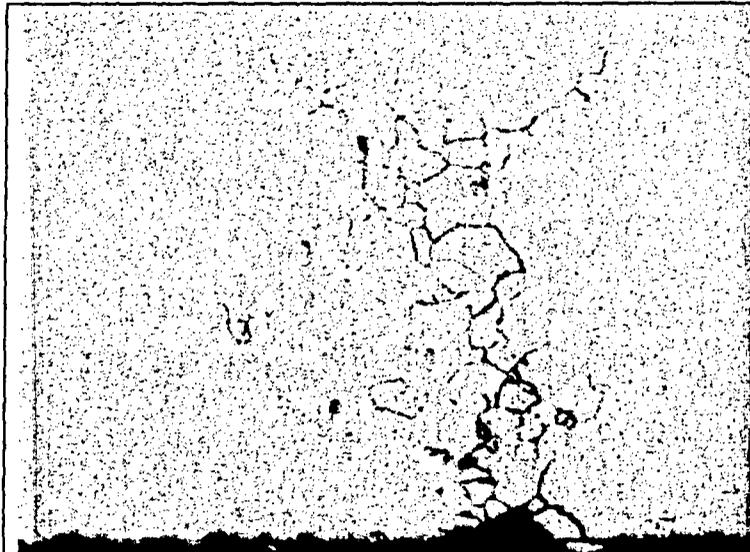
Figure 19 – An un-etched view of cracking in an axial metallurgical section thru the 40 degree location.

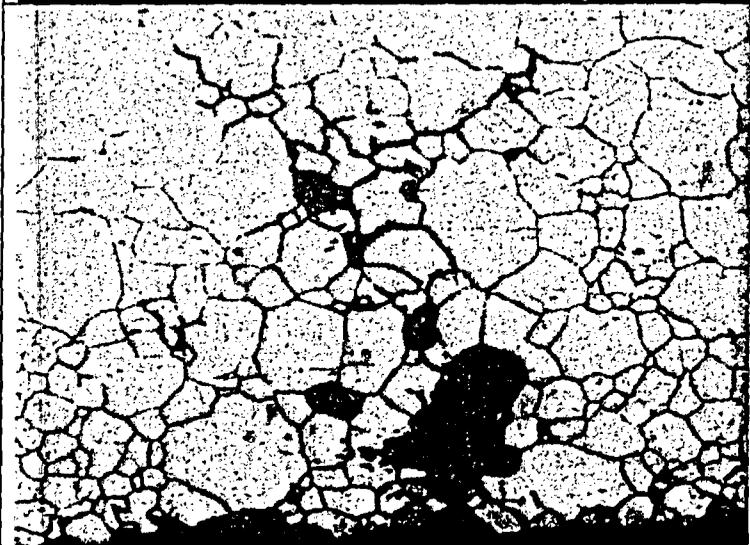
Figure 20 - An etched view of the Figure 19 crack region. All the cracking was intergranular. The heavy grain boundary etching and grain fallout is typical of a sensitized microstructure.

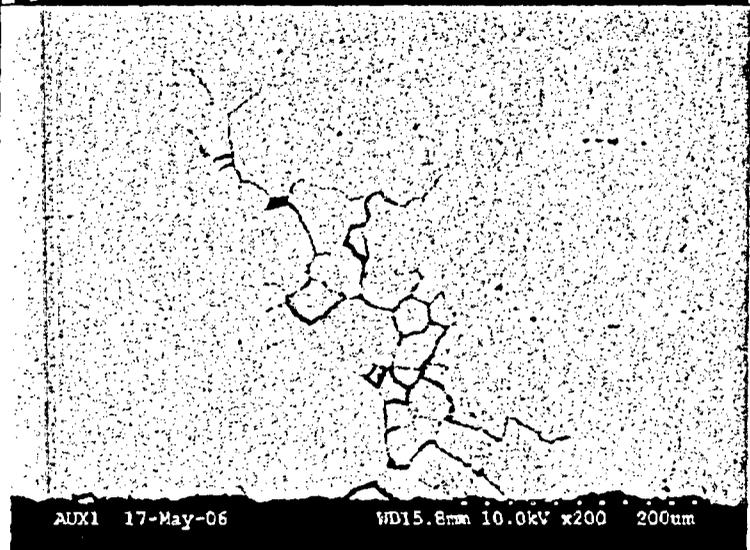
1. All evaluated sections contained branched, intergranular cracks that initiated from the internal surface of the pressure tube (Figures 19, 20 and 21). The cracks were located in the heat-affected zone for the upper coupling weld. At some locations, multiple cracks were present in the evaluated section (Figure 22). No transgranular features were observed. There was no cracking in the coupling or weld.

Figure 21 – A backscatter SEM photo of the 270 degree metallographic section. The branched, intergranular cracking measured 0.015” deep. The cracking initiated from the inner surface of the tube.

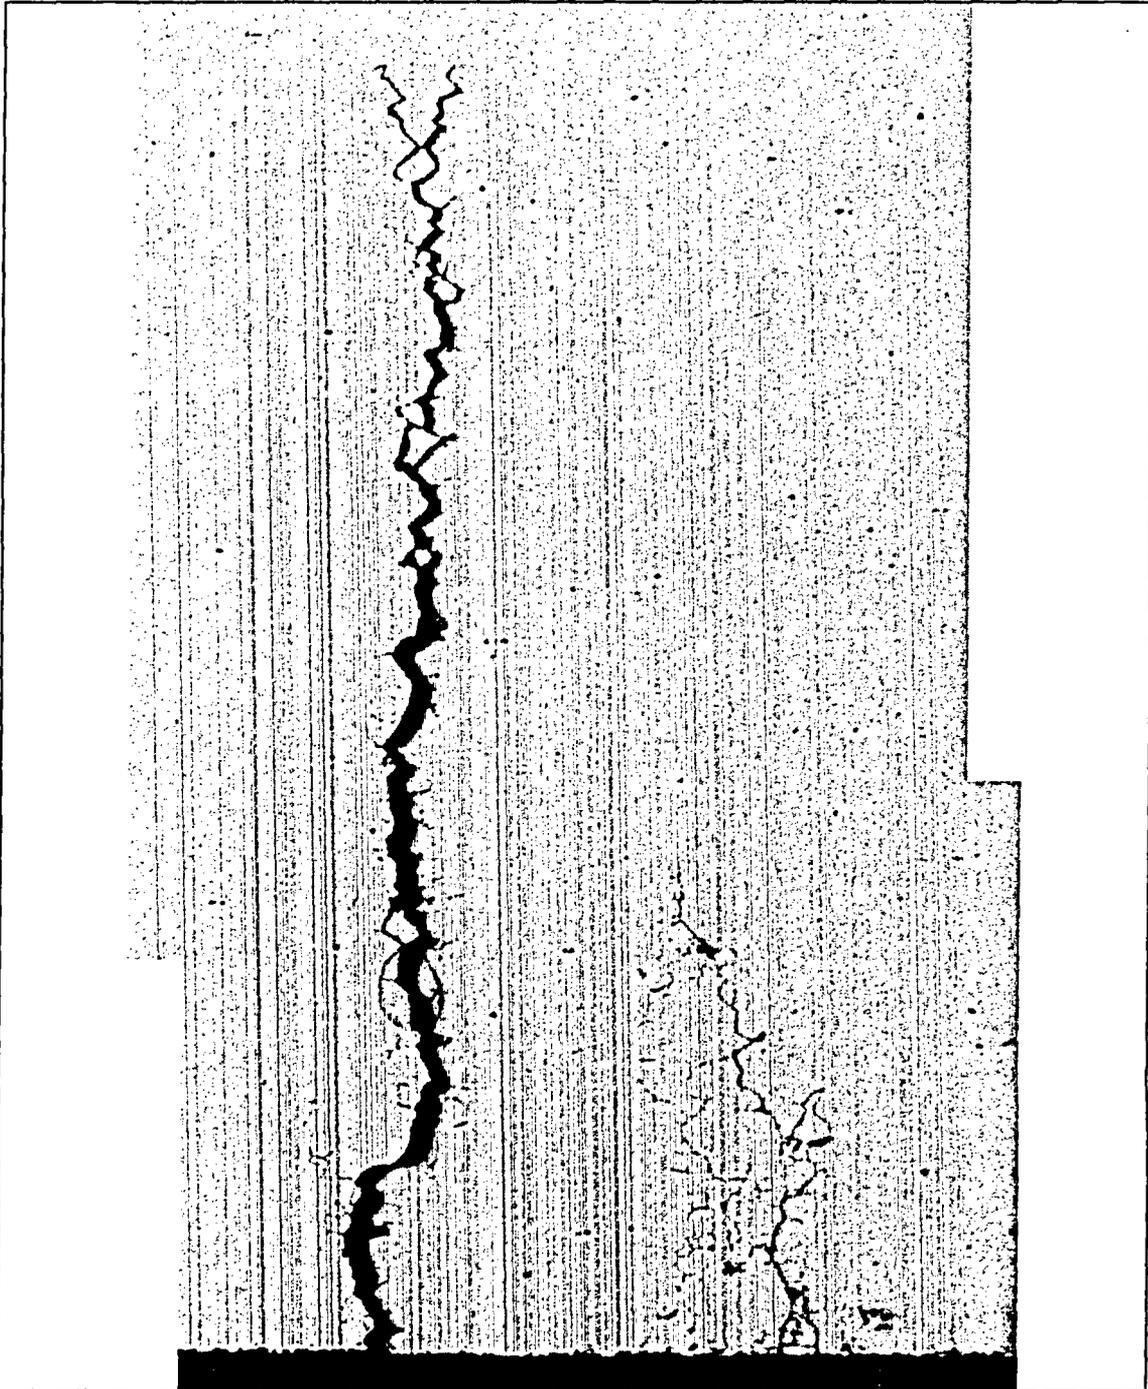
Figure 22 – A montage of the axial metallographic section thru the 65 degree position. Some of the metallurgical sections contained more than one crack that initiated from the inner surface of the tube. The large crack in this photo was 0.070" inches deep. (100x Magnification)

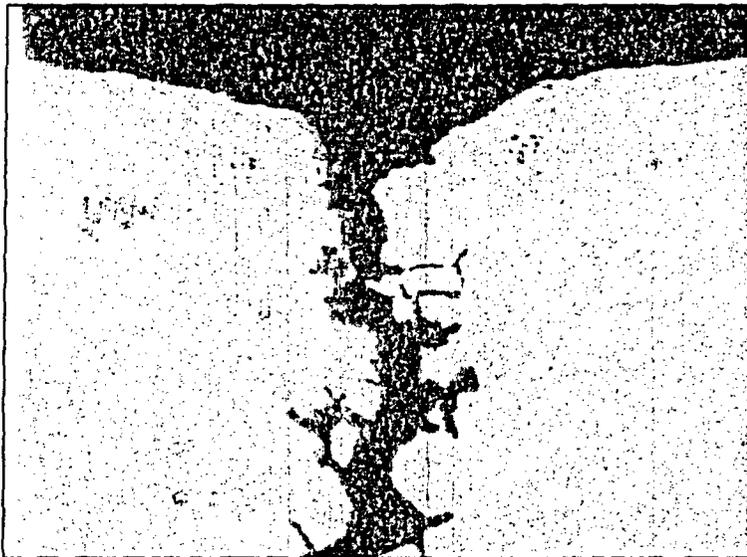
The metallurgical sections revealed evidence of crack tip blunting in the secondary crack branches near the outer diameter of the thru wall leak. The blunted appearance suggests the cracks were present for a relatively long period of time and the crack growth rate was relatively low.

Figure 23 - An un-etched metallographic view near the external surface of the thru wall crack. Note the blunted appearance of the secondary branches. Subsequent etching revealed the branches were intergranular in nature.

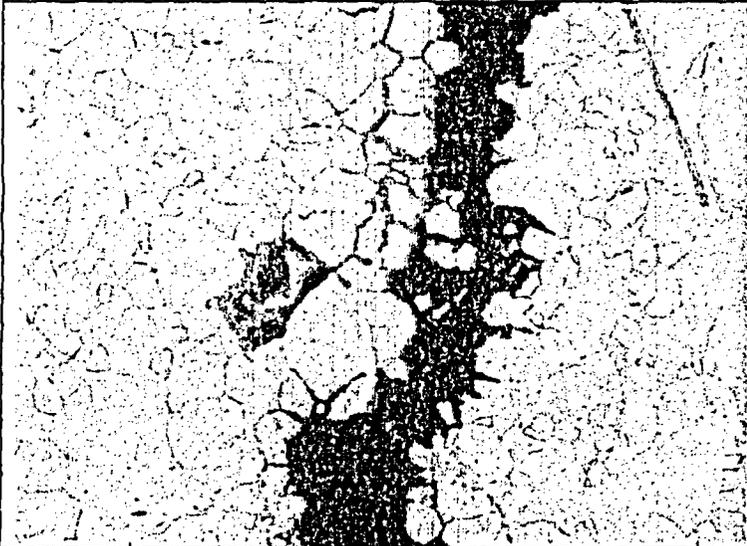
Figure 24 - Intergranular cracking near the midpoint of the thru wall crack. Note the intergranular, oxide-filled branches.

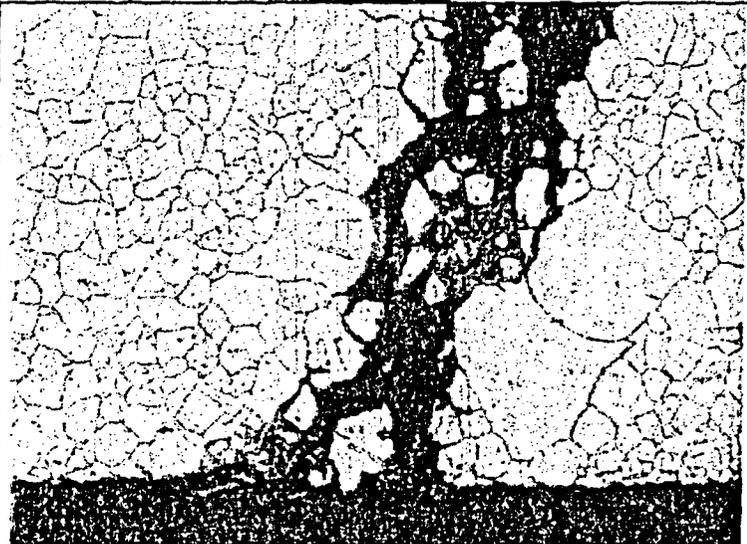
Figure 25 - Intergranular cracking near the ID of the thru wall leak. Note the oxide-filled cracking and the large variation in the adjacent grain size.

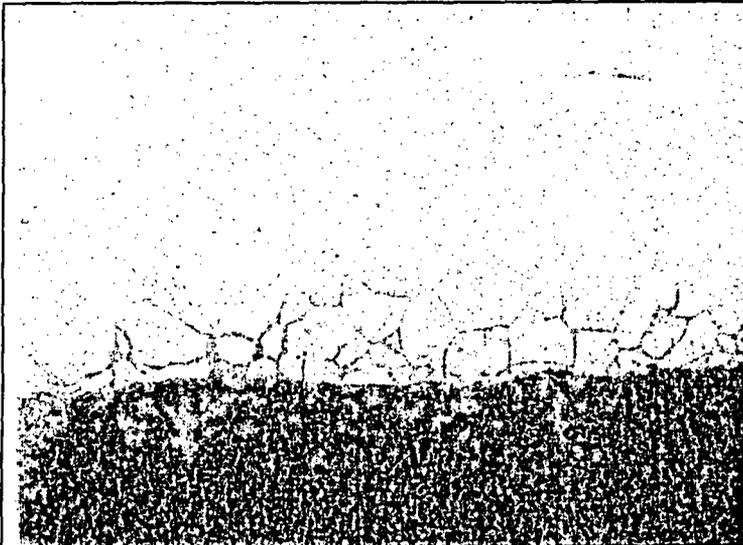
7. Patches of shallow, intergranular oxide-filled penetrations were observed at multiple heat-affected zone locations on the inner surface of the evaluated sections (Figure 26). The depth of the intergranular penetrations was typically less than 0.002".

Figure 26 – A photo showing a patch of intergranular, oxide-filled penetrations on the inner surface of the pressure tube at 180 degree location. Similar cracking was present at multiple heat-affected zone locations.

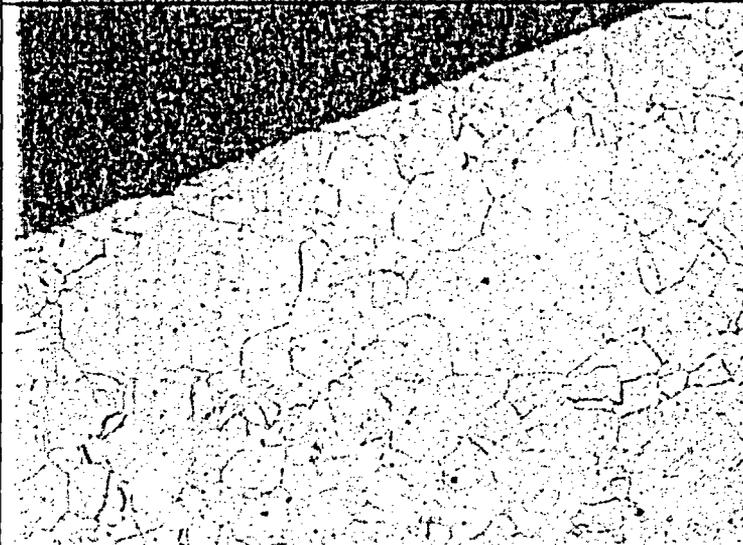
A circumferential metallurgical section was prepared thru the axial surface discoloration in sample 2. The section was located approximately 1 3/4" above the coupling's upper weld toe, which is considered representative of a tube location that is outside of the weld heat-affected zone. The tube microstructure contained duplex grains that were similar to the grains observed in the weld area sections (Figure 27). No microstructural anomalies were associated with the surface discoloration.

Figure 27 – An etched, circumferential metallurgical section thru the axial surface discoloration in sample 2. The duplex grain size is similar to the structure observed in the weld area mounts. There were no microstructural differences in the region that contained the discoloration.

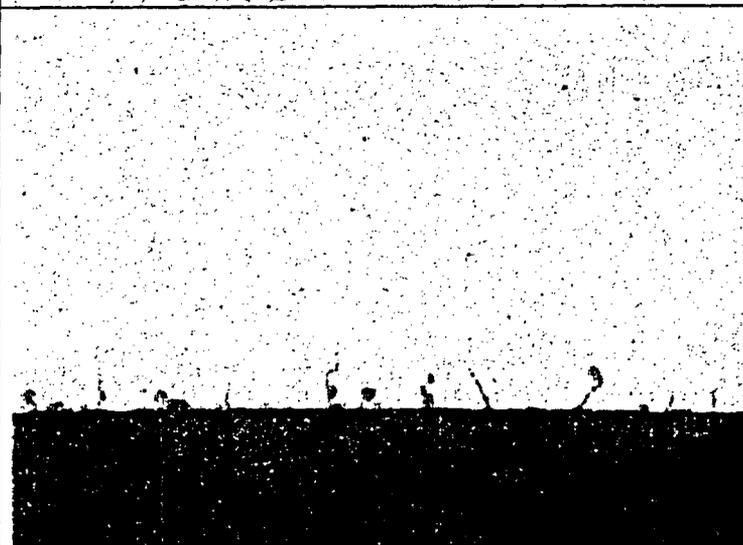
Figure 28 – Shallow intergranular penetrations on the internal surface of the pressure tube. The metallurgical section was located approximately 1 $\frac{3}{4}$ " above the toe of the upper coupling weld. Note the rounded, oxide-filled appearance of several penetrations.

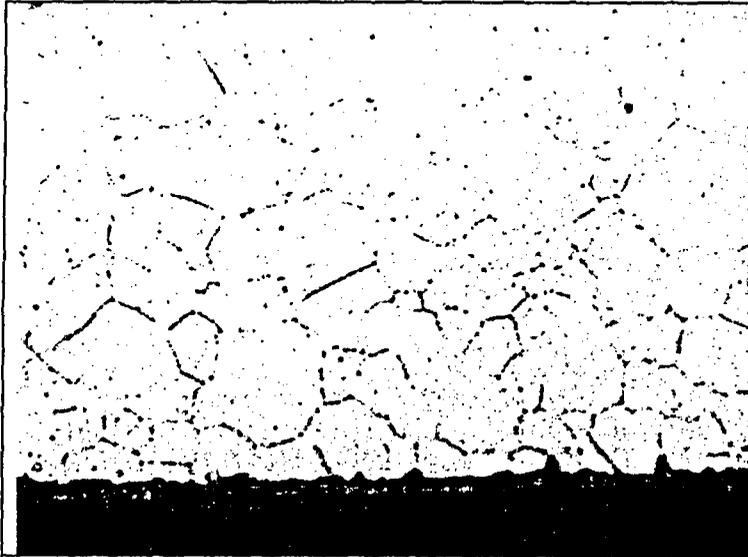
The pressure tube material in the circumferential metallurgical mount was evaluated for susceptibility to intergranular corrosion per ASTM A262, Practice A (i.e., oxalic acid etch test). After the test exposure, the microstructure along the inner surface exhibited a 'dual structure', which means there was partial grain boundary ditching that did not completely surrounding any single grain (Figure 29). The presence of the grain boundary ditching indicates the material near the inner diameter surface could be susceptible to intergranular corrosion in some environments. The grain boundary ditching was only observed within 0.006" of the inner surface of the tube. The microstructure in the remainder of the tube (i.e., away from the weld and away from the inner diameter surface) exhibited a 'stepped structure', which means it would have a low susceptibility to intergranular corrosion. The presence of grain boundary ditching in a tube sample away from the weld region suggests the near-surface intergranular susceptibility was not related to the welding process.

Figure 29 – The partially ditched microstructure that was observed near the inner tube surface after exposure to A262-Practice A etching. The grain boundary attack suggests the material near the tube ID was potentially susceptible to intergranular corrosion. Since the evaluated section was located away from the weld, the susceptibility was not related to the welding process. (333x Mag.)

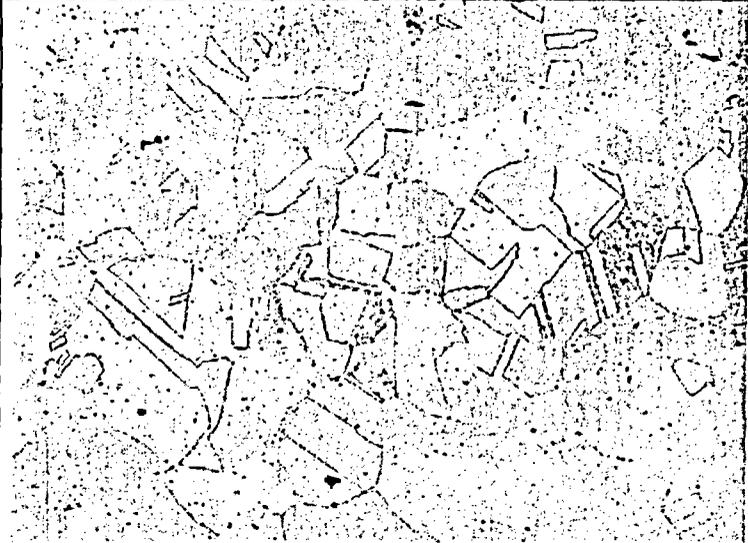
The coupling was also examined after the ASTM A262, Practice A exposure. The testing indicated the coupling material was not susceptible to intergranular corrosion, except for a local region in the weld heat-affected zone (Figure 30). The coupling base metal did not exhibit a duplex grain size.

Figure 30 – The coupling heat-affected zone microstructure after it was exposed to A262, Practice A testing. There was a thin region of grain boundary ditching in the heat-affected zone. The remainder of the coupling sample exhibited no ditching. The microstructure did not exhibit duplex grain sizes.

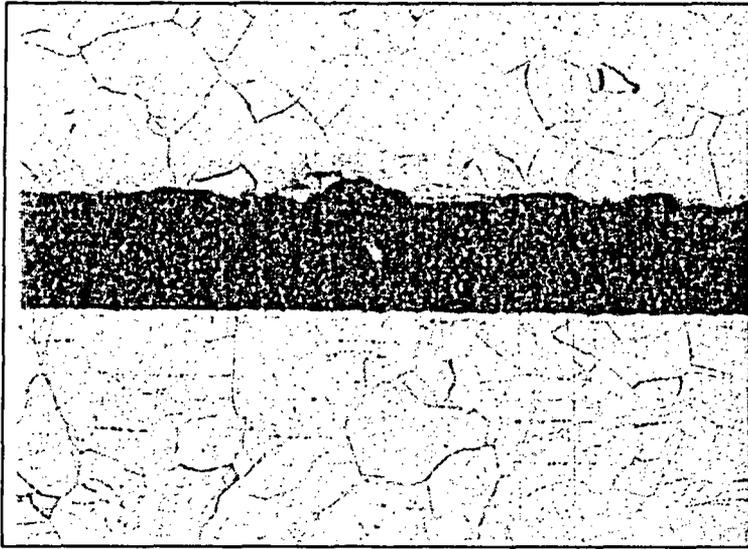
No evidence of intergranular corrosion or cracking was detected in a metallurgical section thru the crevice region for the lower coupling to heater sheath weld.

Figure 32 – The etched microstructure of the coupling (upper sample) and heater sheath, in the wetted crevice near the lower coupling weld. There was no evidence of intergranular corrosion or cracking in the sample.

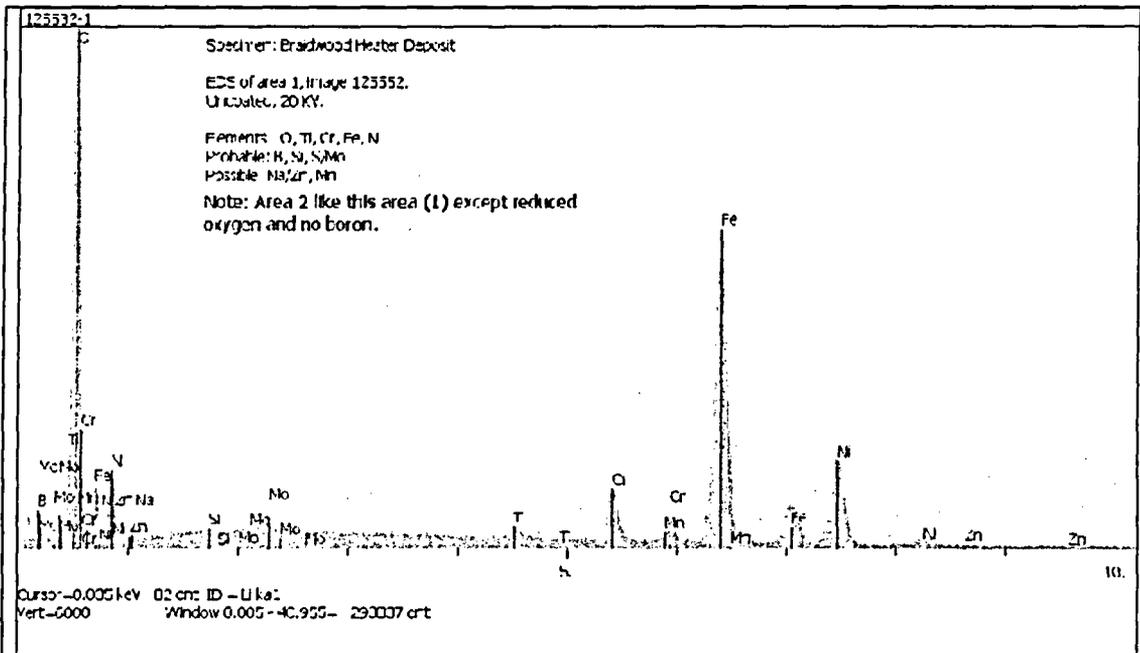
The crack surface deposits were qualitatively evaluated using EDS techniques and a representative spectrum is shown in Figure 36. The deposits contained a high oxygen peak and lesser amounts of iron, chromium, nickel and molybdenum, which is consistent with Type 316 stainless steel

Figure 36 – The EDS spectrum collected from dark deposits on the exposed crack surface. The spectrum contains relatively large oxygen (O), iron (Fe), nickel (Ni) and chromium (Cr) peaks, which is typical of stainless steel corrosion/oxidation products. Similar results were obtained for the deposits on the surface of the heater sheath.

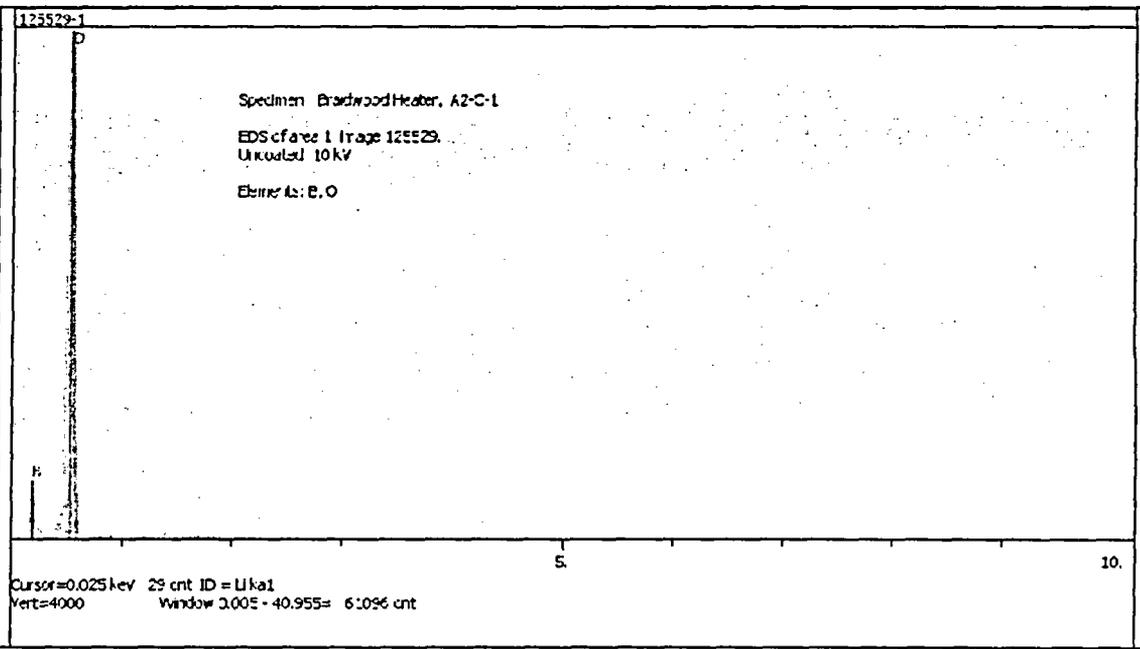
oxidation/corrosion products. The deposits were also evaluated at a low accelerating voltage to enhance the detection of elements with low voltage peaks (e.g., chlorine). The resulting spectrum contained oxygen and boron (Figure 37), which is consistent with boric acid deposits. Similar results were obtained for deposits collected from the outer diameter of the heater sheath.

Figure 37 – A low voltage EDS spectrum collected from a grayish region on the exposed crack surface. The boron (B) peak is typical of a boric acid deposit.

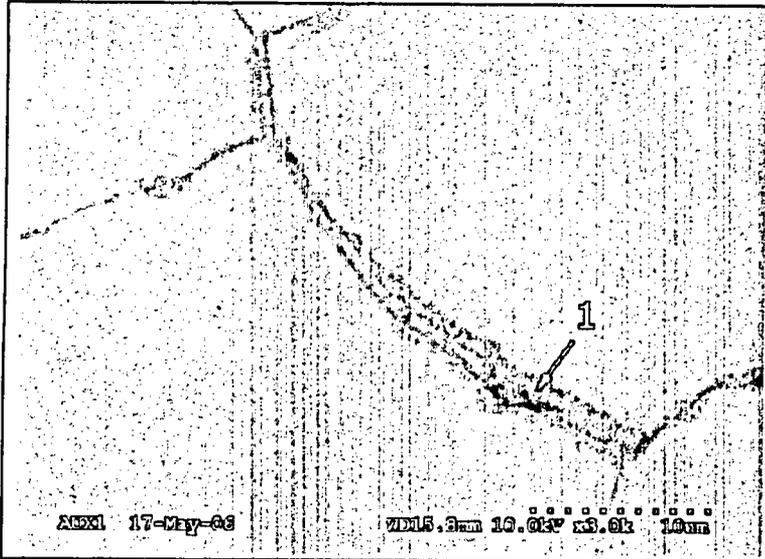
Figure 38 – A scanning electron microscope photo of an oxide-filled crack in the 270 degree section. The arrow points to the location of the Figure 39 EDS analysis. Also note the local corrosion/oxidation on the sides of the cracks.

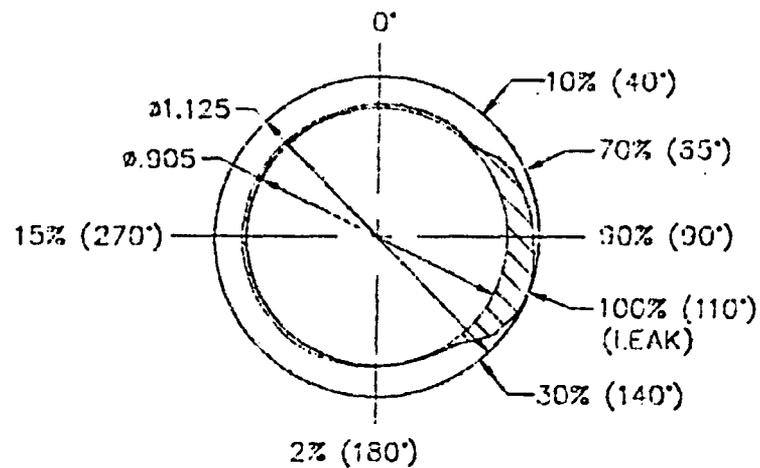
Figure 1: Schematic Representation of Braidwood Pressurizer Heater Sleeve Crack Depth Profile

3. The following maximum crack depths were measured in the axial sections: 0.010" in the 40° section, 0.070" at 65°, 0.090" at 90°, thru wall at 110°, 0.030" at 140°, 0.002" at 180°, and 0.015" at 270°.

CLOCK LOCATION	40°	65°	90°	110°	140°	180°	270°
DEPTH FROM I.D. (INCHES)	0.01	0.07	0.09	0.1	0.03	0.002	0.015
