NUREG/CR-6220
SAND94-0769

An Assessment of Fire Vulnerability for Aged Electrical Relays

Prepared by
R. A. Vigil, S. P. Nowlen

Sandia National Laboratories
Operated by
Sandia Corporation

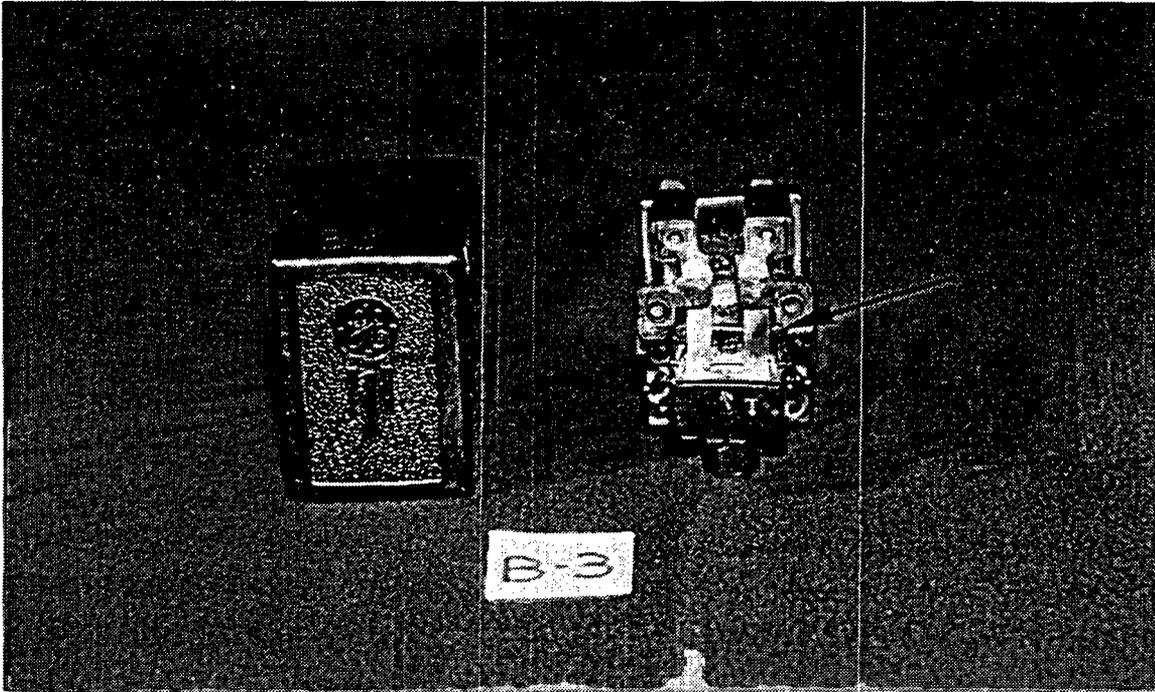
The first unaged relay, B3, was tested in the moderate profile and failed midway through the plateau period. The temperature at the time of failure was 348 °C. The mode of failure was again associated with an armature failure. However, in this case a closer inspection revealed that the armature had fused to the relay's housing. The point of the fusing is shown in Figure 6. The armature arm was separated from the housing when slight pressure was applied. However, it still did not actuate freely because of warpage of the relay's housing.

Figure 6 General Electric HMA relay B-3 after thermal exposure

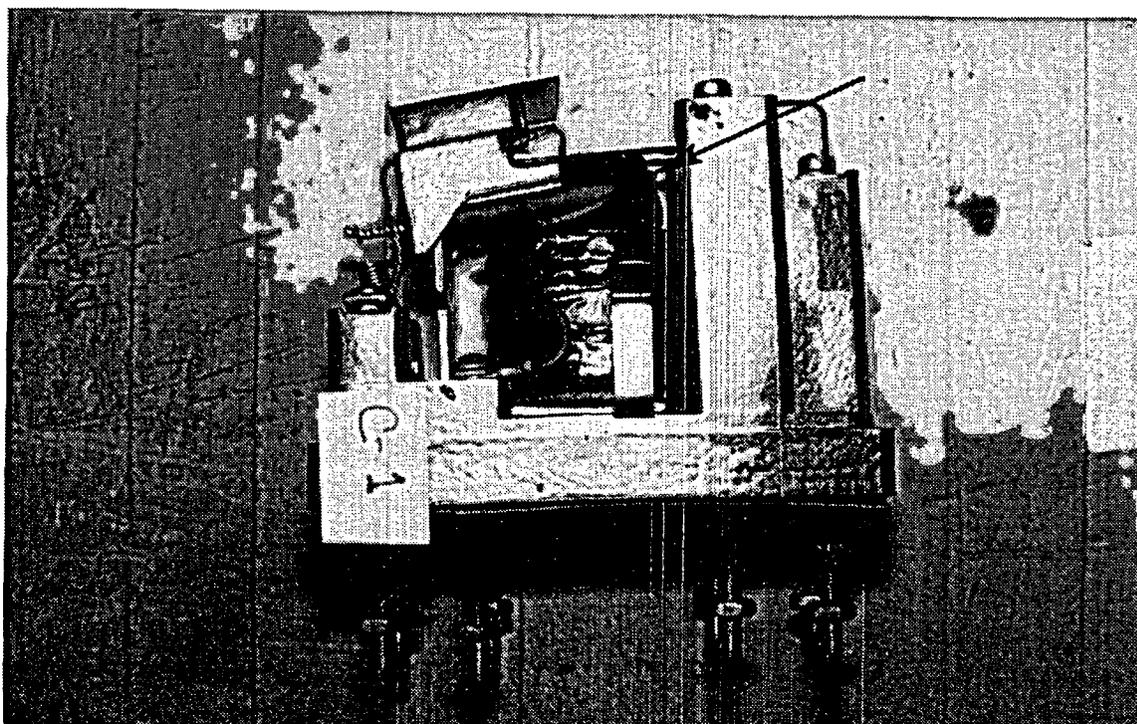
The first aged relay, C1, was tested in the moderate profile and failed during the late stages of the cool-down. The peak exposure temperature was 353 °C, and the temperature at the time of failure was approximately 150 °C.

(Note: data during the cool-down portion of the exposure were not recorded because of a data logging error. The time of failure was recorded by the test operator, but the final temperature was not recorded. The temperature shown in Figure A-11 of Appendix A is an estimate based on other profiles.) The failure was caused by warpage of the top plate of the coil's spool, which curled upwards and prevented the armature from actuating as shown in Figure 7. Note that this was the only instance in which this particular failure mode was observed.

Figure 7 General Electric HGA relay C-1 failure of the spool's top plate

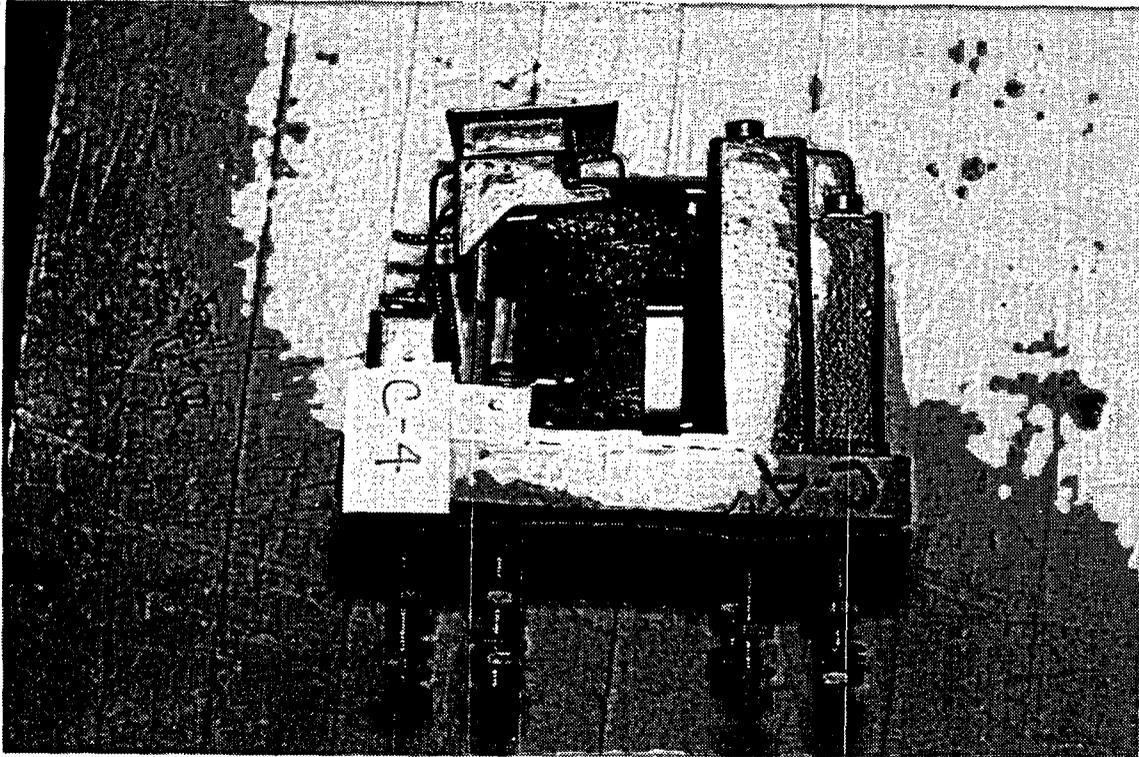
The second unaged relay, C4, was tested in the severe profile and failed at the end of the plateau period. The temperature at the time of failure was 453 °C. The failure mode was identical to that of relay C3; namely, an accumulation of an unknown substance underneath the armature prevented the armature from actuating. This substance can be seen in Figure 8.

Figure 8 General Electric HGA relay C-4 failure of the armature because of blockage

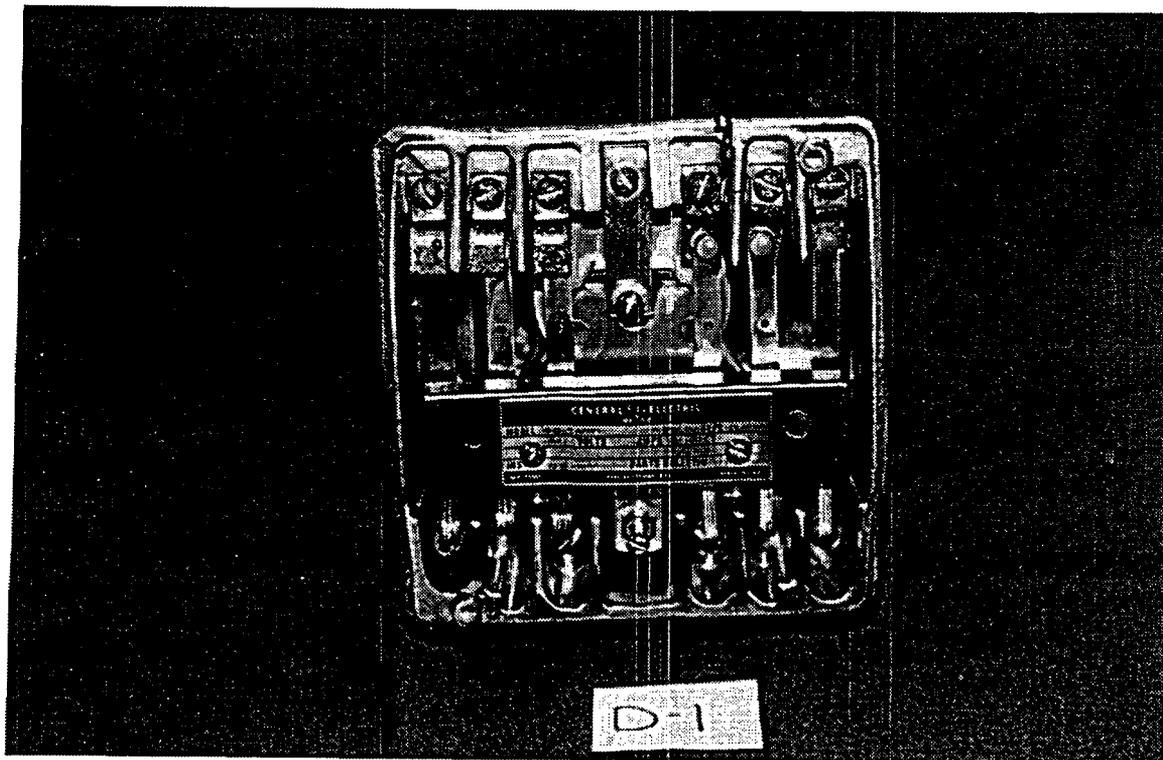
The first aged relay, D1, was tested in the moderate profile and failed early in the cool-down period. The peak exposure temperature was 359 °C, and the temperature at failure was 349 °C. The failure of two of the six contacts pairs was noted in load current measurements. Upon inspection, it was noted that the armature was warped or bowed. This warpage was severe enough to prevent the closure of two of the six contact pairs. However, the coil remained functional during post-test analysis.

All of the relays tested showed signs of deformation of the relay body. Many of the outer shells were cracked. Most of the relay bodies were also bowed or warped, as can be seen in Figure 9. The deformation of the relay body was evident in each of the GE HFA relays, with some more severe than others. The failures for four of the GE HFA relays were attributed to warpage of the armature.

Figure 9 General Electric HFA relay D-1 after thermal exposure
