SUBJECT: NRC INSPECTION REPORT 70-1113/2006-202 AND NOTICE OF VIOLATIONS

Report No.: 70-1113/2006-202

Licensee: Global Nuclear Fuel - Americas, LLC

Global Nuclear Fuel - Americas, LLC Fuel Fabrication Facility NRC Inspection Report 70-1113/2006-202

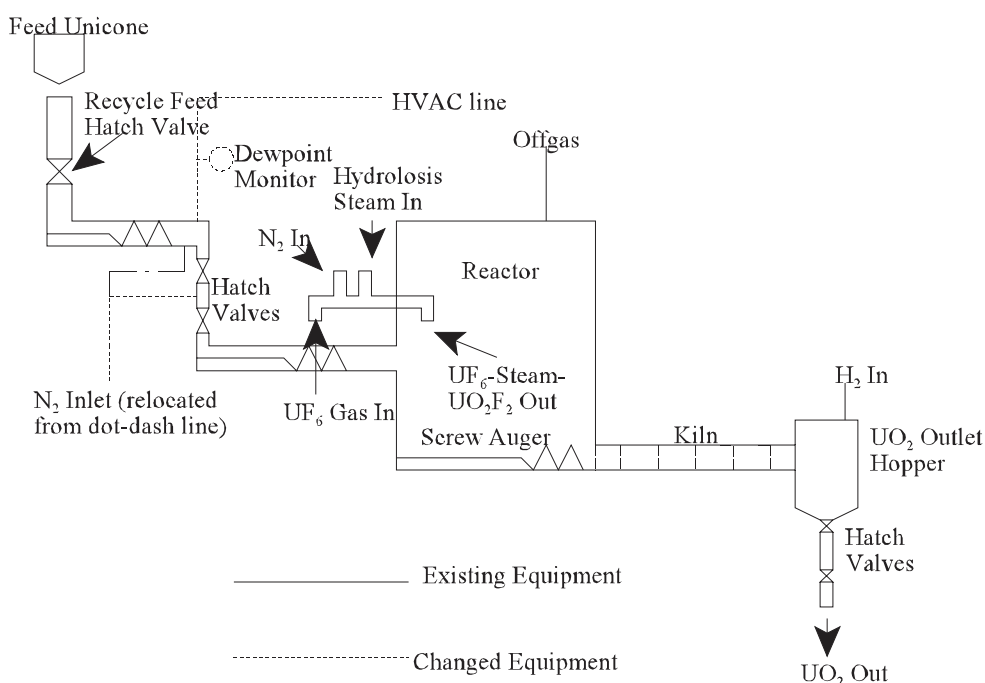
Figure 1 Schematic of Reactor-Kiln

The inspectors reviewed several changes to the DCP Reactor-Kiln CSA made in response to a recent internal event. CSA 1332.01, Rev. 10, was issued to add a dewpoint moisture probe on the Heating, Ventilation, and Air Conditioning (HVAC) vent on the upper recycle screw feed for the reactor-kiln in Conversion Line 1 (Change Request 06.0174). At the same time, the pressure transmitter for the diatomic nitrogen (N₂) supply was relocated (Change Request 06.0231) so that pressure could be easily controlled (see Figure 1). The licensee stated that these changes were made following a recent event in which a unicone feeding the reactor-kiln was left attached and accumulated a small quantity (stated as ~1/2 cup) of liquid water. The licensee

determined that this occurred as a result of two leaking “hatch valves” on the reactor feed. The two valves comprise an air lock on the inlet side that is intended to maintain the appropriate atmosphere in the interior of the kiln and prevent backflow to the feed unicone. As a result of that event, the licensee determined that the failure of the hatch valves could lead to a previously unanalyzed backflow scenario. The inspectors determined that the event was not safety significant because the unicone must be essentially empty for backflow to occur, and the amount of uranium and moisture present was small. The inspectors determined that the moisture probe, upstream of the hatch valves, should provide for effective early warning of backflow.

The inspectors confirmed that functional test 1332-20 for the dewpoint monitor specified that the test must confirm that the recycle feed hatch valve closes when the moisture detection probe exceeds its setpoint. The licensee indicated that it performed the test by removing the probe and exposing it to ambient air, which contains enough moisture to actuate the interlock. The inspectors determined that the functional test was adequate in that it tested the entire system. The inspectors determined that the change was safe.
