SUBJECT: INSPECTION REPORT NO. 70-1151/2006-203

**U.S. NUCLEAR REGULATORY COMMISSION
OFFICE OF NUCLEAR MATERIAL SAFETY AND SAFEGUARDS**

Report No.: 70-1151/2006-203

**Westinghouse Electric Company
NRC Inspection Report No. 70-1151/2006-203**

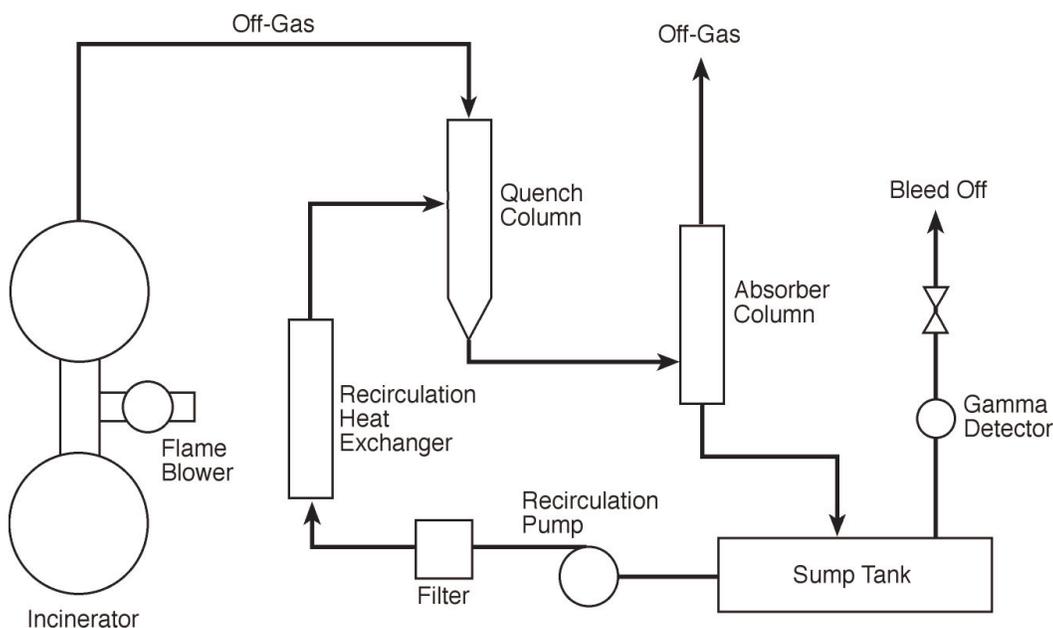
Figure 1

The inspectors reviewed the licensee investigation of a blower fire in the recently restarted incinerator. The inspectors noted that discharge from the quench sump tank was interrupted when uranium content increased beyond discharge limits resulting in an increase in water level in the absorber tanks until the incinerator off-gas ceased to flow through the quench tanks. As a result of increased system pressure, off-gas leaked through the flame blower and caused a fire in the flame blower filter. The incinerator quench system is illustrated in Figure 1.

The licensee proposes to correct the problem by redirecting the sump discharge through the quench recirculation line filter to reduce contamination levels at discharge. The licensee investigation was not complete at the time of the inspection. The inspectors did not identify any safety concerns during review of the flame blower fire. Because the incinerator quench system is a key component of the criticality safety basis for the incinerator, corrective actions for the incinerator flame blower fire will be tracked as **Inspection Follow-up Item (IFI) 70-1151/2006-203-01**.
