Subject: Licensee Event Report 2006-002 Revision 0 for the Fort Calhoun Station

1. FACILITY NAME Fort Calhoun Station	2. DOCKET NUMBER 05000285	3. PAGE 1 OF 7
---	-------------------------------------	--------------------------

4. TITLE
Inadequate Design Control Results in Potentially Insufficient Auxiliary Feedwater Flow

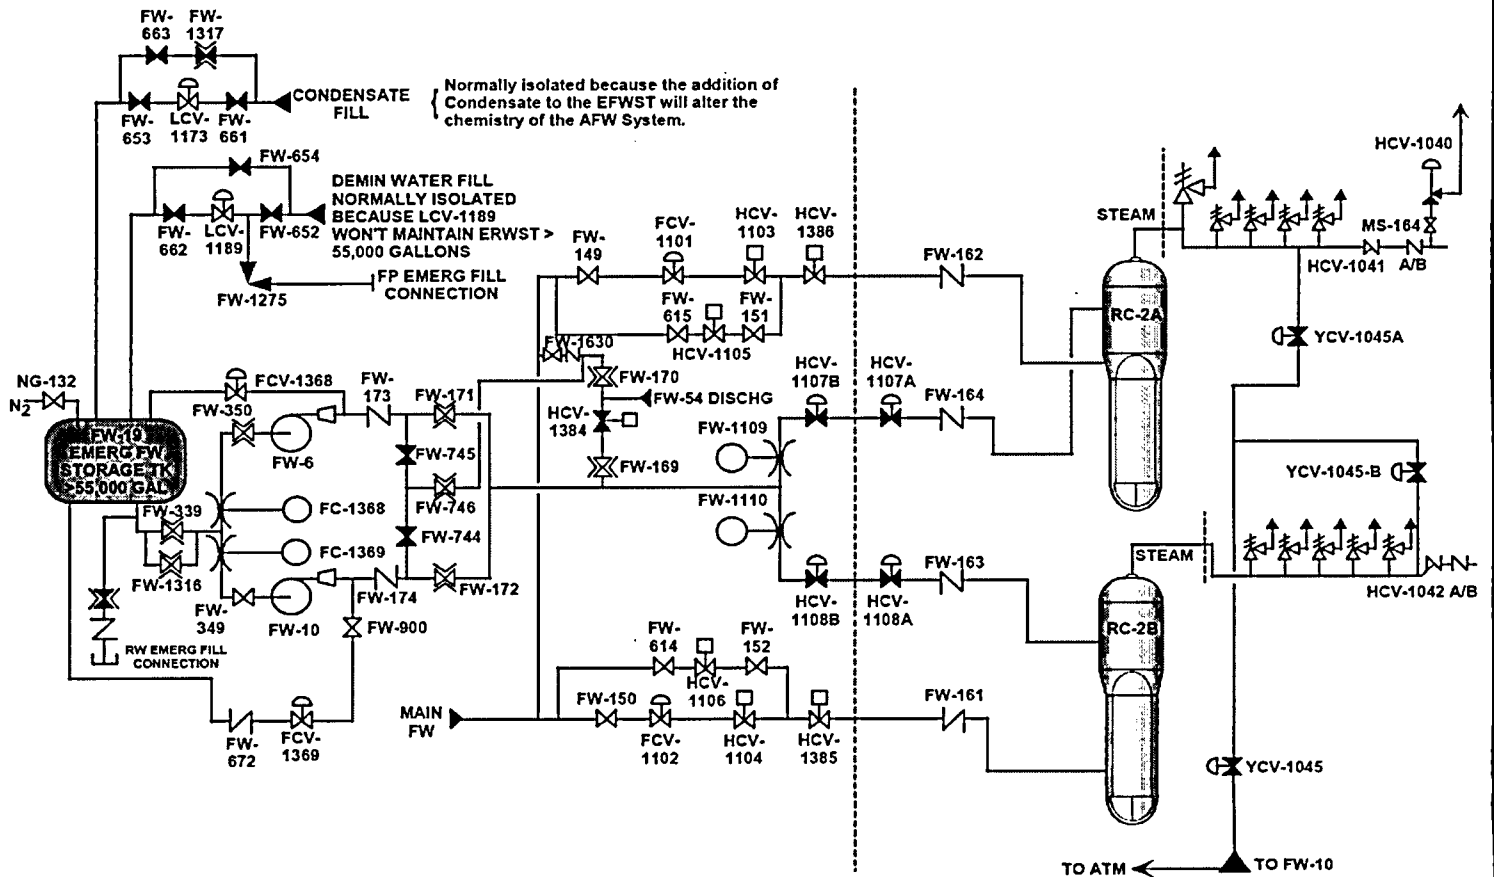
Figure 1

The system is designed to add feedwater to either or both steam generators under any condition, including the loss of all electrical power along with the loss of the MFW system and the loss of the main steam piping downstream of the main steam isolation valves. The AFW system fulfills both safety-related and non-safety-related functions. See Figure 1.

AUXILIARY FEEDWATER DIAGRAM
