Beaver Valley Power Station, Unit No. 1
Docket No. 50-334 License No. DPR-66
LER 2006-003-00

LER 2006-003-00, 10 CFR 50.73(a)(2)(i)(B), "Inadvertent Technical Specification Noncompliance Due to Inoperable Containment Isolation Valve."

4. TITLE
Inadvertent Technical Specification Noncompliance Due to Inoperable Containment Isolation Valve

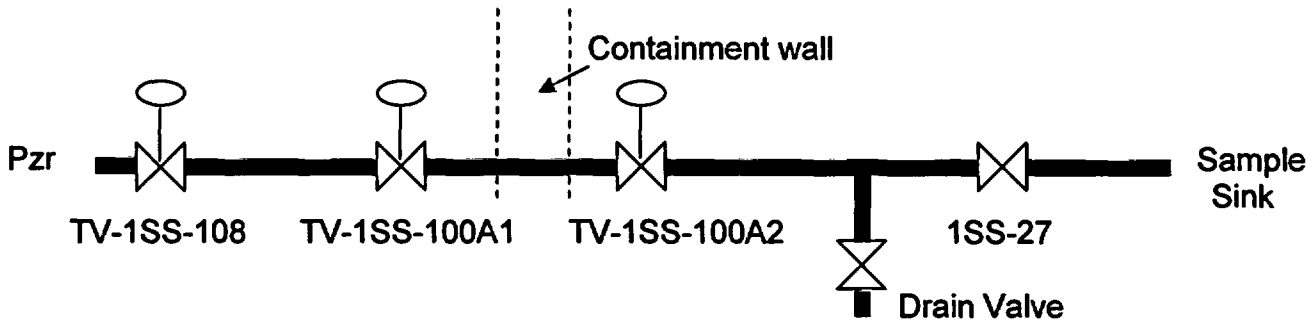
Simplified Sketch of Valves

At approximately 1300 hours, a maintenance clearance was initiated to isolate sample system manual valve 1SS-27 just downstream of the outside containment isolation valve, TV-1SS-100A2. The air supply to TV-1SS-100A2 was isolated shortly thereafter. Since the valve's actuator was not vented, the valve remained open, and was inoperable due to it not being capable of automatic closure. The upstream inside containment isolation valve (TV-1SS-100A1) remained in its normally open position during this time (which was not intended to be closed). Although the next further upstream valve inside containment, TV-1SS-108, remained in its normally closed position, it did not have its power removed.
